**National Register of Historic Places
Inventory—Nomination Form**

Historic Resources of Stamford

Name of property- J.P. Astin House

Address of property- 111 E. Campbell

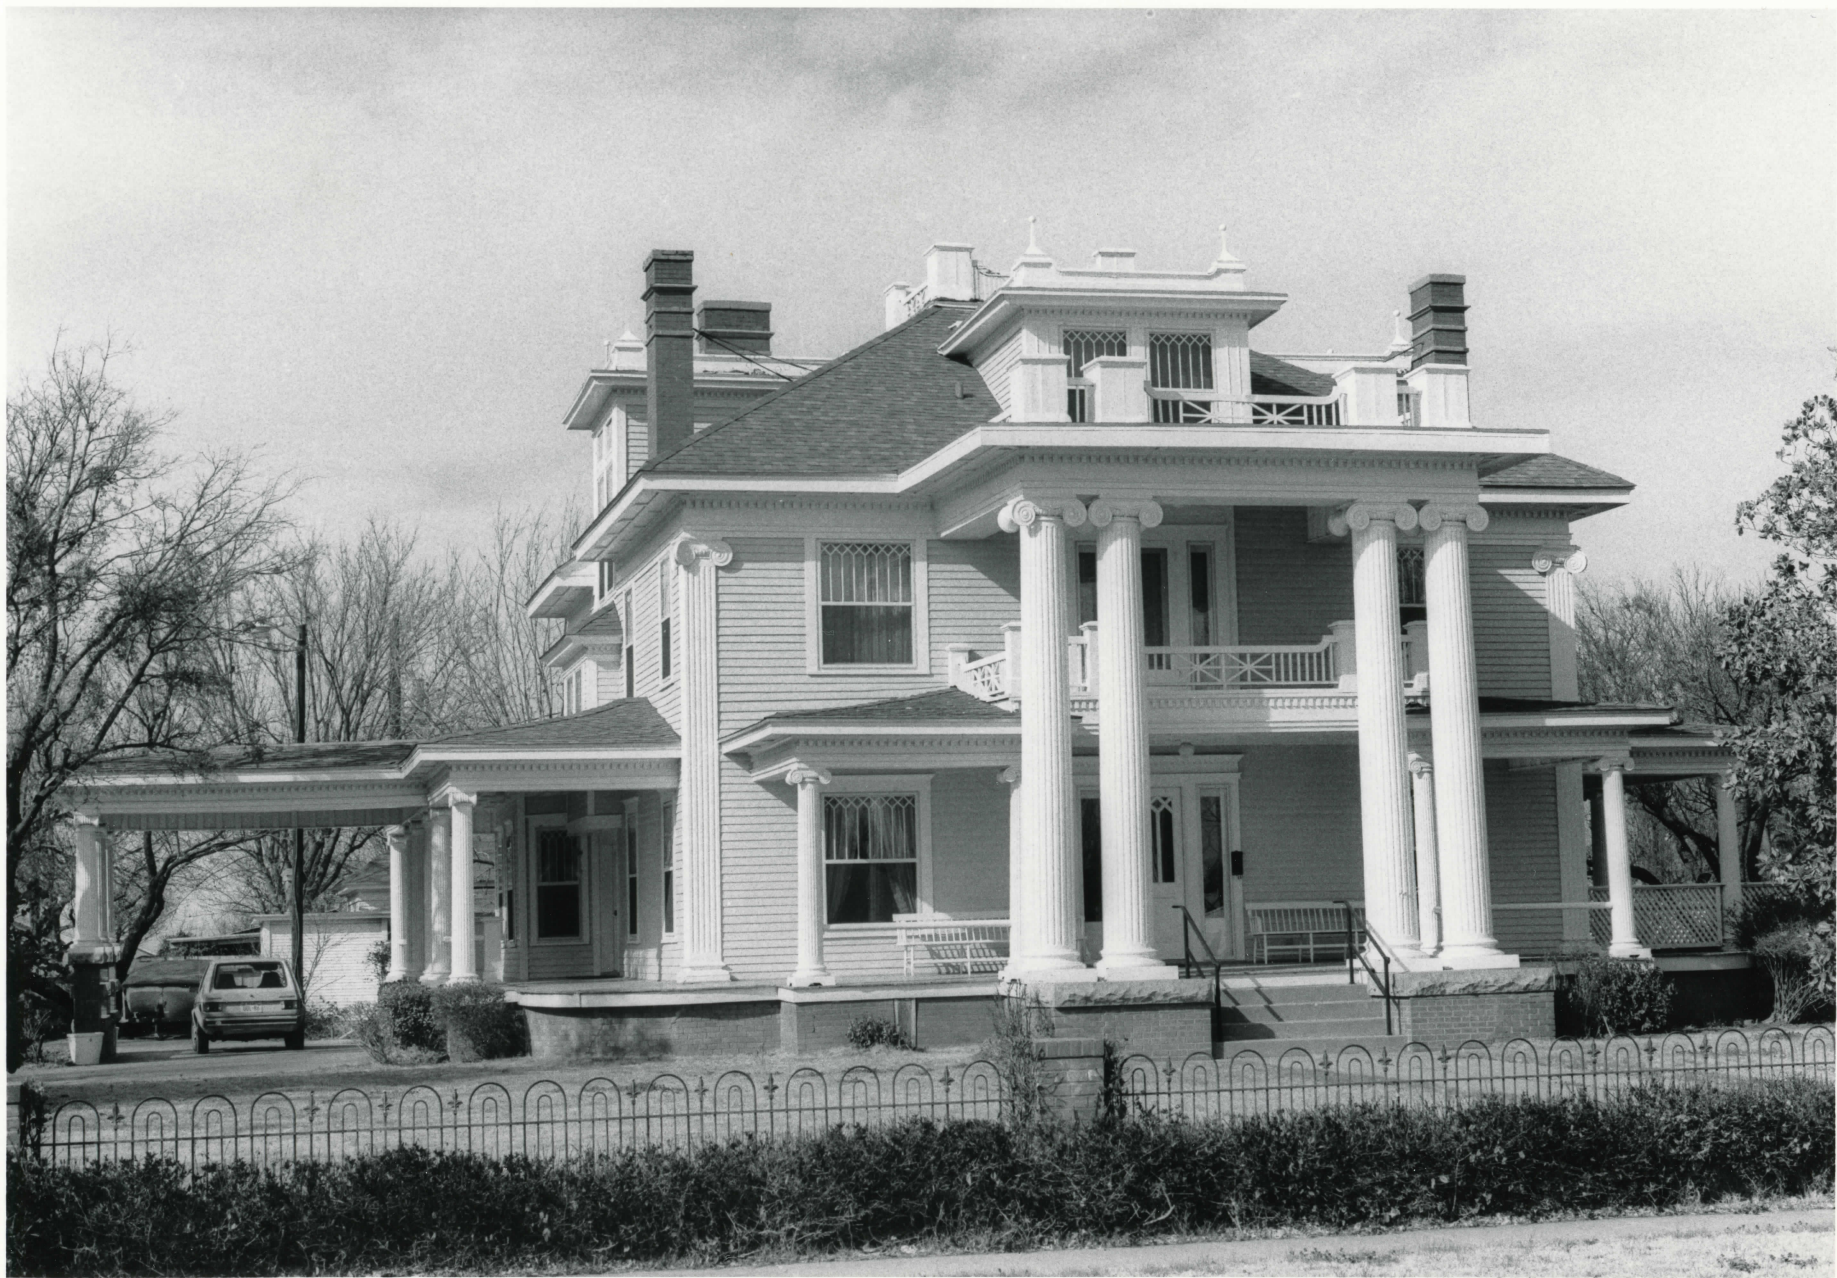
9-19A

Property No. 17 (Sta-115), J.P. Astin Home,
111 E. Campbell, looking NW

This elaborate Neo-Classical Revival home is of wood-frame construction with wooden detailing. The two-story house has a hipped roof now covered in composition shingles.

A widow's walk on the roof provides a view for many miles in all directions. Large, square dormers project from each side of the roof, each with lozenge windows and parapet; the cornice detailing repeats that found elsewhere on the house. The boxed eaves of the roof have modillions, a row of dentils, and a wide and simple frieze. Three interior chimneys are found on the roof.

The two-story flat-roofed entry portico is supported by matched pairs of wooden fluted columns with Ionic capitals. The portico is topped with a wooden railing consisting of slat balusters and a decorative pattern representing St. George's cross.

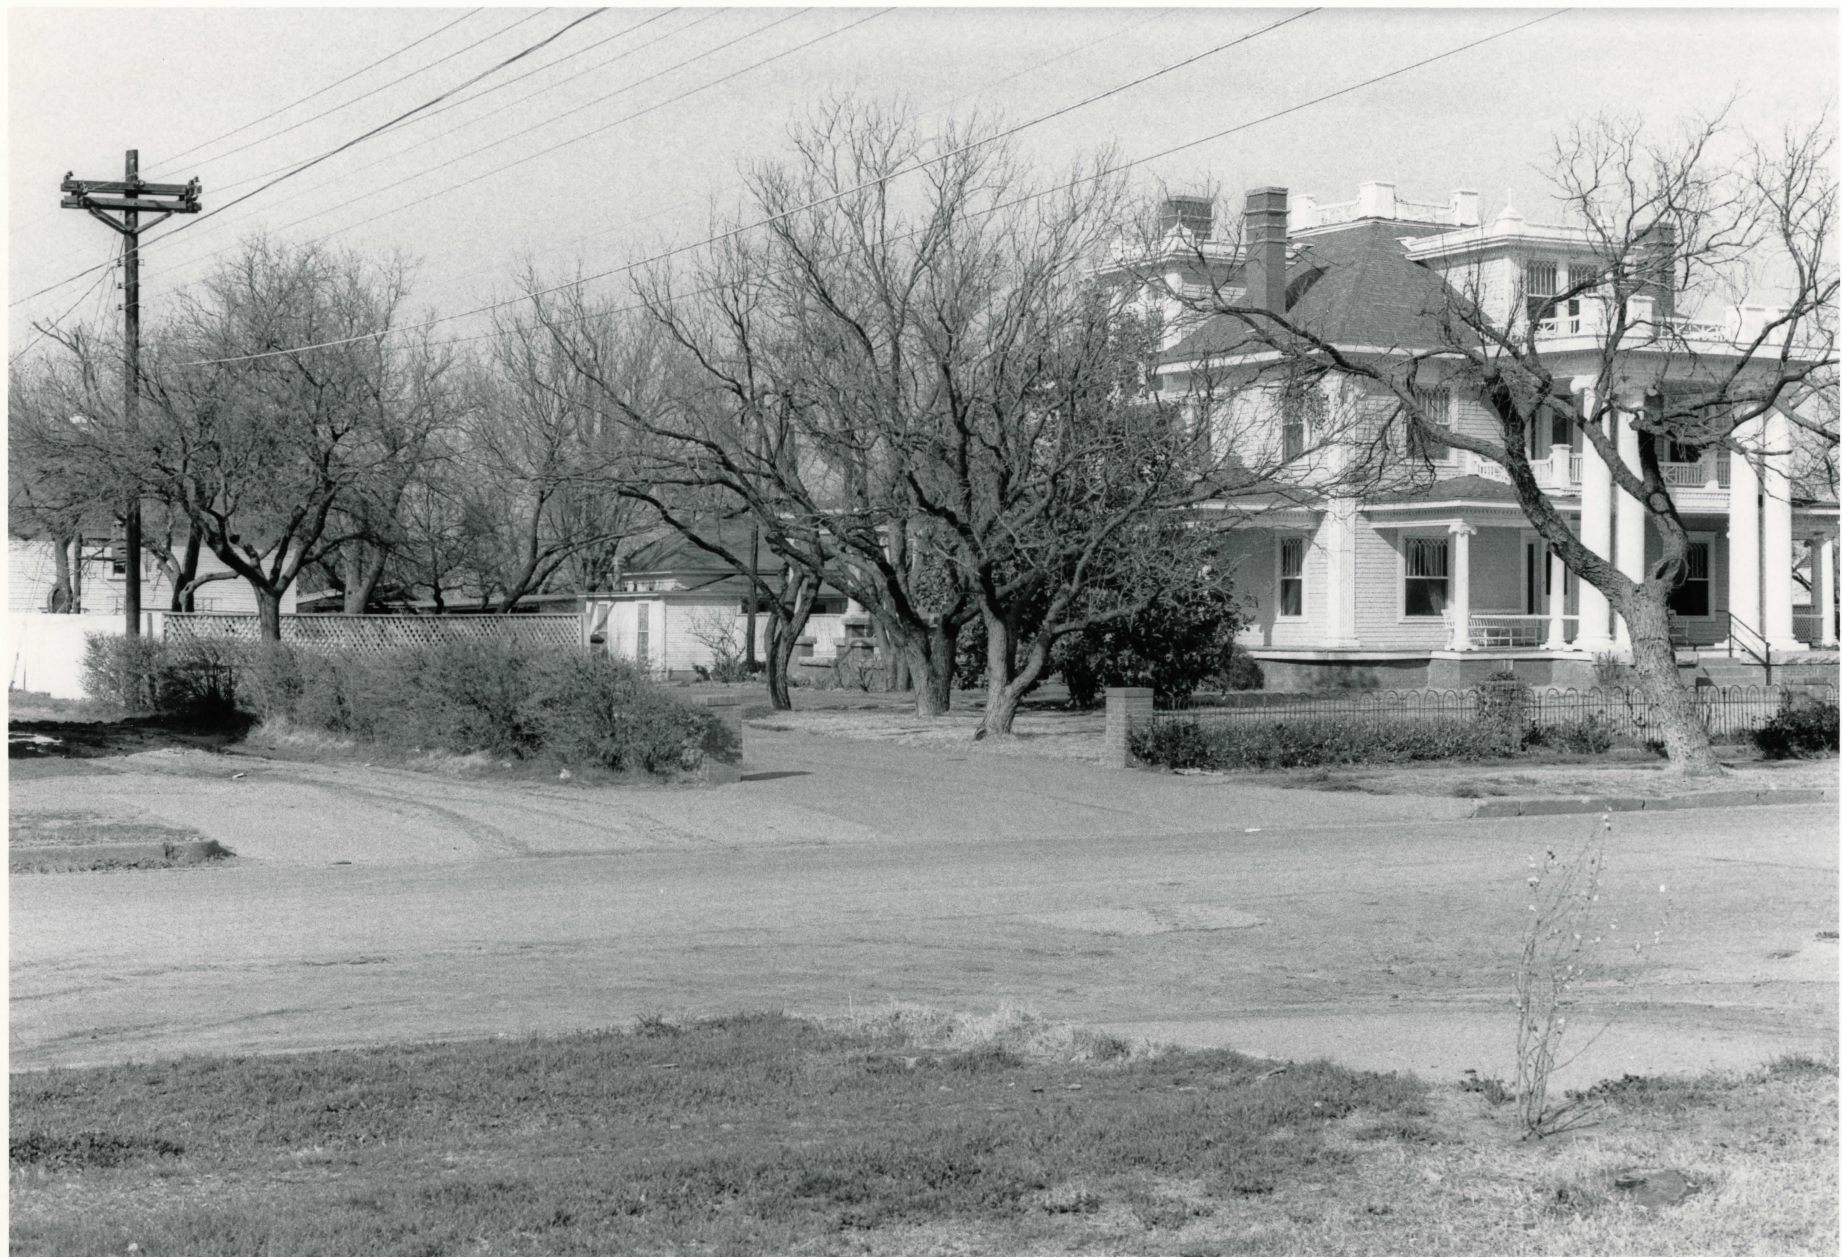
9-20A

Property No. 17 (Sta-115), J.P. Astin Home,
111 E. Campbell, looking NE

Independent one-story porches are found on each side of the house. These hipped-roof porches have slender Ionic columns and cornice detailing similar to the main roof line. The porch that passes under the full-height entry forms a porch for the second story. The balustrade of this porch repeats the railing motif of the portico.

Bay windows are found under the east and west porches. A porte cochere with similar detailing extends from the west porch.
