National Register of Historic Places
Inventory—Nomination Form

1. O'Connor - Proctor Building

2. 202 N. Main

O'Connor--Proctor Building (Victoria MRA)
Victoria County
TEXAS

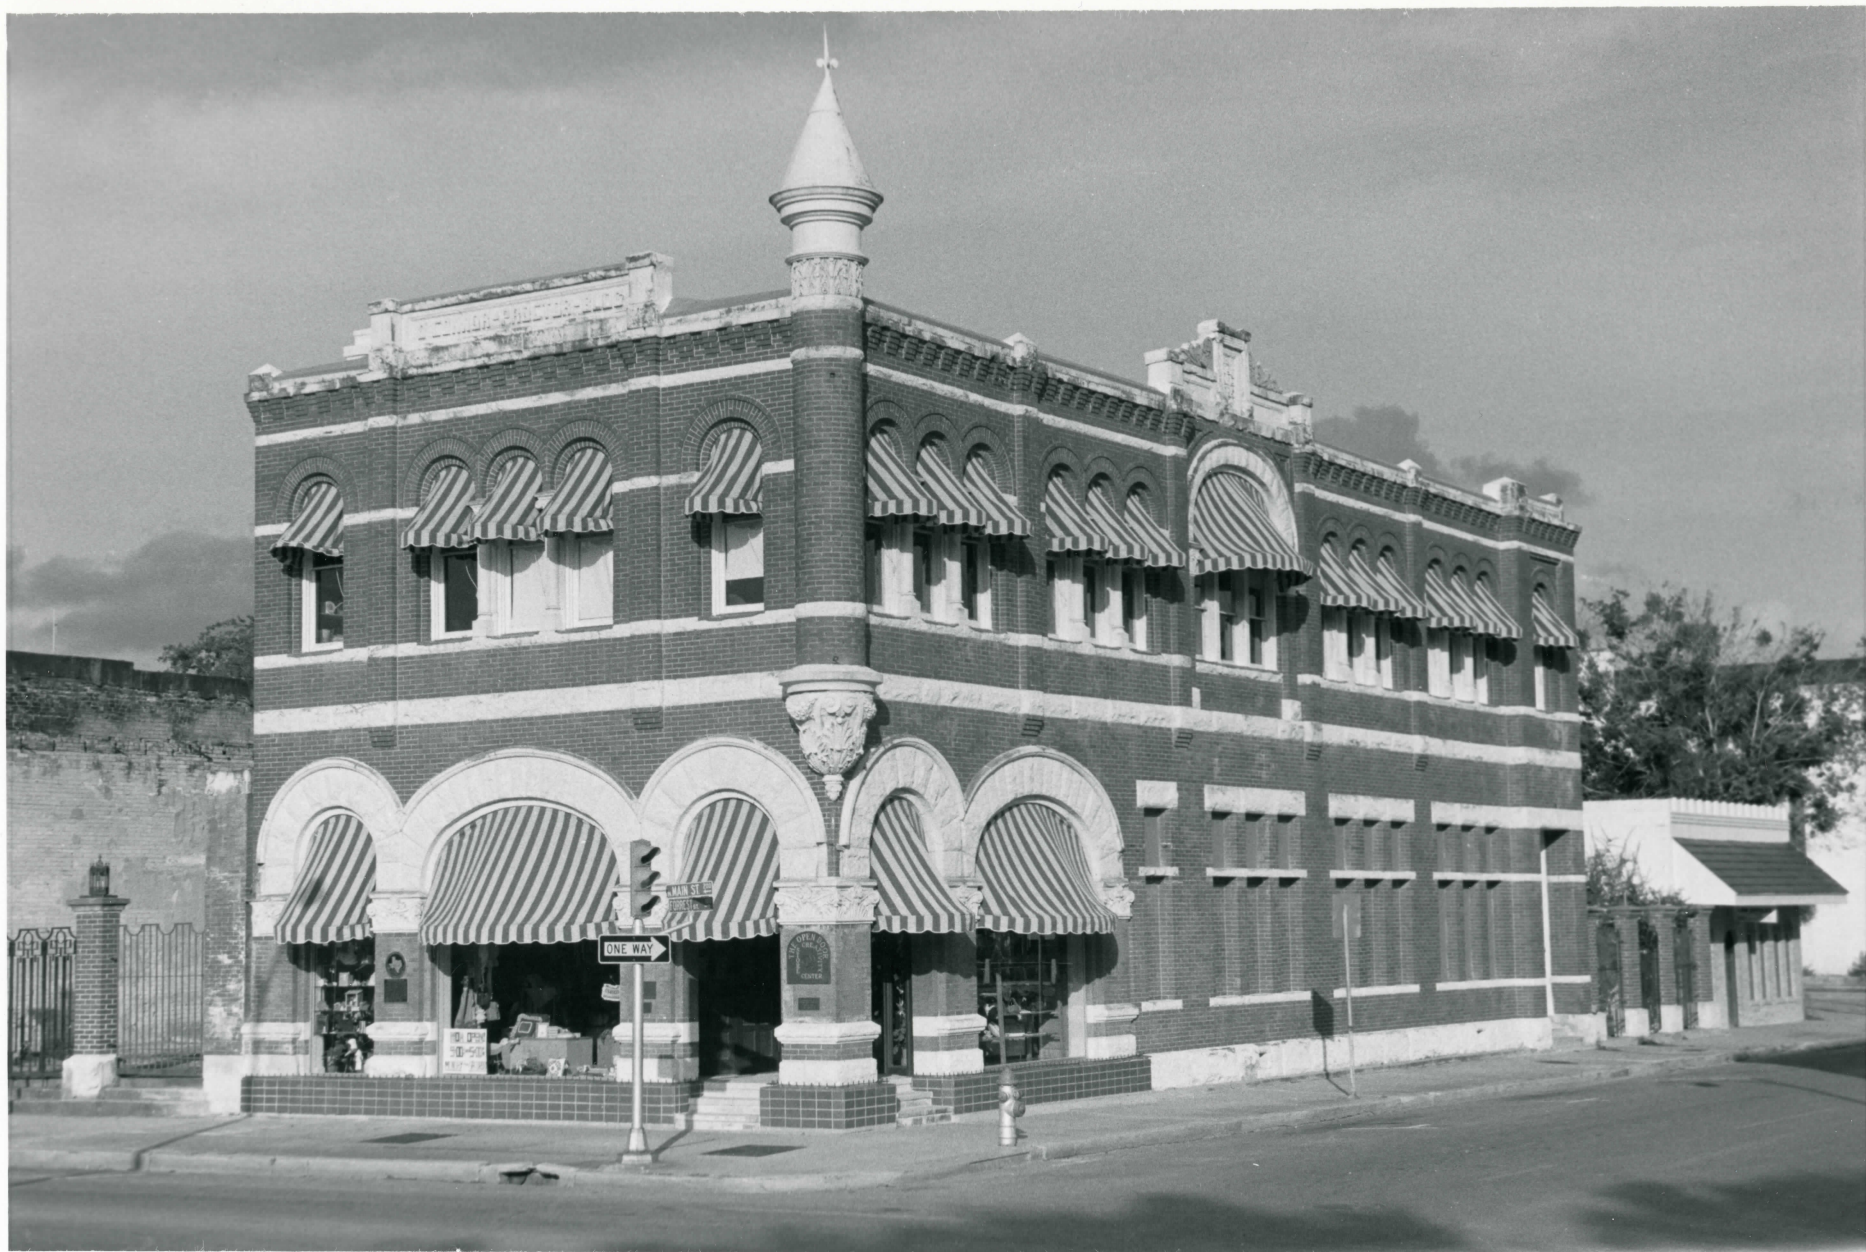
Photo

O'Connor-Proctor Building

Camera facing Northeast
