National Register of Historic Places  
Registration Form

historic name Grapevine Commercial Historic District

street & number 404-432 South Main Street ☒ not for publication

city or town Grapevine ☒ vicinity

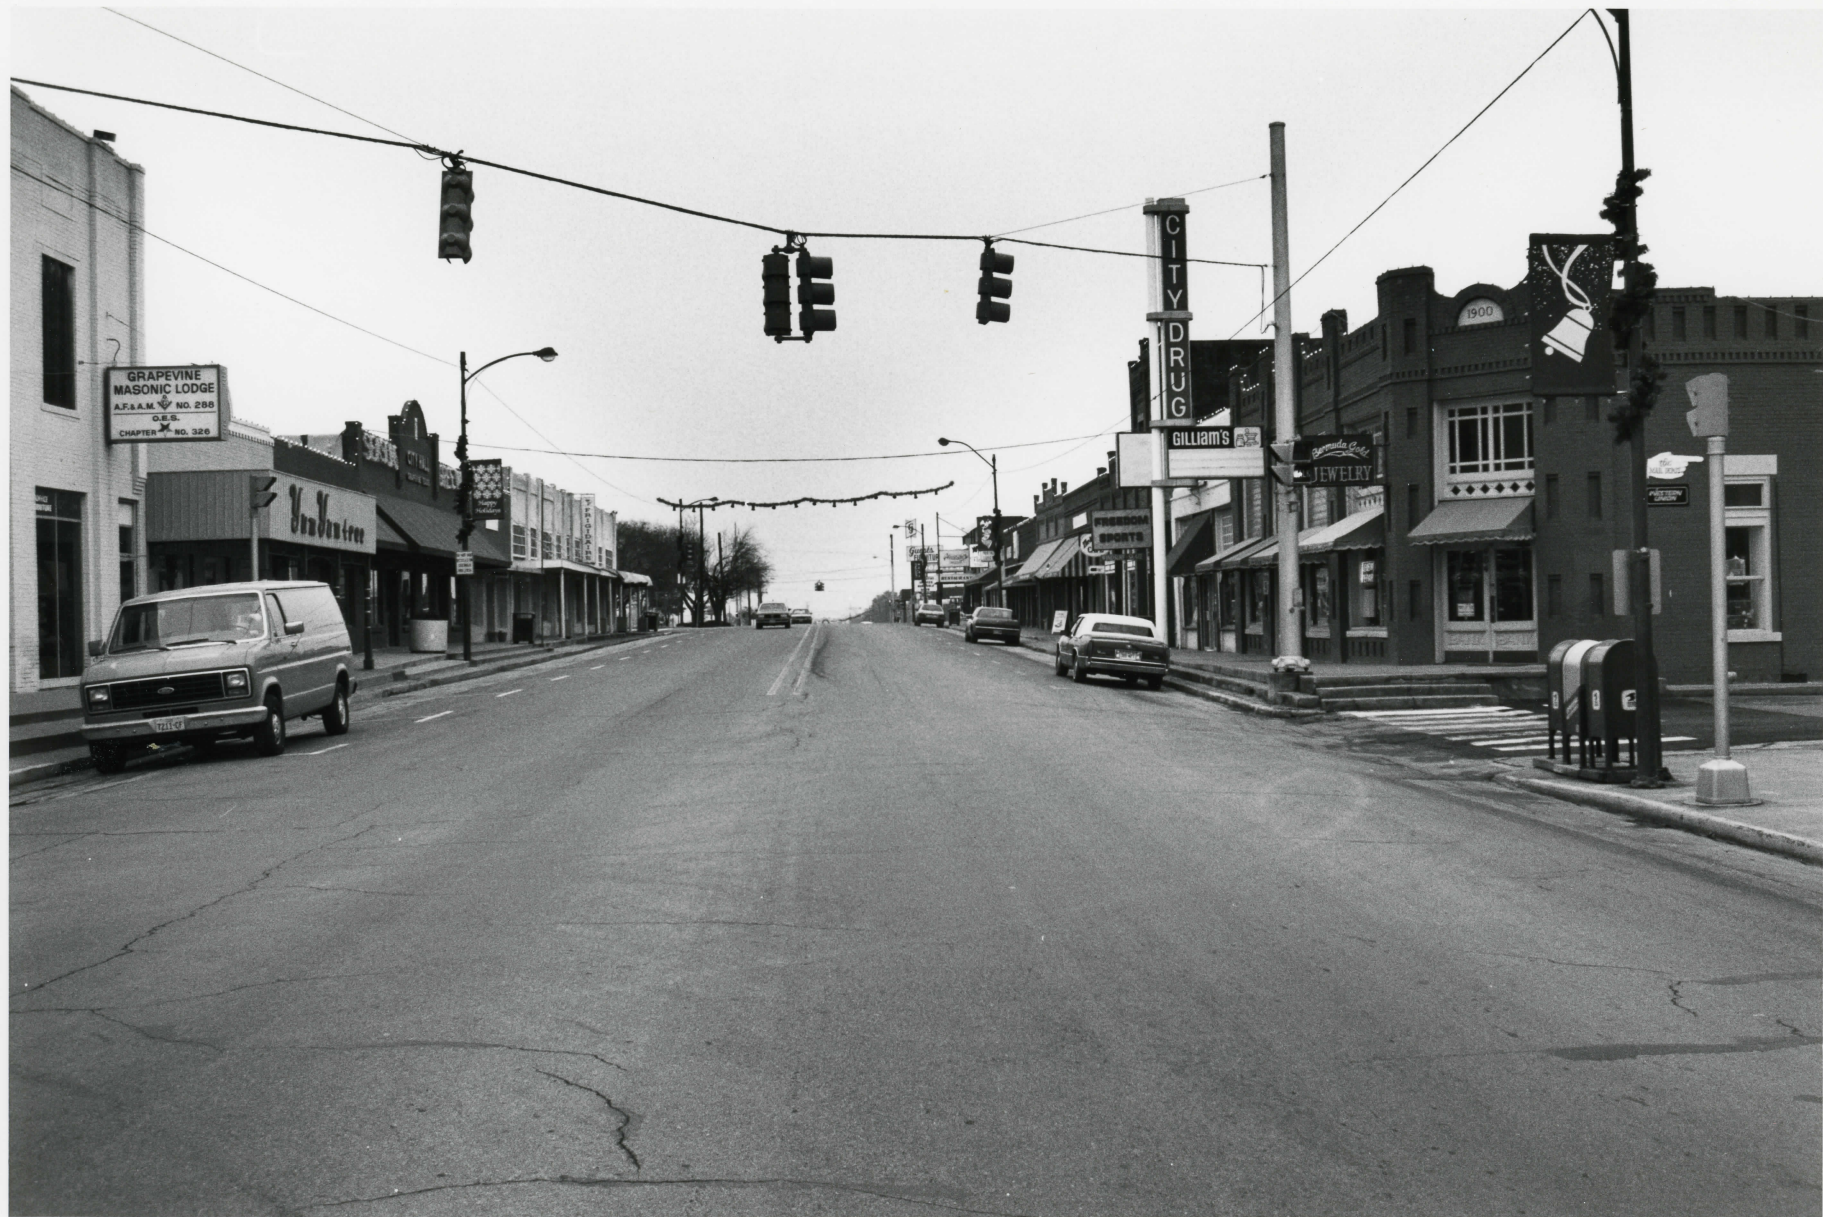
PHOTOGRAPH 1 of 10

PHOTOGRAPH 1 - 400 block South Main Street, camera facing south.

Built as the Grapevine Home Bank (est. 1901), the building is typical of a small town Main Street commercial structure, with fine brickwork and detailed transoms and windows, that retains its architectural integrity. (See Photograph #1, 3)

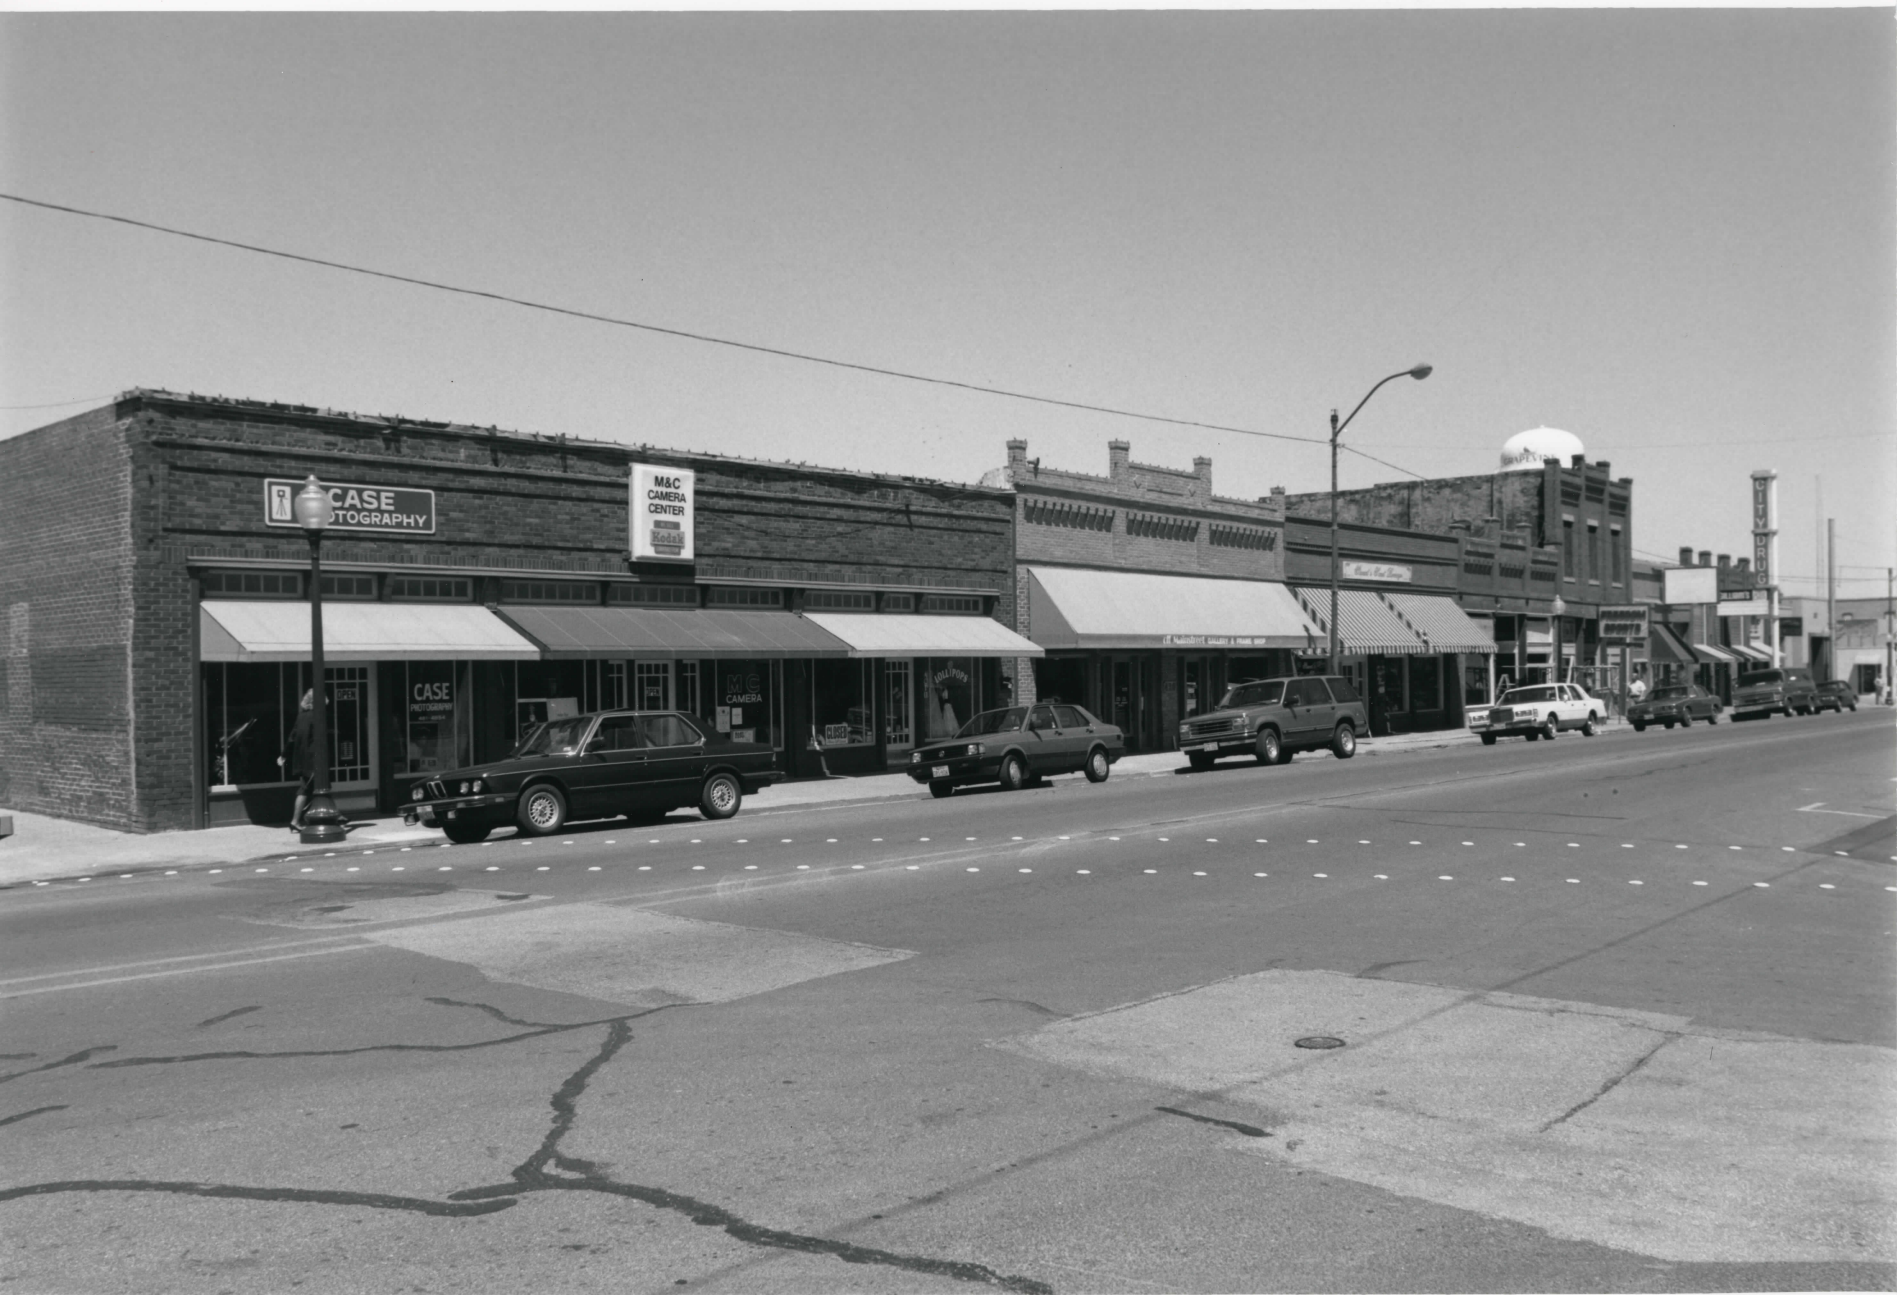
PHOTOGRAPH 2 of 10

PHOTOGRAPH 2 - 404-426 South Main Street, camera facing northwest.

GRAPEVINE COMMERCIAL HISTORIC DISTRICT  
GRAPEVINE, TARRANT COUNTY, TEXAS  
GENERAL STREETScape VIEW  
404-426 SOUTH MAIN

The Tate Hardware Company was an early tenant of this typical, small Main Street commercial row building retaining its original integrity. (See Photograph #2)

Long the site of the E.J. Lipscomb and Son family drygoods business (1900 - 1967), this typical small town commercial row building uses the same brick as the four similar structures at 412, 414, 418 and 422 S. Main. The building retains its architectural integrity. (See Photograph #2)

The multi-light transoms and center entry doors of these three structures mark them as typical of small town Main Street commercial row buildings. They retain their architectural integrity. (See Photograph #2, 5, 7)

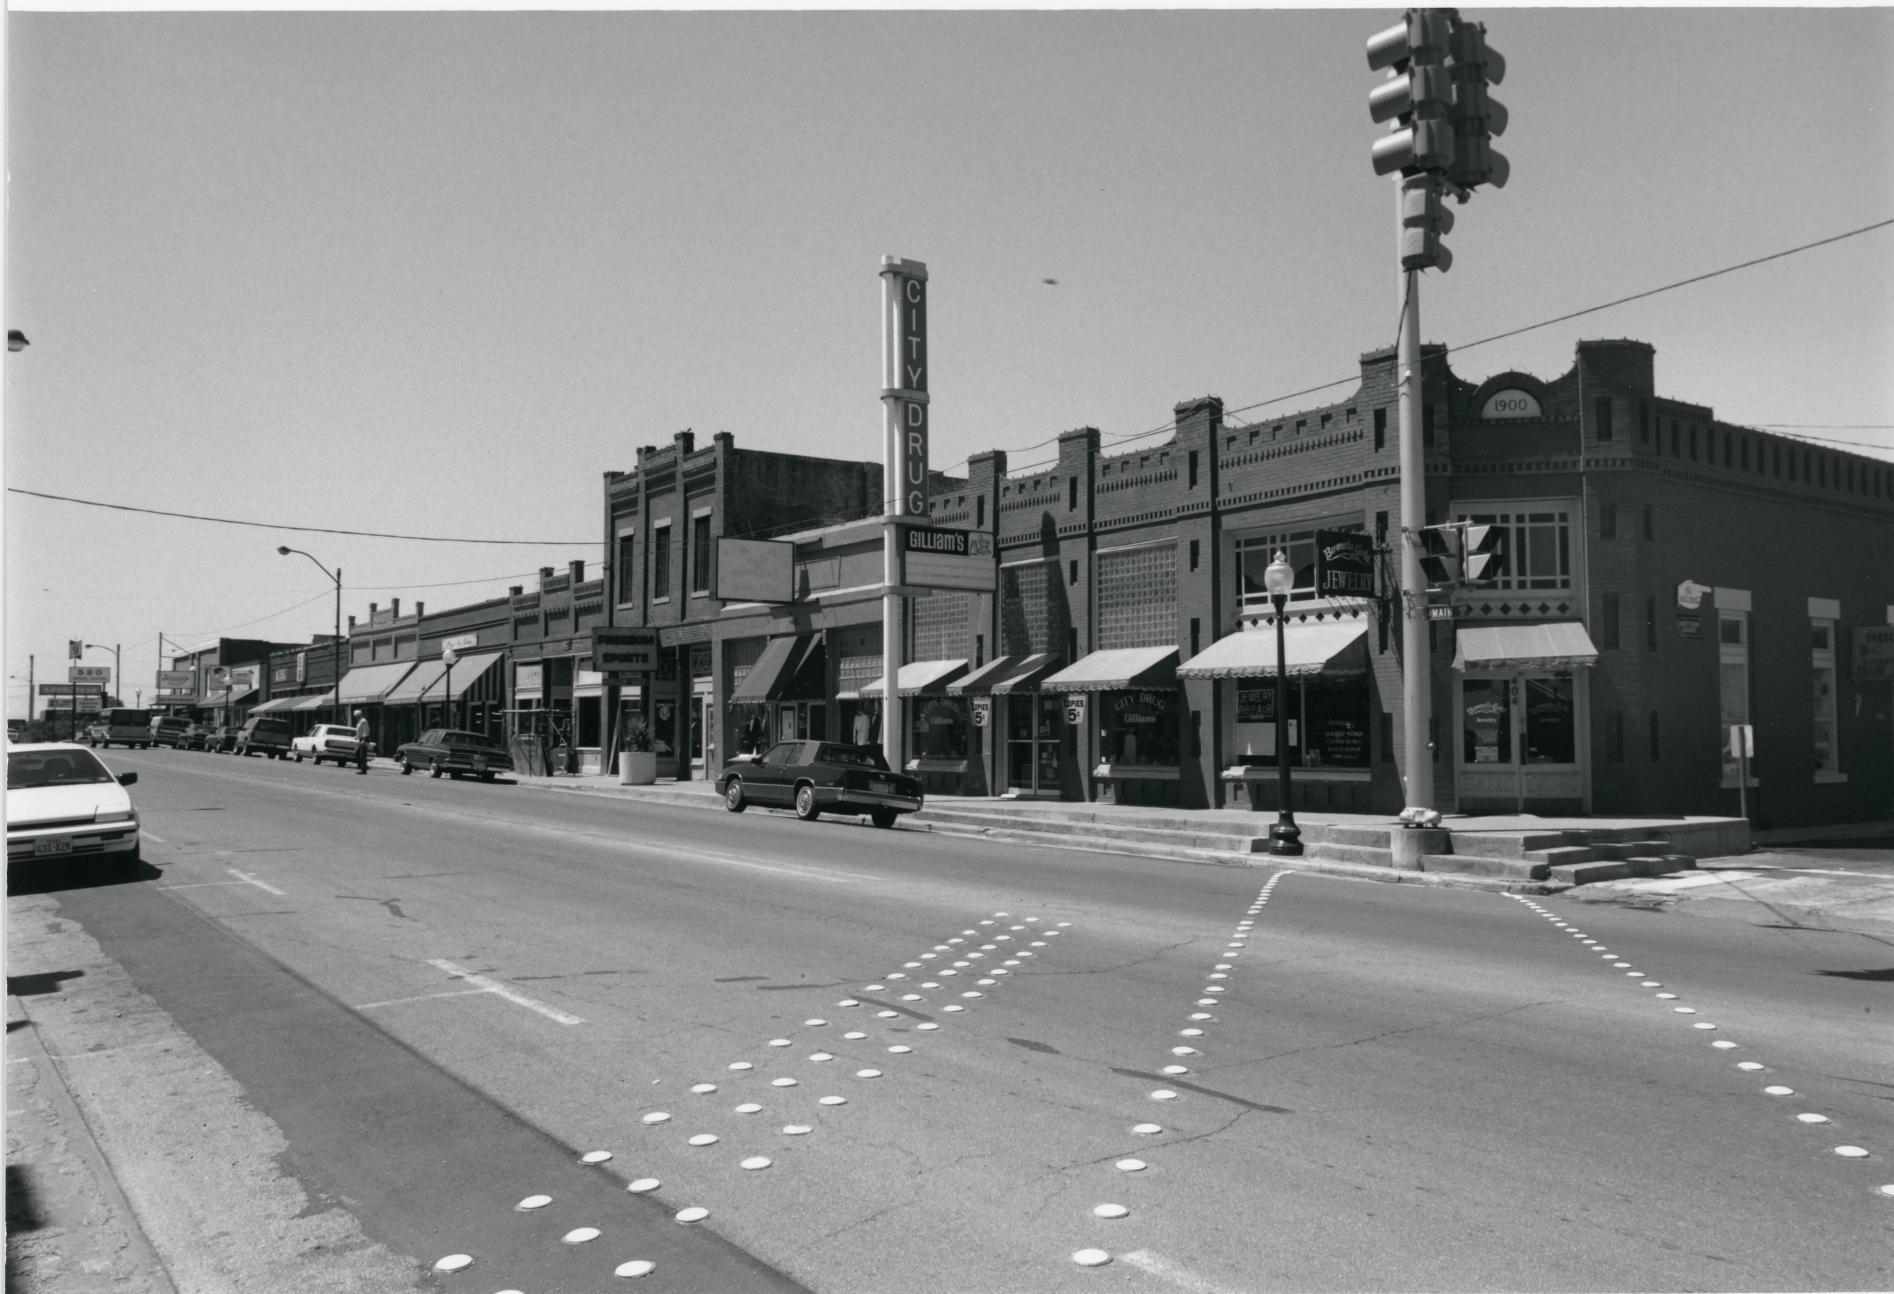
PHOTOGRAPH 3 of 10

PHOTOGRAPH 3 - 404-432 South Main Street, camera facing southwest.

GRAPEVINE COMMERCIAL HISTORIC DISTRICT  
GRAPEVINE, TARRANT COUNTY, TEXAS  
GENERAL STREETScape VIEW  
404-432 SOUTH MAIN

E.M. Jenkins was an early owner of this commercial building, followed by his daughter Elizabeth Bushong who acquired ownership in 1910 when Jenkins' estate was partitioned. It is a typical small-scale brick Main Street commercial building that retains its architectural integrity. (See Photograph # 3)

Constructed about 1900 as a 1-story structure, the Lucas Grocery building had its 2nd story added circa 1910 to serve as a funeral parlor. It is typical of a small town Main Street commercial building and retains its architectural integrity. (See Photograph #3, 6)

Typical of a small town, Main Street commercial row building of its period, this building maintains its architectural integrity. (See Photograph #3, 6)

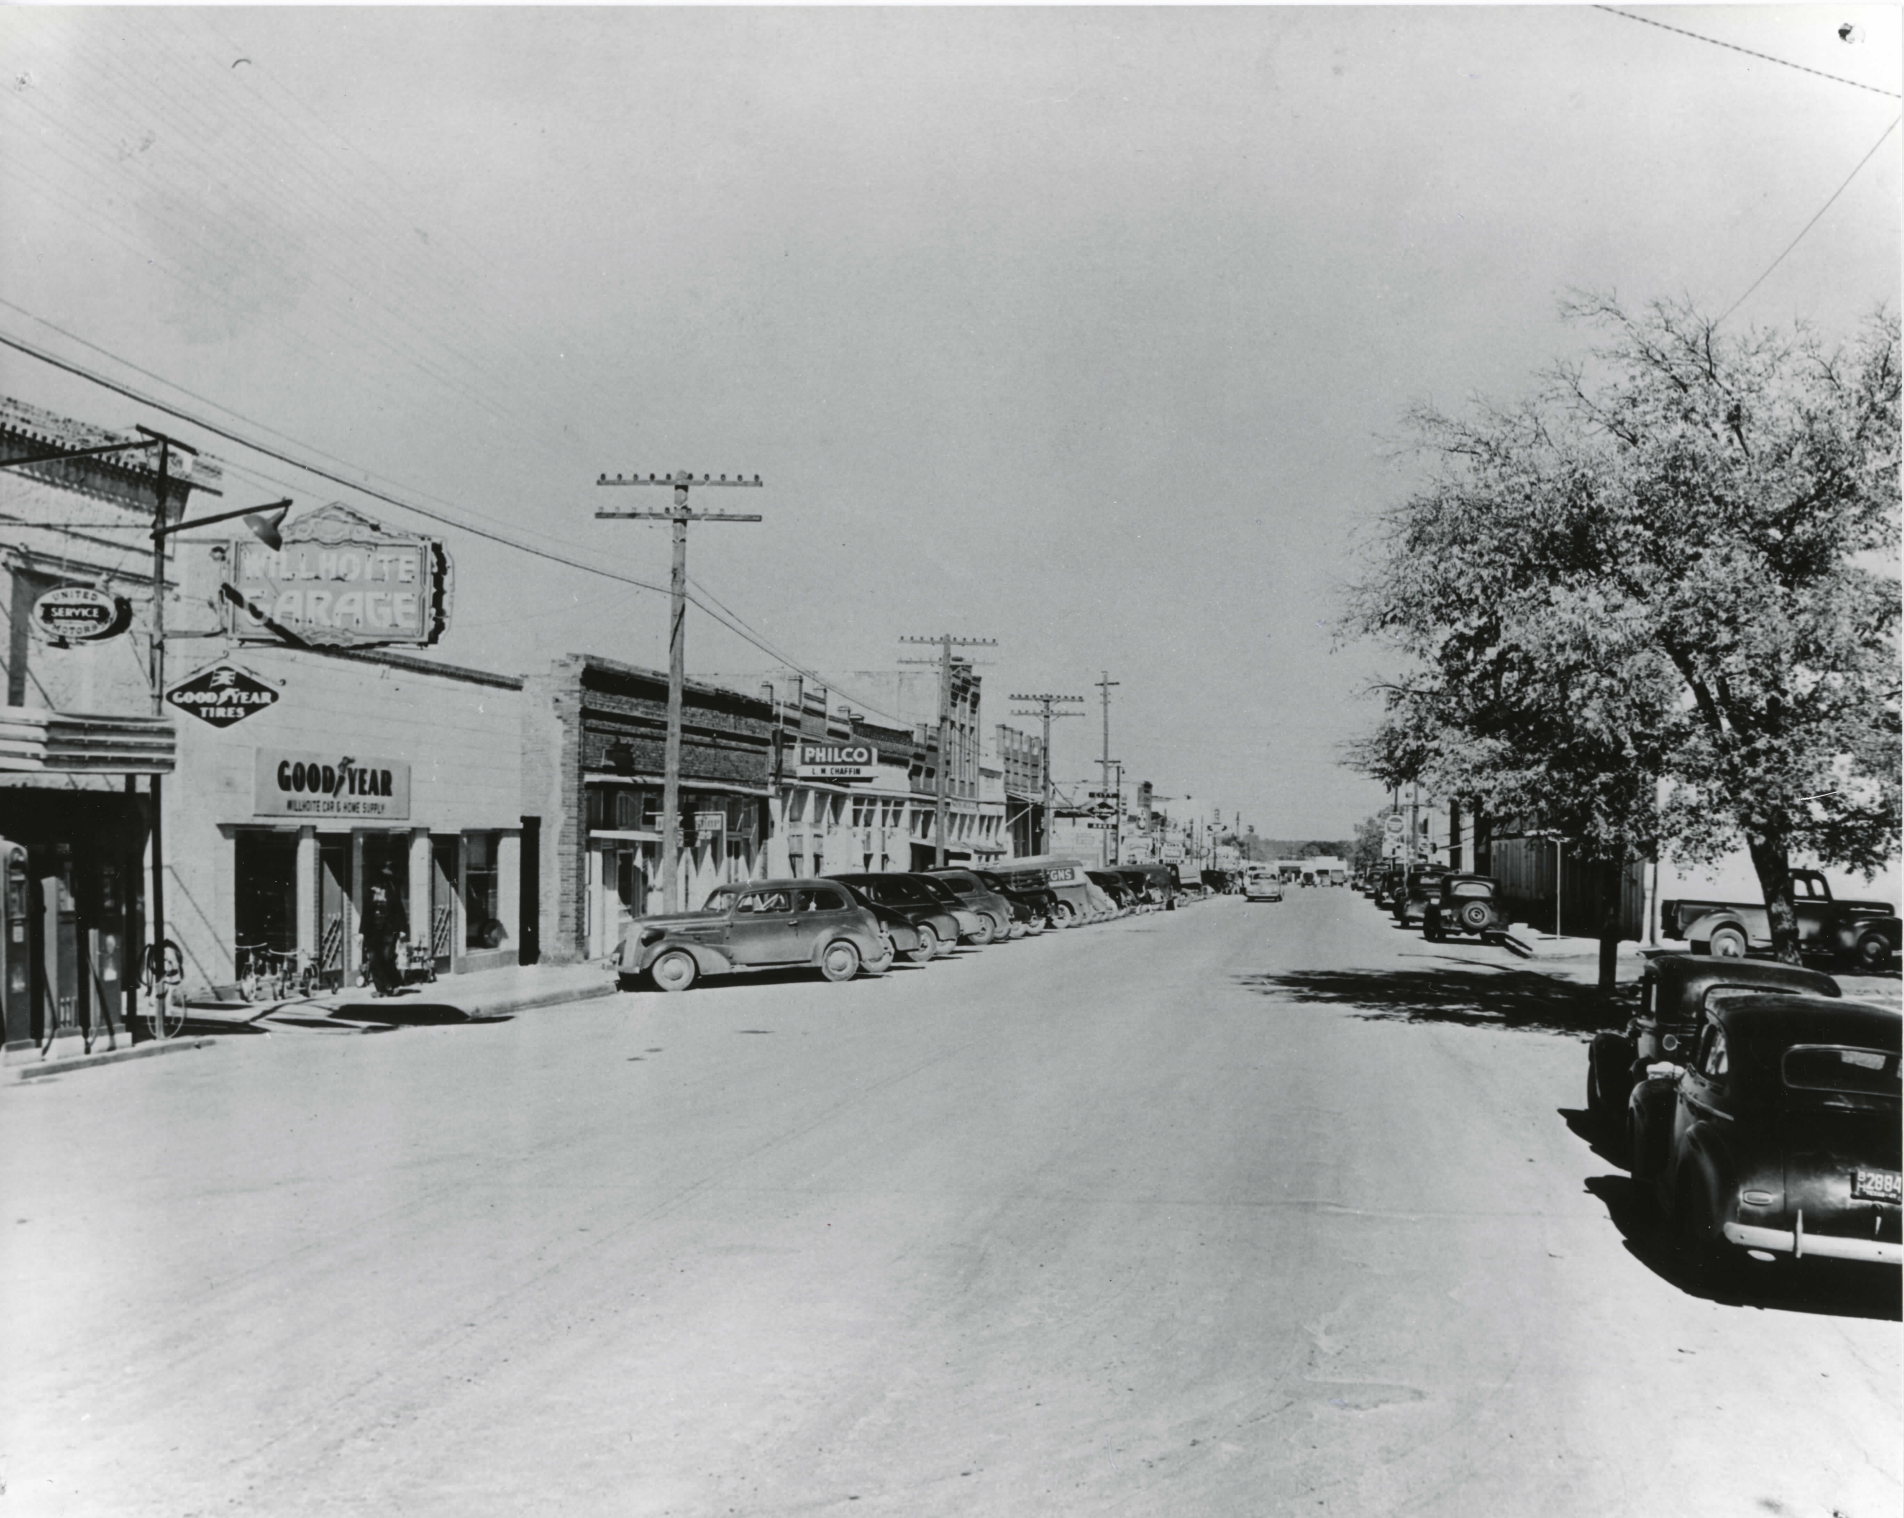
PHOTOGRAPH 4 of 10

Historic photographs reveal that many of the block's structures at one time had iron awnings suspended over the raised sidewalk, and the building at 404/406 South Main had iron awnings noted in 1921 and 1935 Sanborn Fire Insurance Company maps; all the historic awnings have since been removed. The Sanborn Maps also indicate all buildings were of masonry construction, except for the two small wood frame and iron structures at 428 and 430 S. Main, which were removed and replaced by the shellstone veneer structure in 1948.

PHOTOGRAPH 4 - 404-432 South Main Street circa 1940, negative on file at Case  
Photography at 426 South Main, Grapevine, Texas, 76051, camera facing northwest.

GRAPEVINE COMMERCIAL HISTORIC DISTRICT  
GRAPEVINE, TARRANT COUNTY, TEXAS  
432-404 SOUTH MAIN  
HISTORIC PHOTOGRAPH

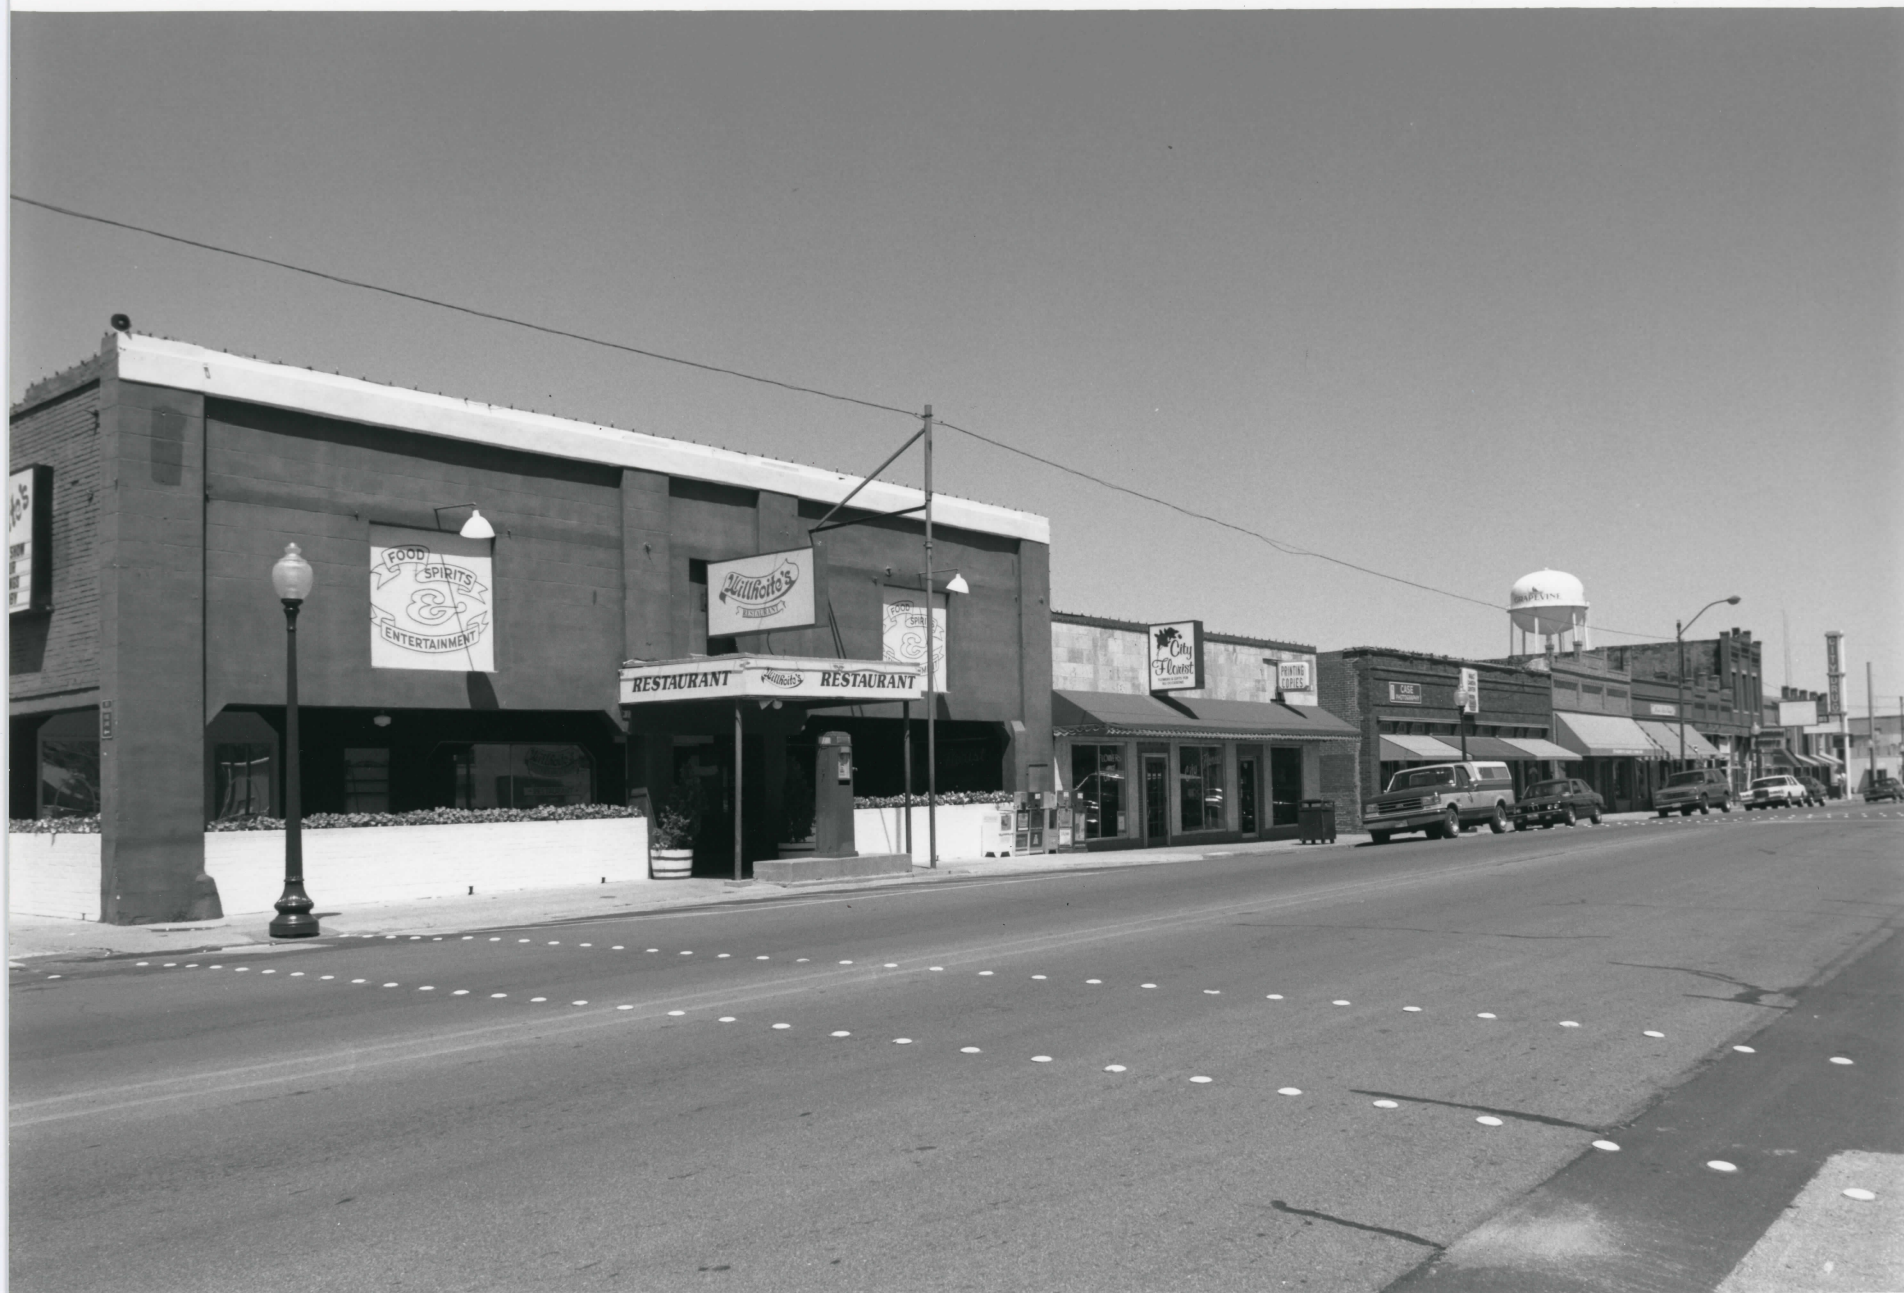
PHOTOGRAPH 5 of 10

PHOTOGRAPH 5 - 404-432 South Main Street, camera facing northwest.

GRAPEVINE COMMERCIAL HISTORIC DISTRICT  
GRAPEVINE, TARRANT COUNTY, TEXAS  
GENERAL STREETScape VIEW  
404 - 432 SOUTH MAIN

Built to replace two small wood and iron buildings which appeared on the 1921 Sanborn maps, this structure is a post-war, commercial row building. Though the building has different exterior facing material and detailing from the c.1900 buildings, it has a similar texture as well as rhythm of storefront windows and entry doors. In addition, its massing, placement and use are an integral part of the district. Since the building exhibits similar massing, spatial relationships, proportion, rhythm of windows and doors, and texture of material, it is a contributing property and does need to meet Criteria Consideration G, as stated in NPS Bulletin 15, p. 41, last paragraph. (See Photograph #5, 7)

Built in 1913 for commercial use, including a cinema, this structure was remodeled as a service station circa 1930 and later received its stucco finish. Subsequent alterations included infill of second story windows and changes to the ground story service station bays. (See Photograph #5, 7, 9)

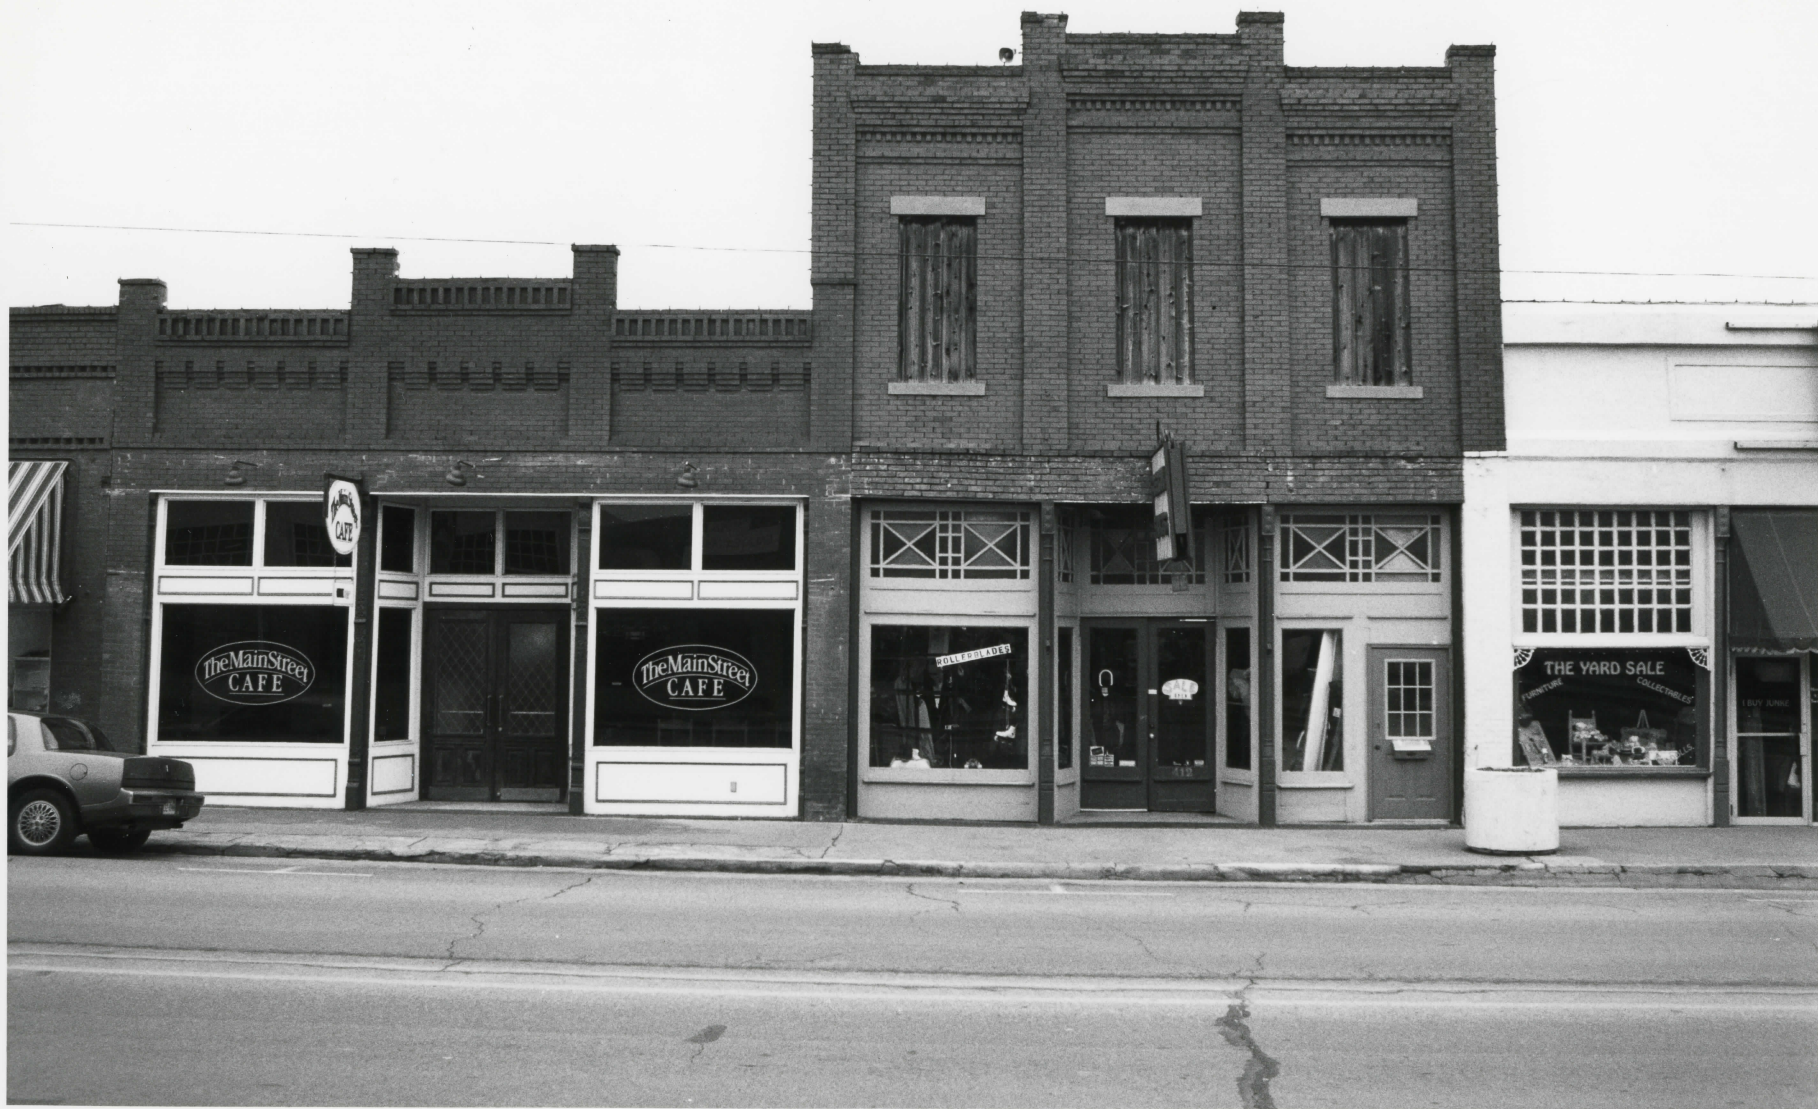
PHOTOGRAPH 6 of 10

PHOTOGRAPH 6 - 412-414 South Main Street, camera facing west.

GRAPEVINE COMMERCIAL HISTORIC DISTRICT  
GRAPEVINE, TARRANT COUNTY, TEXAS  
LUCAS GROCERY & FUNERAL HOME  
412-414 SOUTH MAIN

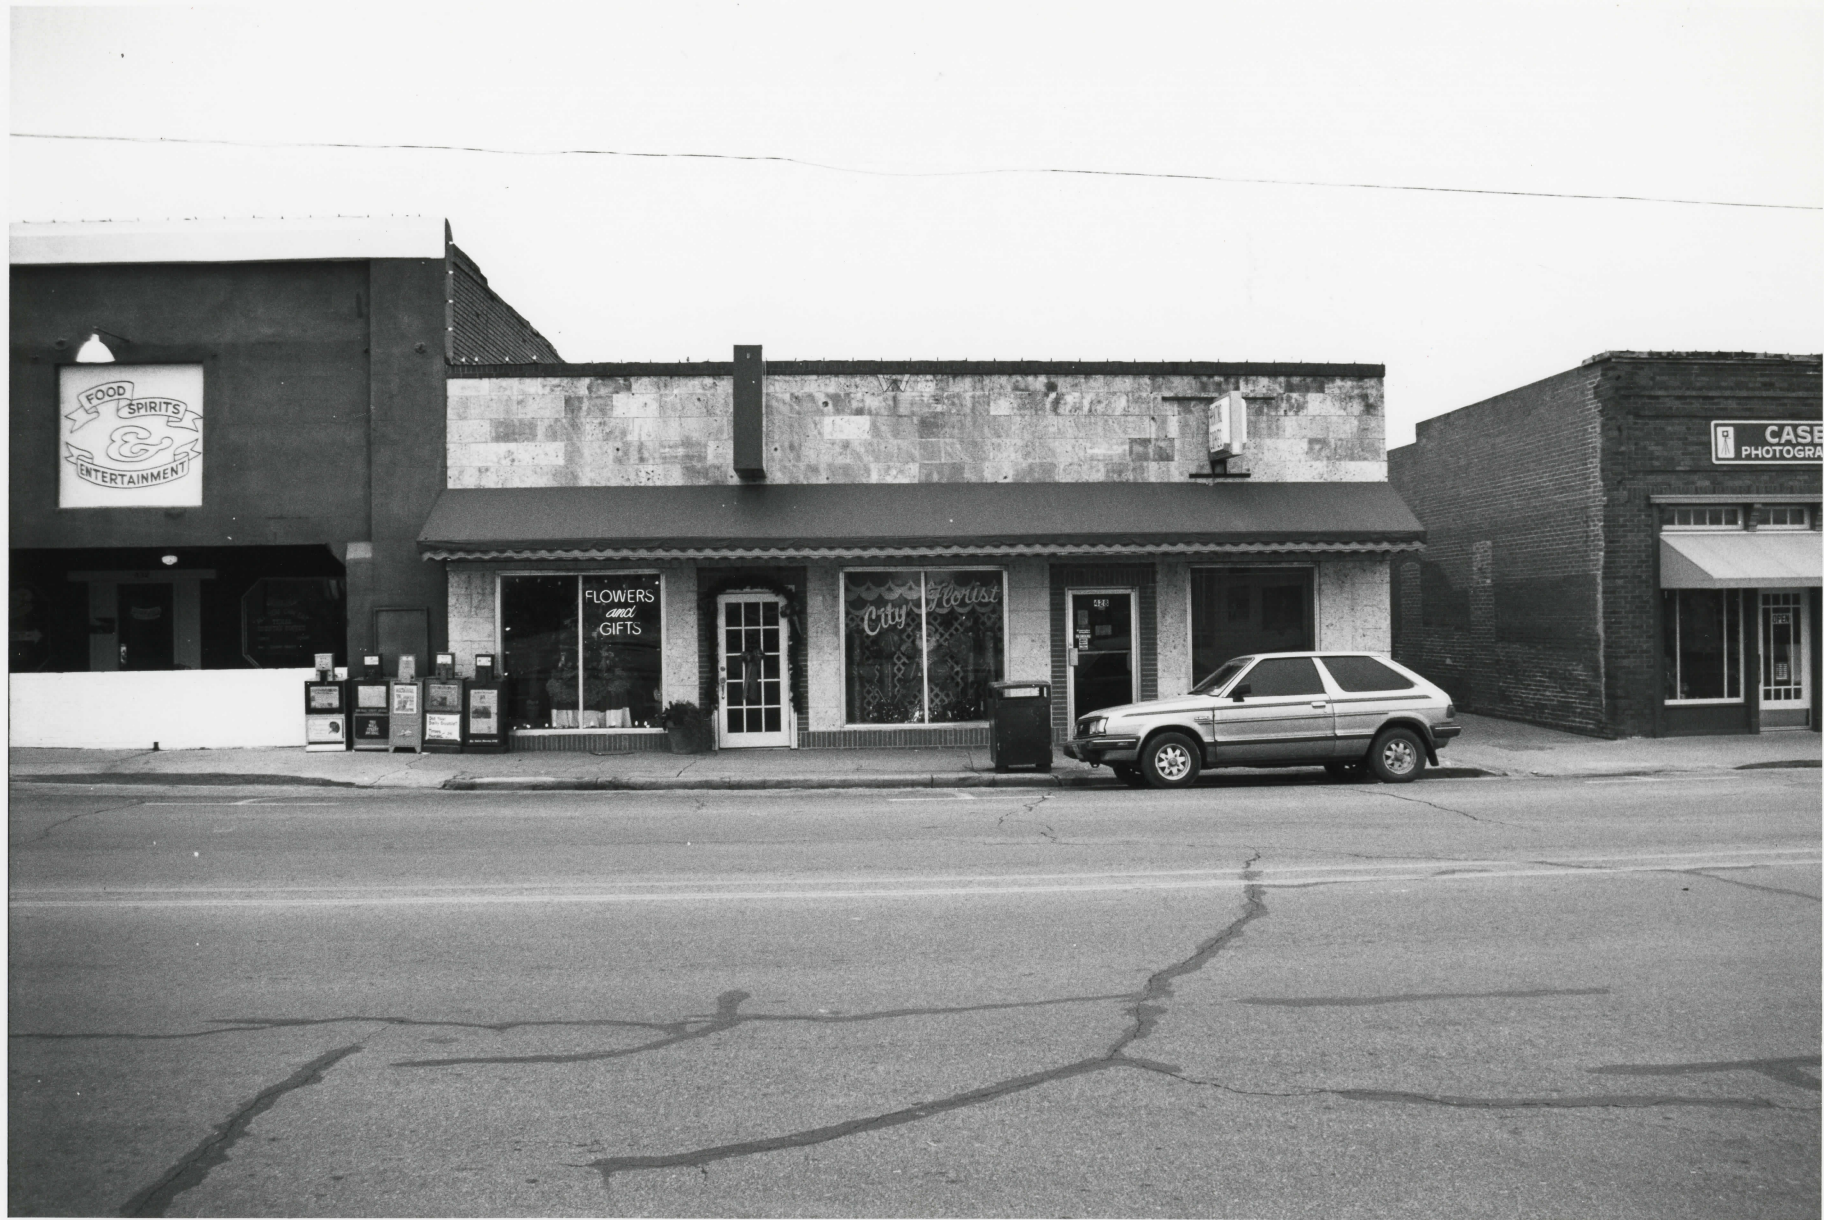
PHOTOGRAPH 7 of 10

PHOTOGRAPH 7 - 428/430 South Main Street, camera facing west.

GRAPEVINE COMMERCIAL HISTORIC DISTRICT  
GRAPEVINE, TARRANT COUNTY, TEXAS  
428/430 SOUTH MAIN

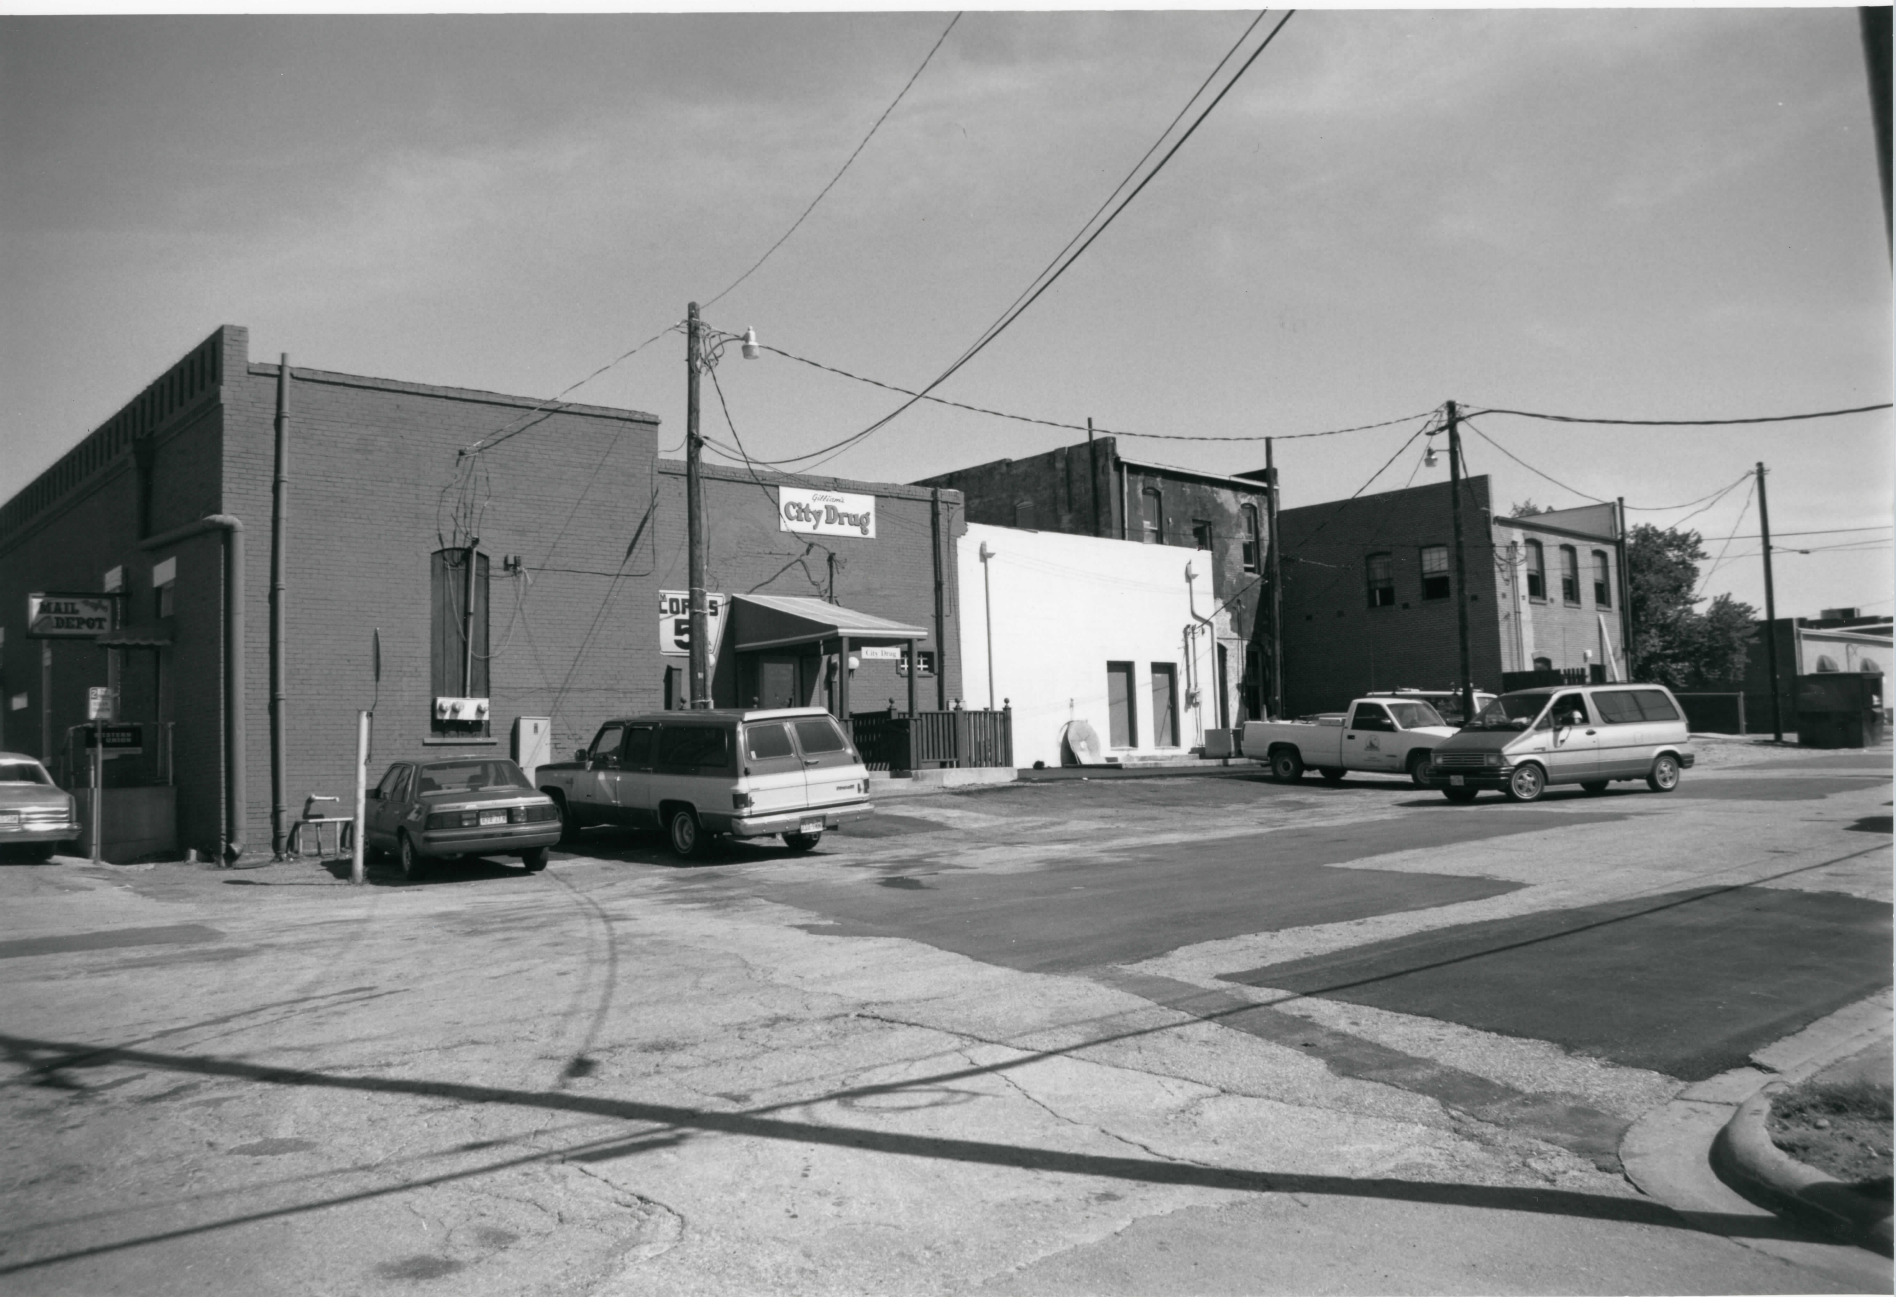
PHOTOGRAPH 8 of 10

PHOTOGRAPH 8 - 404-414 South Main Street rear facades, camera facing southeast.

REAR FACADES of 404-406, 408, 412 & 414 MAIN STREET

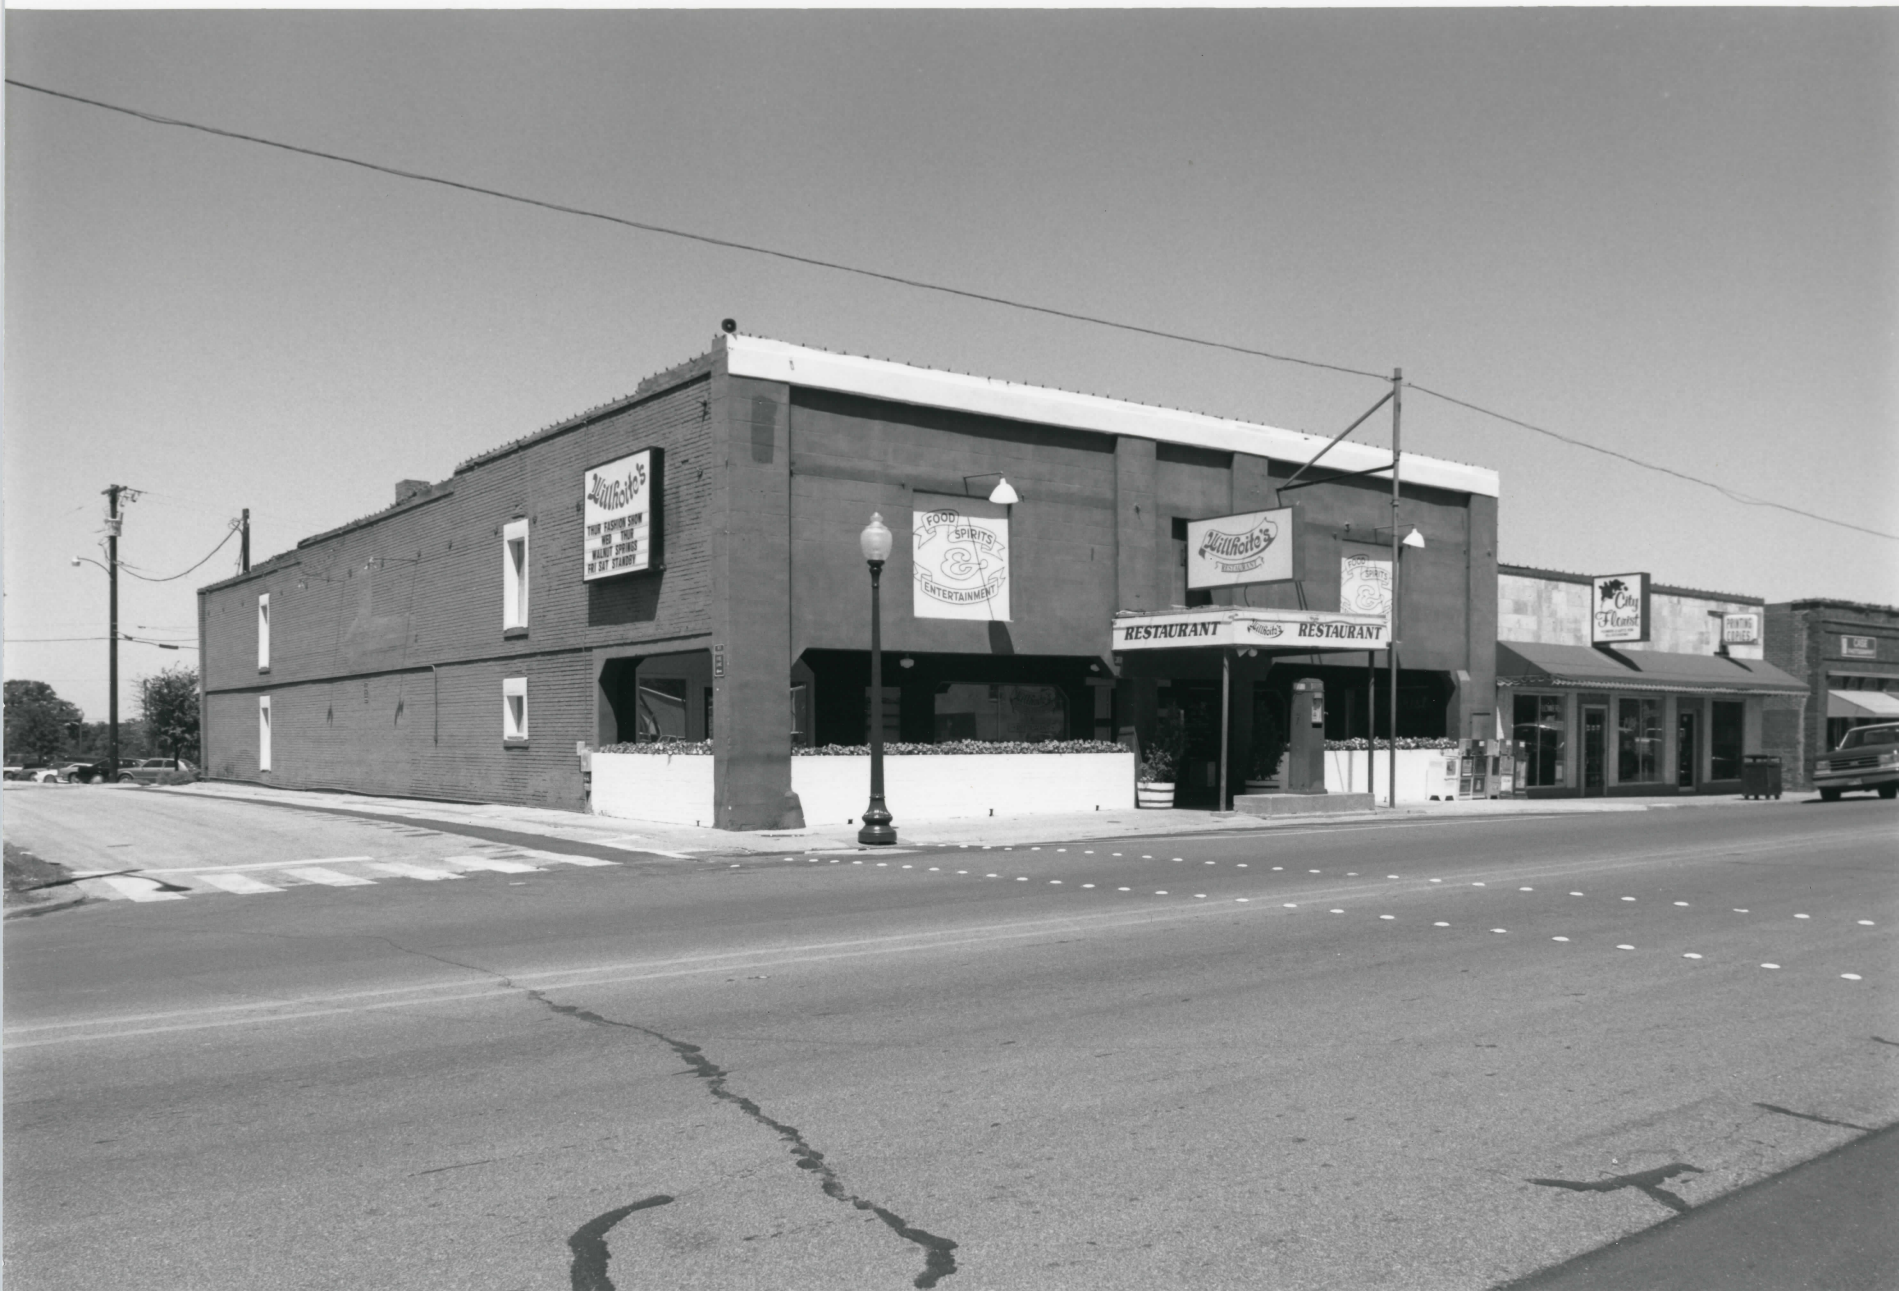
PHOTOGRAPH 9 of 10

The Noncontributing building at 432 S. Main has been altered several times since 1945: its brick exterior is sheathed in painted stucco, upper story windows are blocked in and a concrete block balustrade encloses the historically open service station bays. It retains some of its interior detailing.

PHOTOGRAPH 9 - 432 South Main Street, camera facing northwest.

GRAPEVINE COMMERCIAL HISTORIC DISTRICT  
GRAPEVINE, TARRANT COUNT  
ROBINSON'S MERCANTILE STORE/WILHOITE GARAGE  
432 SOUTH MAIN (NONCONTRIBUTING)
