National Register of Historic Places  
Registration Form

historic name Grapevine Commercial Historic District

street & number 404-432 South Main Street ☒ not for publication

city or town Grapevine ☒ vicinity

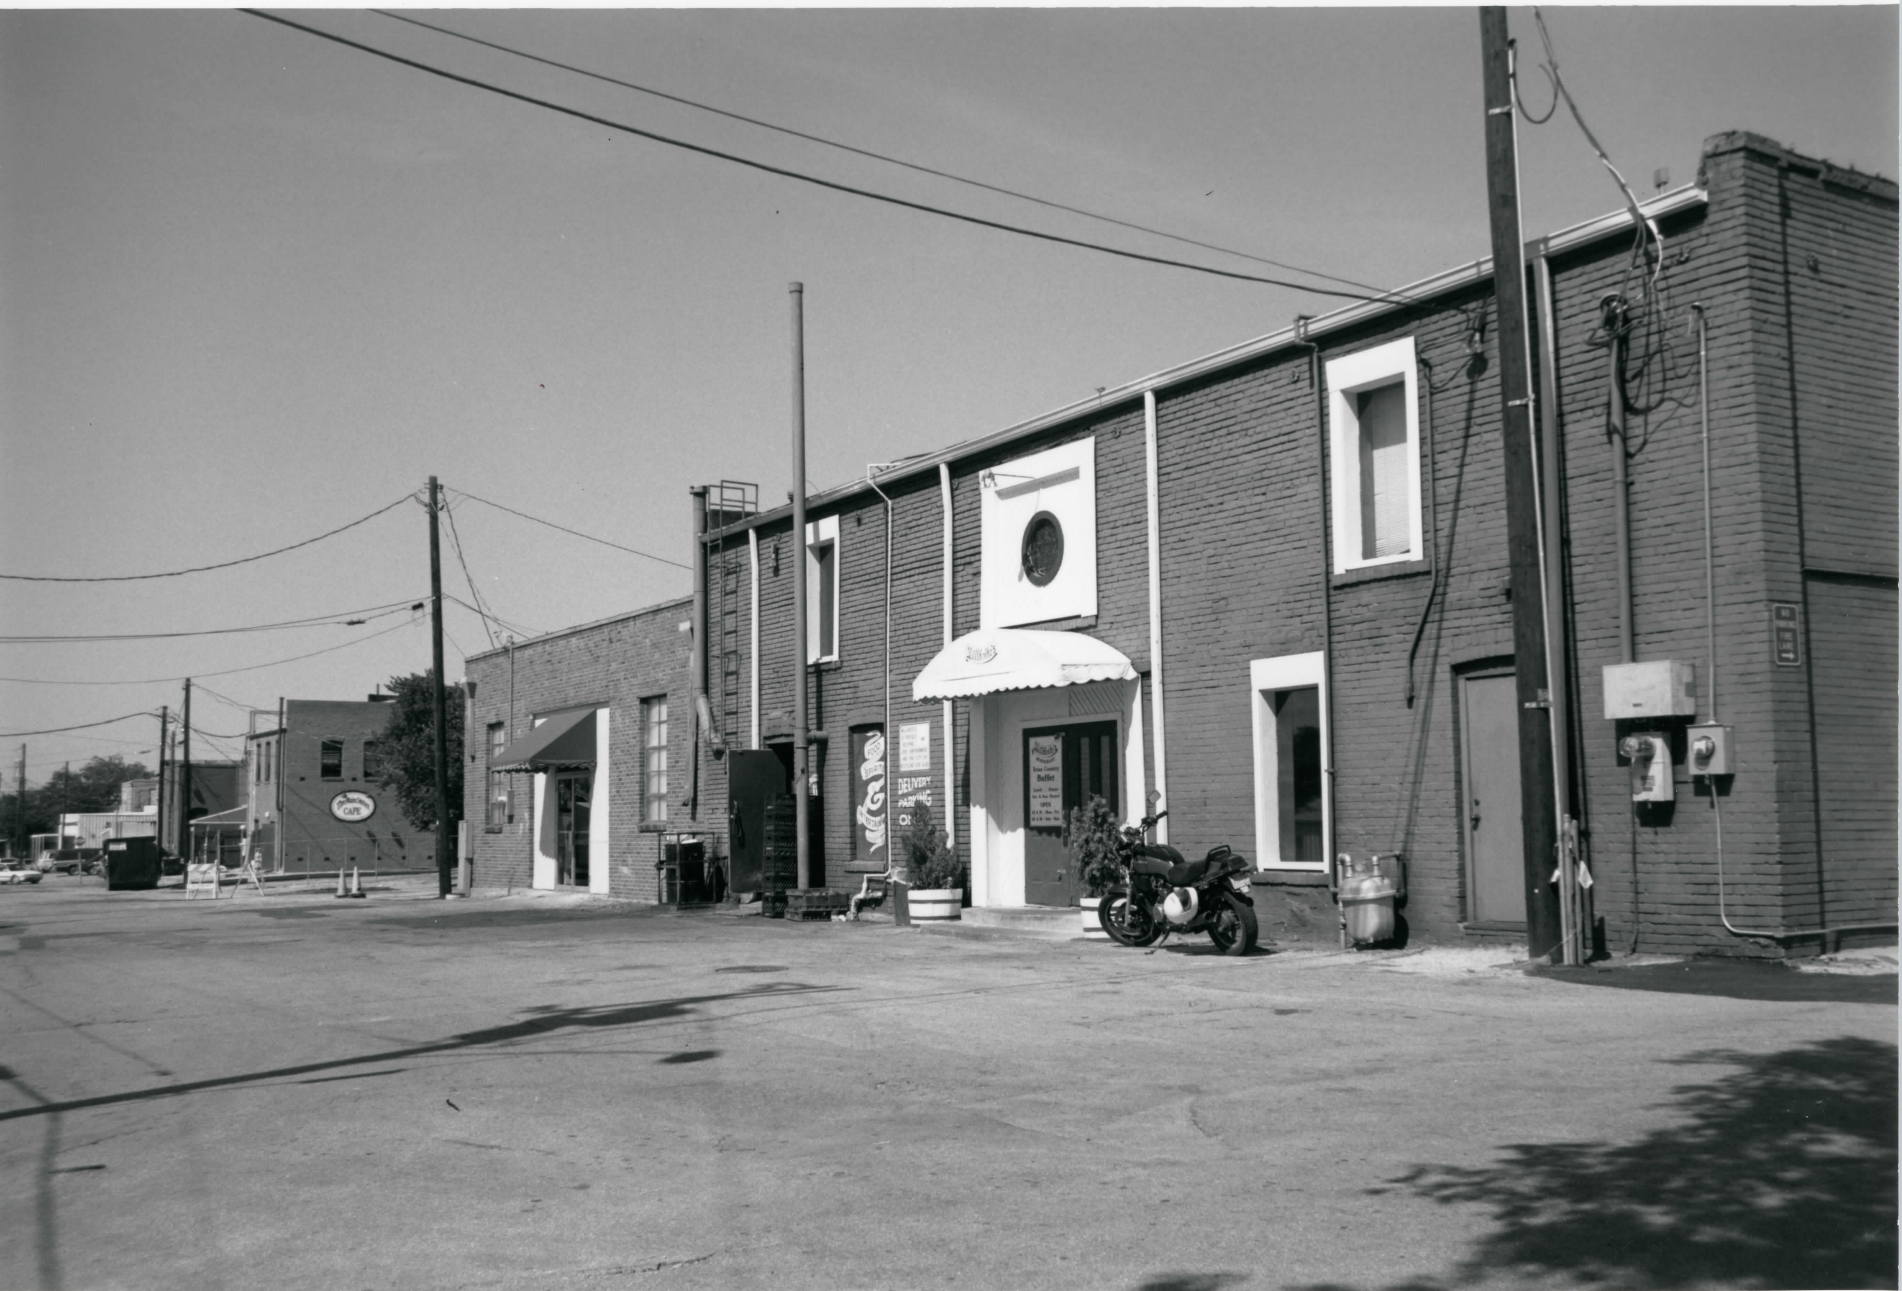
PHOTOGRAPH 10 of 10

PHOTOGRAPH 10 - 428-432 South Main Street rear facades, camera facing northeast.

GRAPEVINE COMMERCIAL HISTORIC DISTRICT  
GRAPEVINE, TARRANT COUNTY, TEXAS  
REAR FACADE of 428/430 & 432 MAIN STREET
