NATIONAL REGISTER OF HISTORIC PLACES  
REGISTRATION FORM

HISTORIC NAME: Rio Vista Farm Historic District

OTHER NAME/SITE NUMBER: El Paso County Poor Farm; Camp Rio Vista; Bracero Center

STREET & NUMBER: 800-01 Rio Vista Road

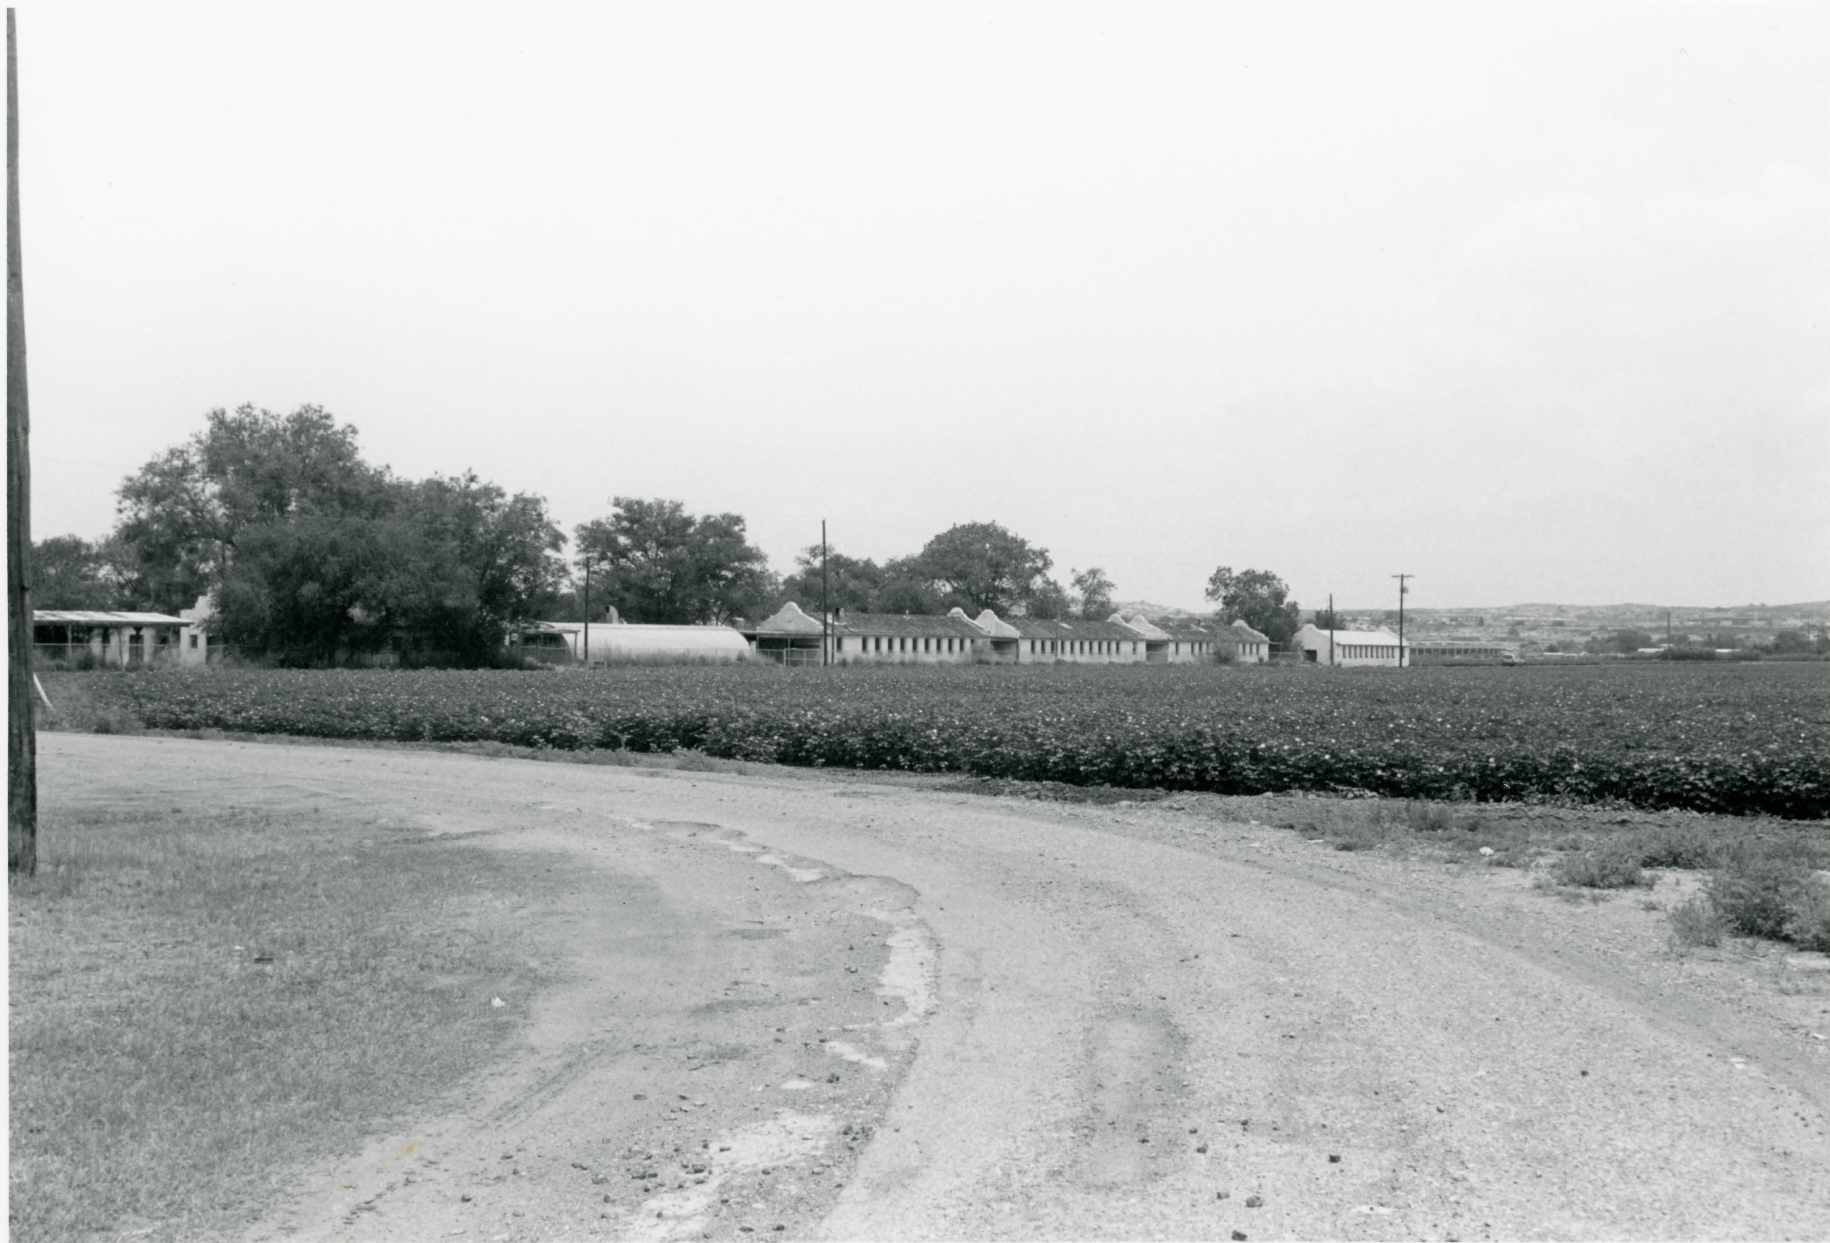
PHOTOGRAPH 1 of 10

- PHOTO 1 - View of the district from entry road, camera facing northeast
- PHOTO 2 - View of primary (north) elevation of main building, camera facing southeast
- PHOTO 3 - Oblique view of southwest wing of main building, camera facing southeast
- PHOTO 4 - Oblique view of north and west elevations of Infirmary, camera facing southeast
- PHOTO 5 - View of interior courtyard towards Recreation Hall, camera facing east
- PHOTO 6 - View along east side of Loop Road, camera facing northwest
- PHOTO 7 - Oblique view of south and west elevations of dormitory, camera facing northeast
- PHOTO 8 - View of east elevation of mess hall and kitchen, camera facing northeast
- PHOTO 9 - Oblique view of north and east elevations of sheriff's facility, camera facing southwest
- PHOTO 10 - Oblique view of south and west elevations of quonset hut, camera facing northeast

Upon purchasing Tract 6 of the Socorro Grant, Block No. 3, in 1915, El Paso County immediately subdivided the 204.69-acre parcel into lots 6A, 6B and 6C. The county established its poor farm on Lot 6A (15.14 acres), while the State of Texas leased lots 6B (124.65 acres) and 6C (64.52 acres) for use as an experimental farm. About 1940 the county divided lot 6D (.43 acres) from lot 6A (see Map-52), turning control of this small parcel over to the state. As all buildings and activities associated with the historic operation of Rio Vista Farm were confined to these lots, the district embraces only tracts 6A and 6D. El Paso County recently sold tract 6A to the City of Socorro, with the State of Texas retaining control of tract 6D. Texas A&M University continues to use 6B, 6C and 6D as an experimental cotton farm. The neatly plowed rows of these fields set the district apart from its agricultural surroundings (see Photo 1). Most property beyond these tracts
