NATIONAL REGISTER OF HISTORIC PLACES
REGISTRATION FORM

HISTORIC NAME: South Main Street Historic District
OTHER NAME/SITE NUMBER: NA

South Main Street Historic District
Fort Worth, Tarrant County, Texas

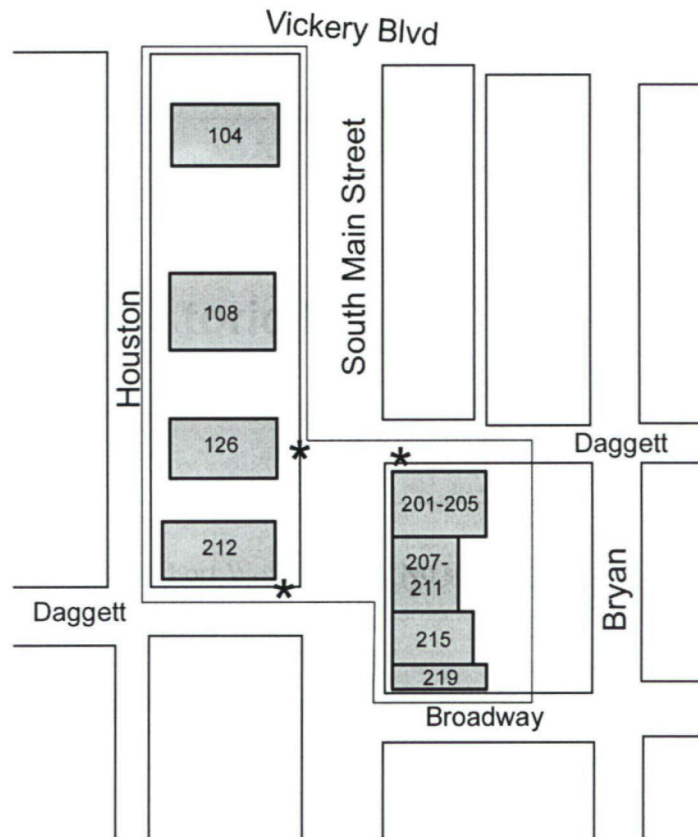
Map 1: South Main Street Historic District, Fort Worth, Texas. No scale.

* = location of ceramic curb tiles

Curb Tiles, c. 1930. Within the boundaries of the district are three historic way-finding devices. These are embedded in the curb and consist of a rectangular block of small ceramic tiles giving the number of the block and the name of the street. The block number and street name are written with blue ceramic tile with a white tile background. Knowing that Main Street was widened in 1929-30, it is assumed that these curb tiles were created around that time. They are located on the south side of East Daggett Street near the intersection with South Main Street, on the west side of South Main Street in front of 126 S. Main Street (where it would be visible to westbound traffic on East Daggett Street) and on the north side of West Daggett Street near the intersection with South Main Street. Although in need of repair, they are counted as three contributing objects.

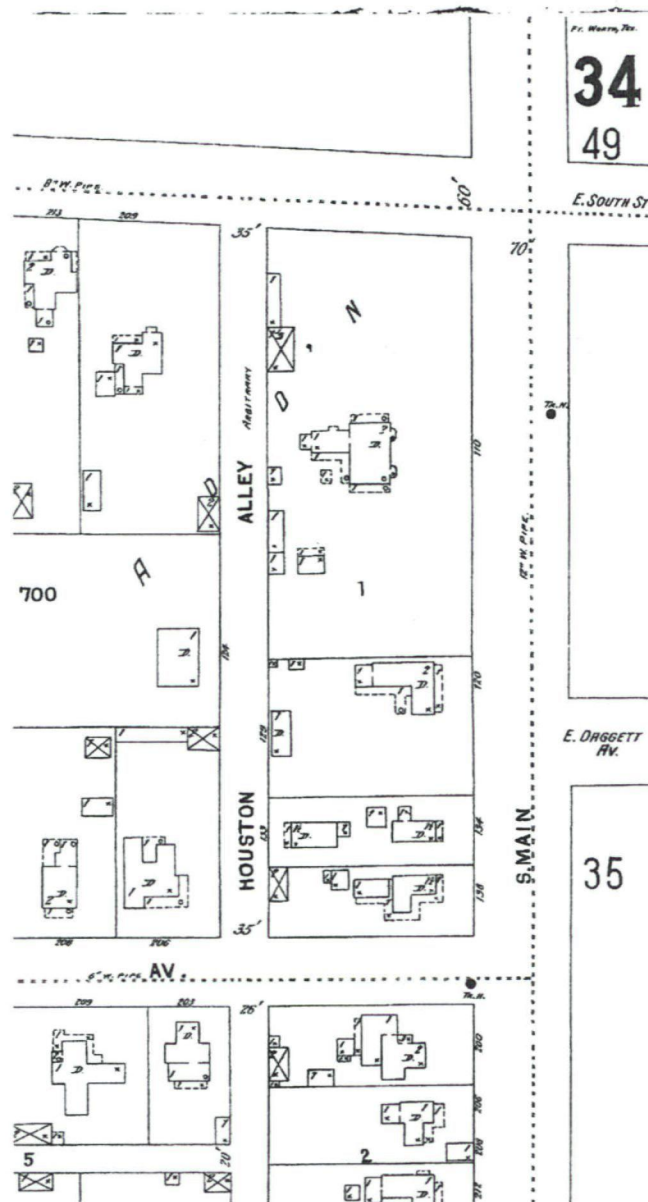
Figure 1: Sanborn Fire Insurance Map, Fort Worth, Texas, 1898, Sheet 34. The map shows the residential nature of the west side of South Main Street prior to the Great Southside Fire of April 3, 1909.

The early development of the two blocks within the nominated district was primarily residential in nature but included a few commercial structures. The 1898 Sanborn Fire Insurance Map for Fort Worth indicates that the block on the west side of South Main Street had six dwellings. Four of these faced South Main Street and two faced Houston Alley (now known as South Houston Street). The largest home faced South Main Street. Known as the Harrold residence, it was two-stories and had four outbuildings including a large one-and-one-half-story stable. The property associated with these buildings encompassed slightly more than the north half of the block. In 1901, Drs W. A. Adams and A. C. Walker purchased the property and established the Protestant Sanitarium at that location. The *Fort Worth Star-Telegram* described the site as one of the most beautiful in the city. It contained not only the stately home but also “large and small shade trees, shrubbery, walks, fountains, etc., [and is] in fact an ideal site and location for just such an institution.” The doctors retained the large house and made additional improvements to the property to accommodate its new use.⁸

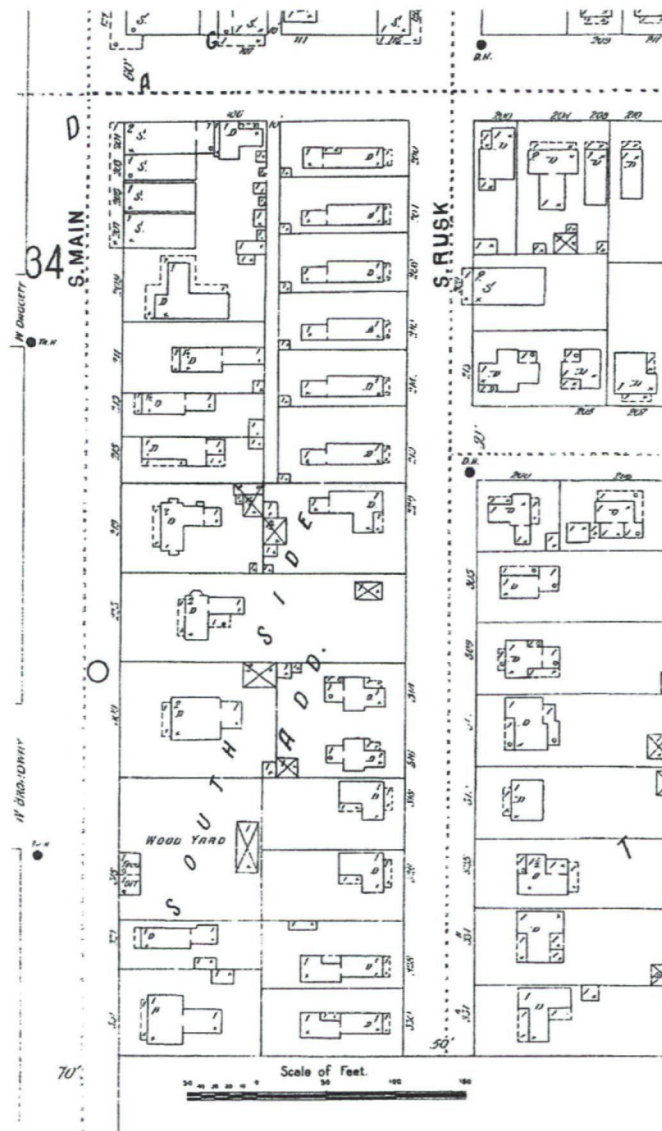
Figure 2: Sanborn Fire Insurance Map, 1898, Volume 1, Sheet 35. Prior to the Great Southside Fire, Dagget's Hillside Addition (on the east side of South Main Street) was long block. After the fire, East Broadway Street was cut through the block.

The 1898 Sanborn Map showing the east side of the street indicated that this block had houses facing both South Main and Rusk streets. It also had a wood yard near the south end of the block (this portion was later severed from the north end by the extension of Broadway Street) and four adjoining commercial buildings at the northwest corner of the block, what would today correspond with 201-05 and 207-11 S. Main Street. It is difficult to discern from the map if the buildings were wood-framed or brick. The building at the north end of the block (201 S. Main Street) was two-stories with a one-story dwelling attached at the rear with the address of 106 E. Daggett Street. The other three buildings were one-story and had the addresses of 203, 205 and 207 S. Main Street. All four appeared to be tied together with a continuous awning.⁹

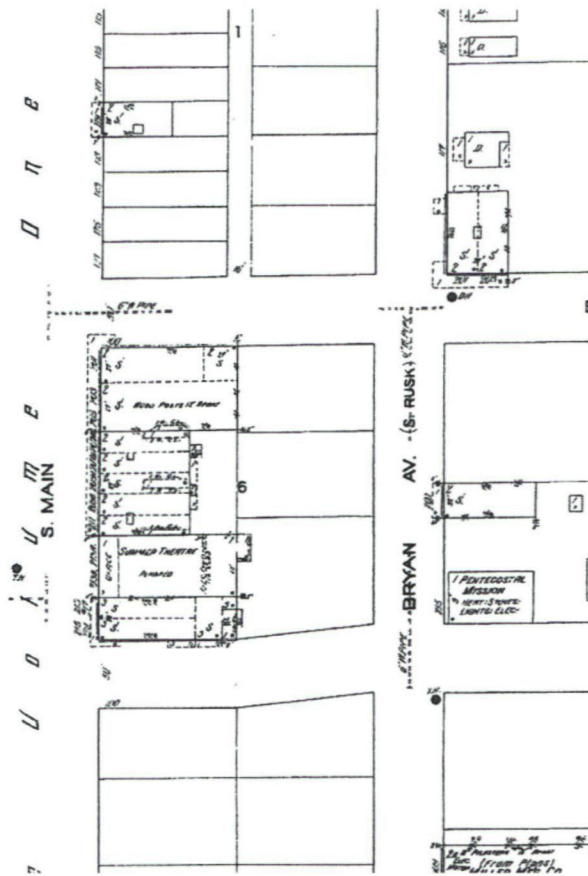
Figure 3: Sanborn Fire Insurance Map, Fort Worth, Texas, 1911, Volume 2, Sheet 129. This map depicts the east side of South Main Street (no extant map for the west side). Note that East Broadway Street has been cut through Daggett Hillside Addition

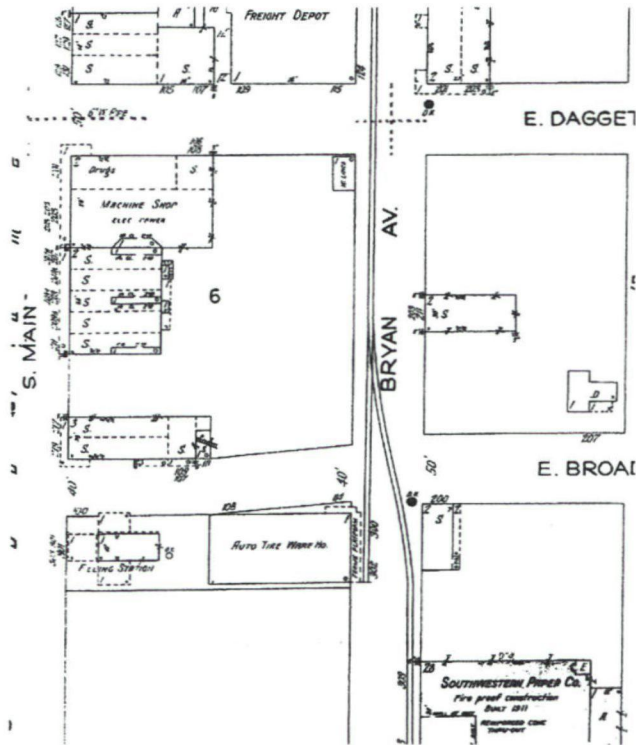
Figure 4: Sanborn Fire Insurance Map, Fort Worth, Texas, 1926, Volume 2, Sheet 241. This map depicts the east side of South Main Street (no extant map for the west side).

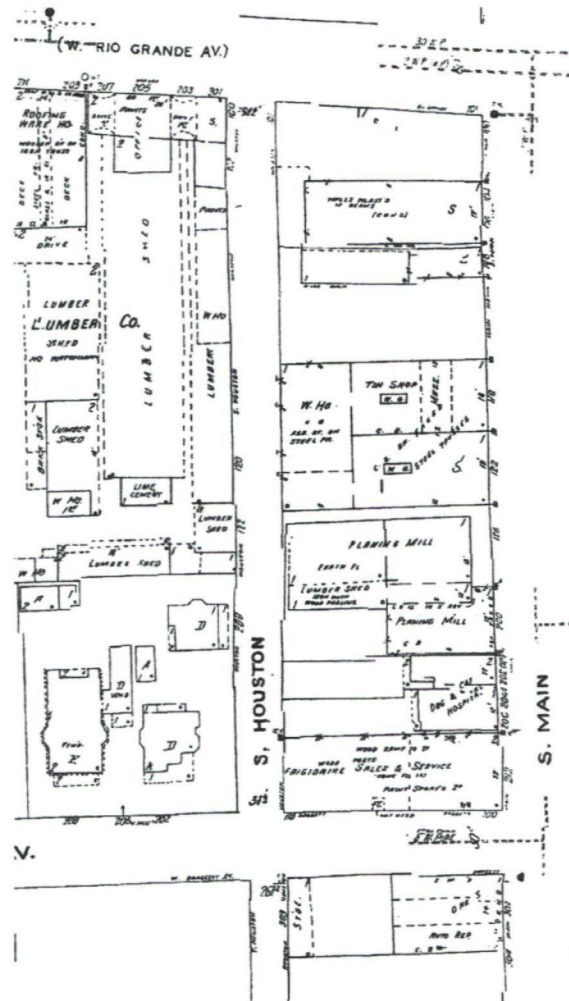
Figure 5: Sanborn Fire Insurance Map, Fort Worth, Texas, 1951, Volume 1, Sheet 28. This map depicts the west side of South Main Street.

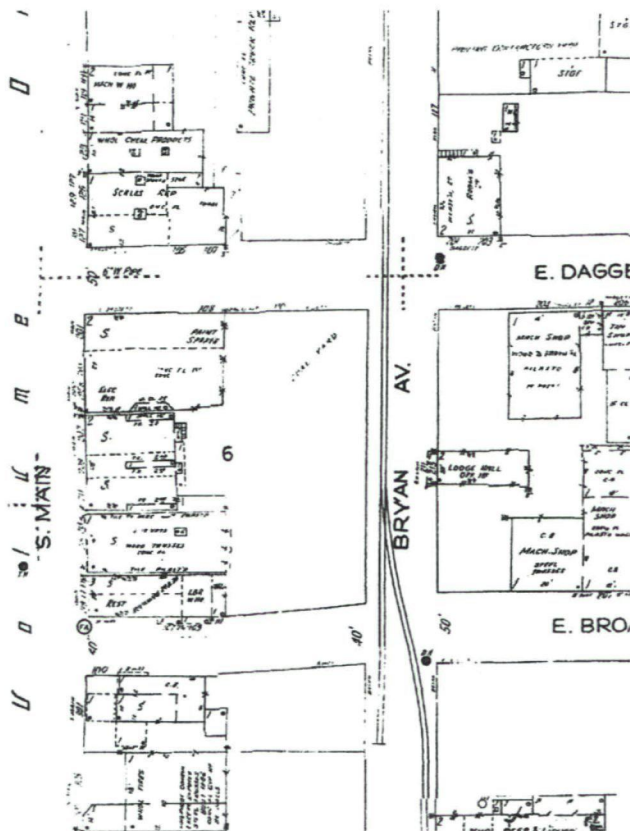
Figure 6: Sanborn Fire Insurance Map, Fort Worth, Texas, 1951, Volume 2, Sheet 241. This map depicts the east side of South Main Street.

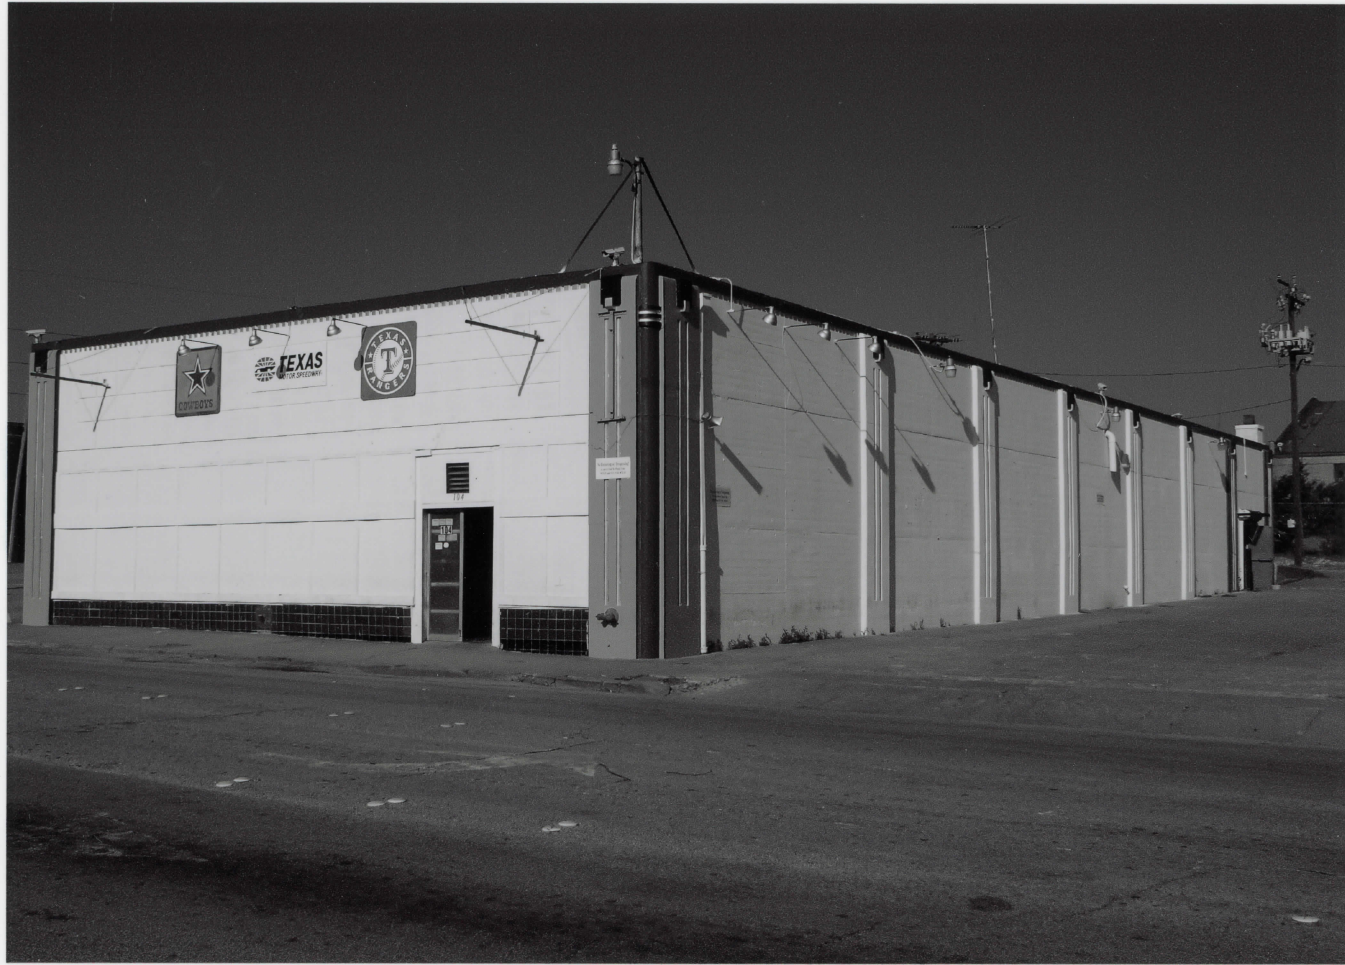
7. #2

1. 104 S. Main St.
South Main Street H. D.
2. Fort Worth, Tarrant Co., TX

104 S. Main Street, Safeway Store No. 332, 1940-41. Constructed of reinforced concrete, the Safeway Store No. 332 is the only poured-in-place concrete building within the district. Classified as a one-part Commercial Block, the building features a large expanse of display windows (currently boarded over) above a tiled bulkhead. The vertical emphasis given to pilasters at the corners (currently painted green) and on the side elevations suggests an Art Deco/Moderne influence. The building's design is also an example of corporate branding as it is similar to several extant former Safeway stores in South and Southeast Fort Worth. Although it is the northernmost building on the block, this building is not sited directly on the corner. The building currently houses a day labor center.

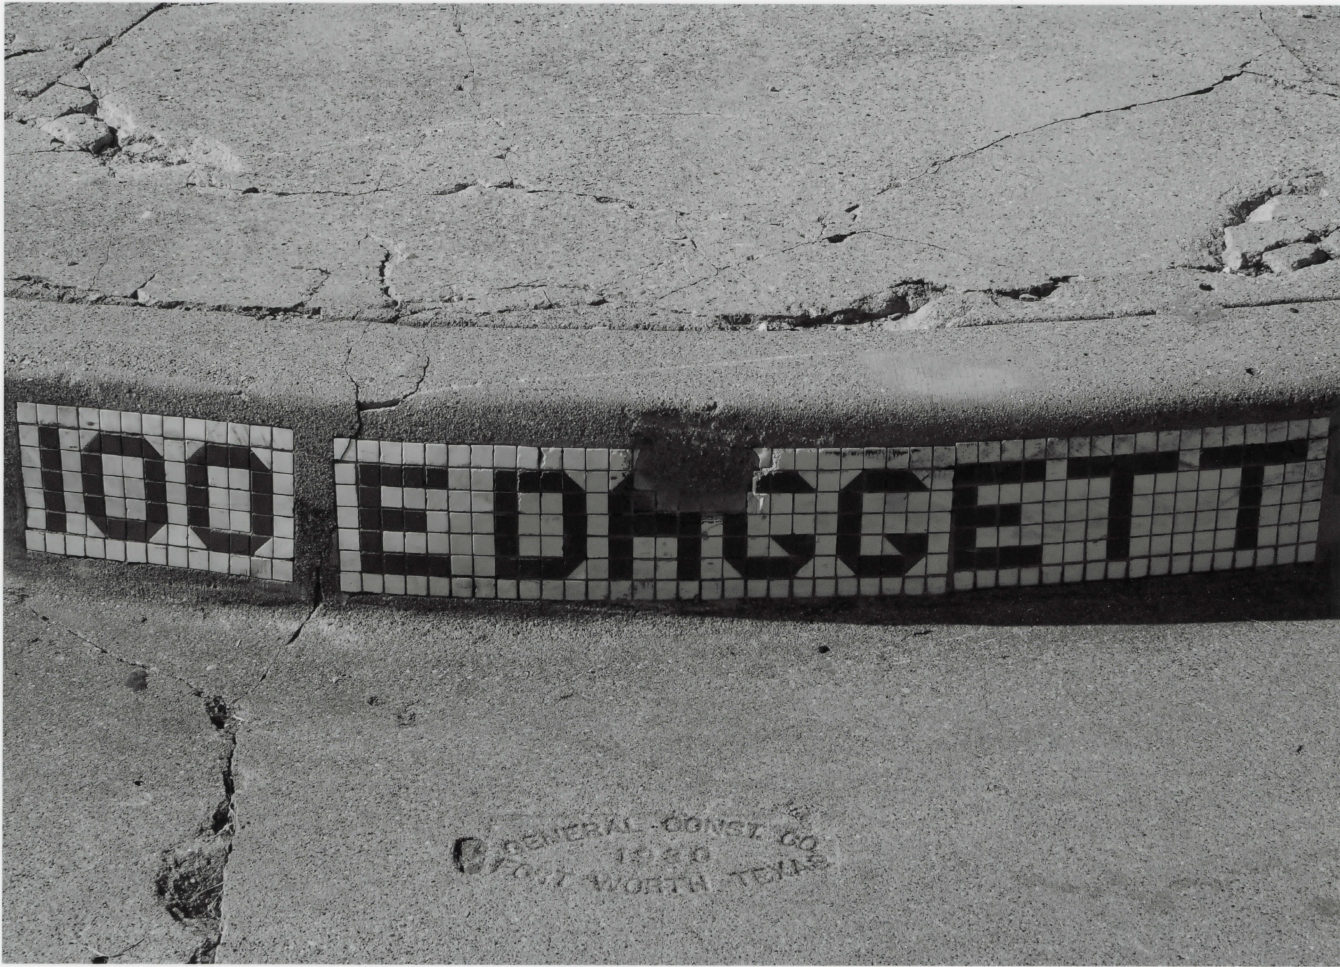
1. Curb tiles on E. Daggett St. near S. Main
South Main Street H.D. St.
