USDI/NPS NRHP Registration Form

Heidemann Ranch, San Antonio, Bexar County, Texas

INVENTORY OF PROPERTIES

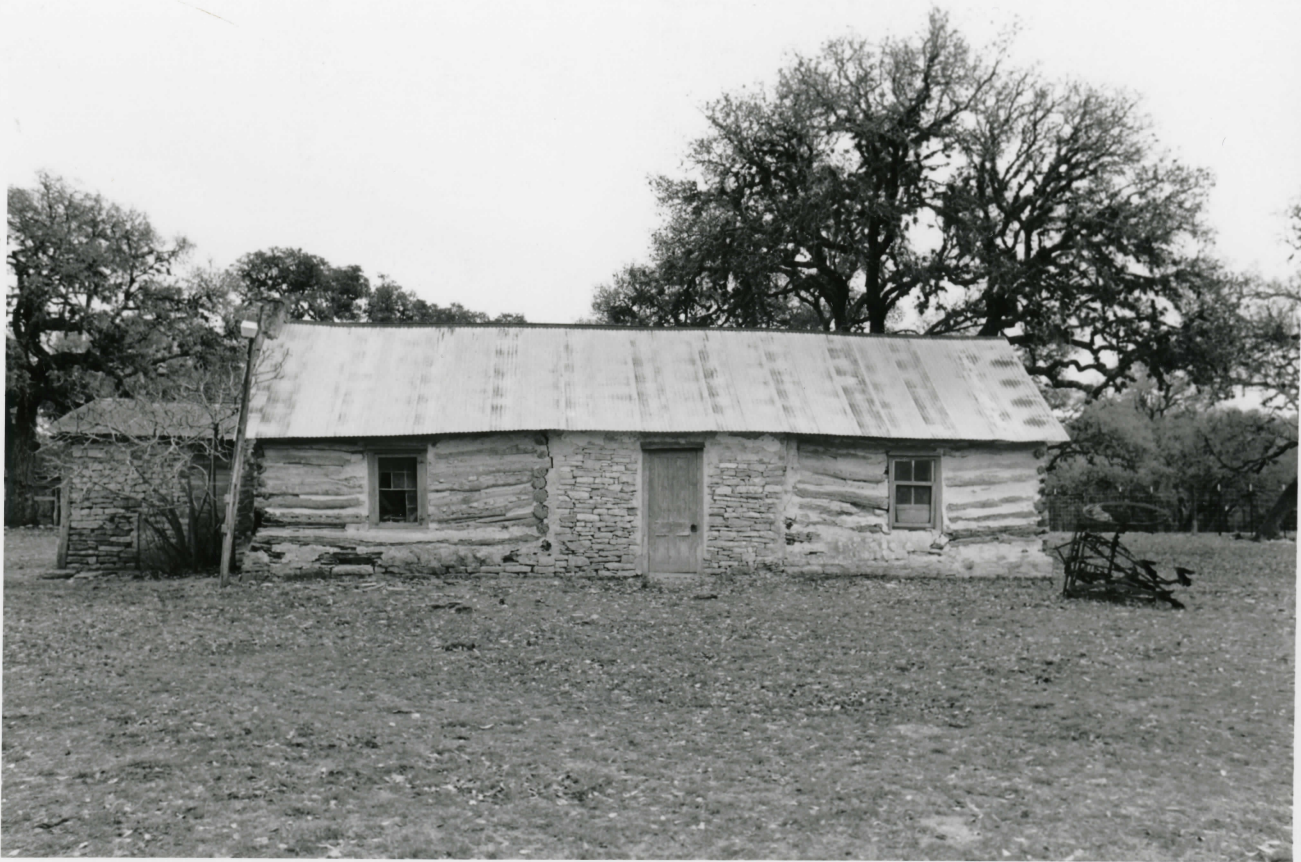
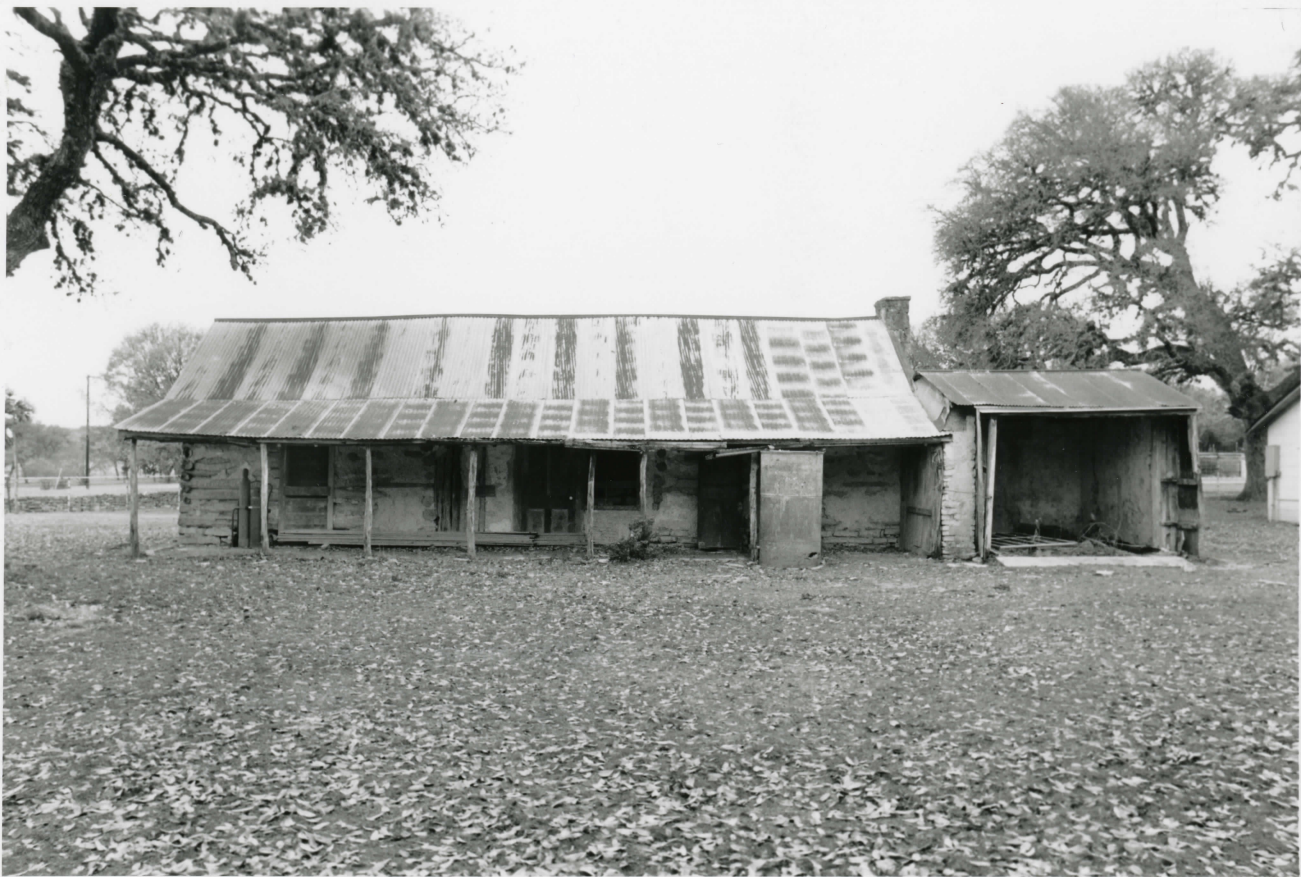
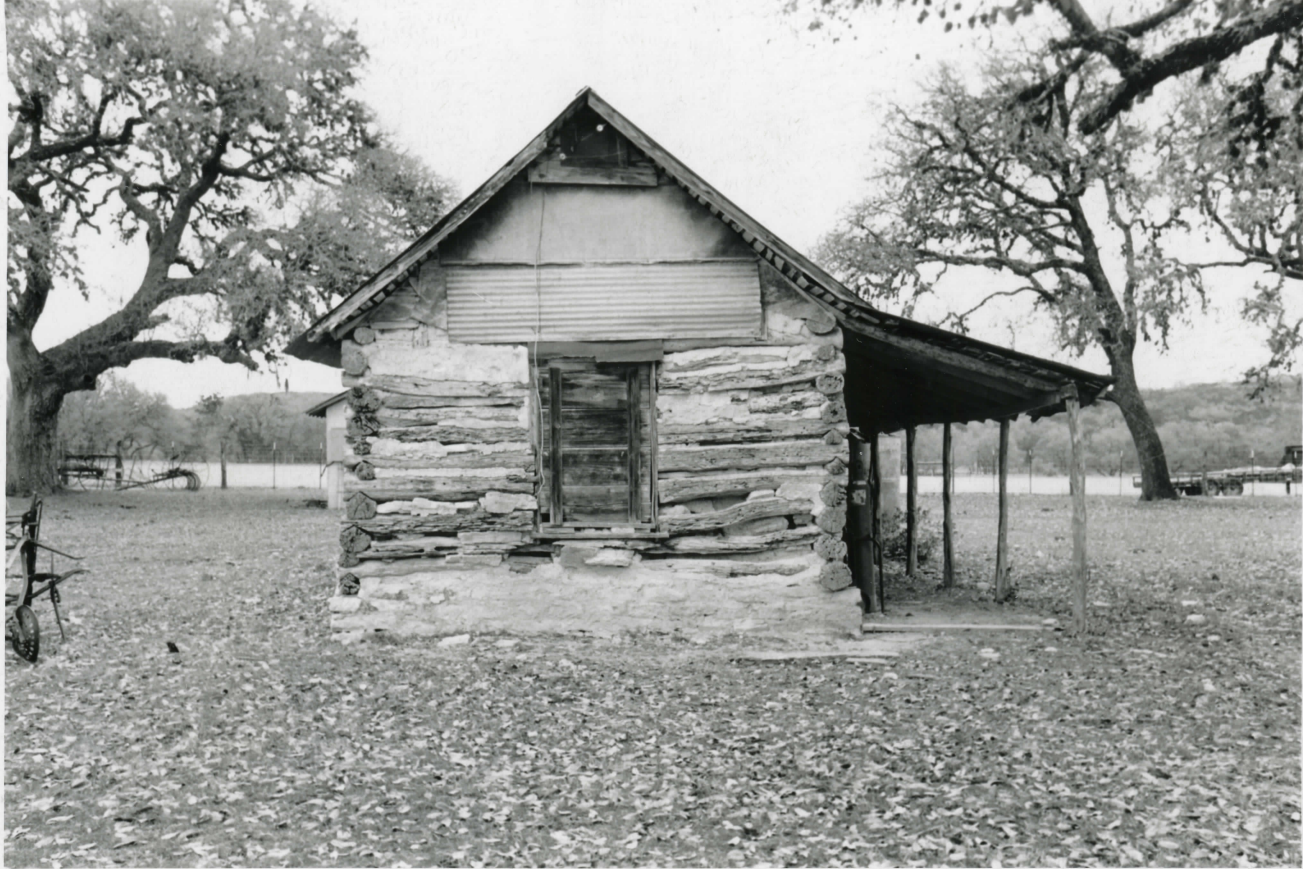
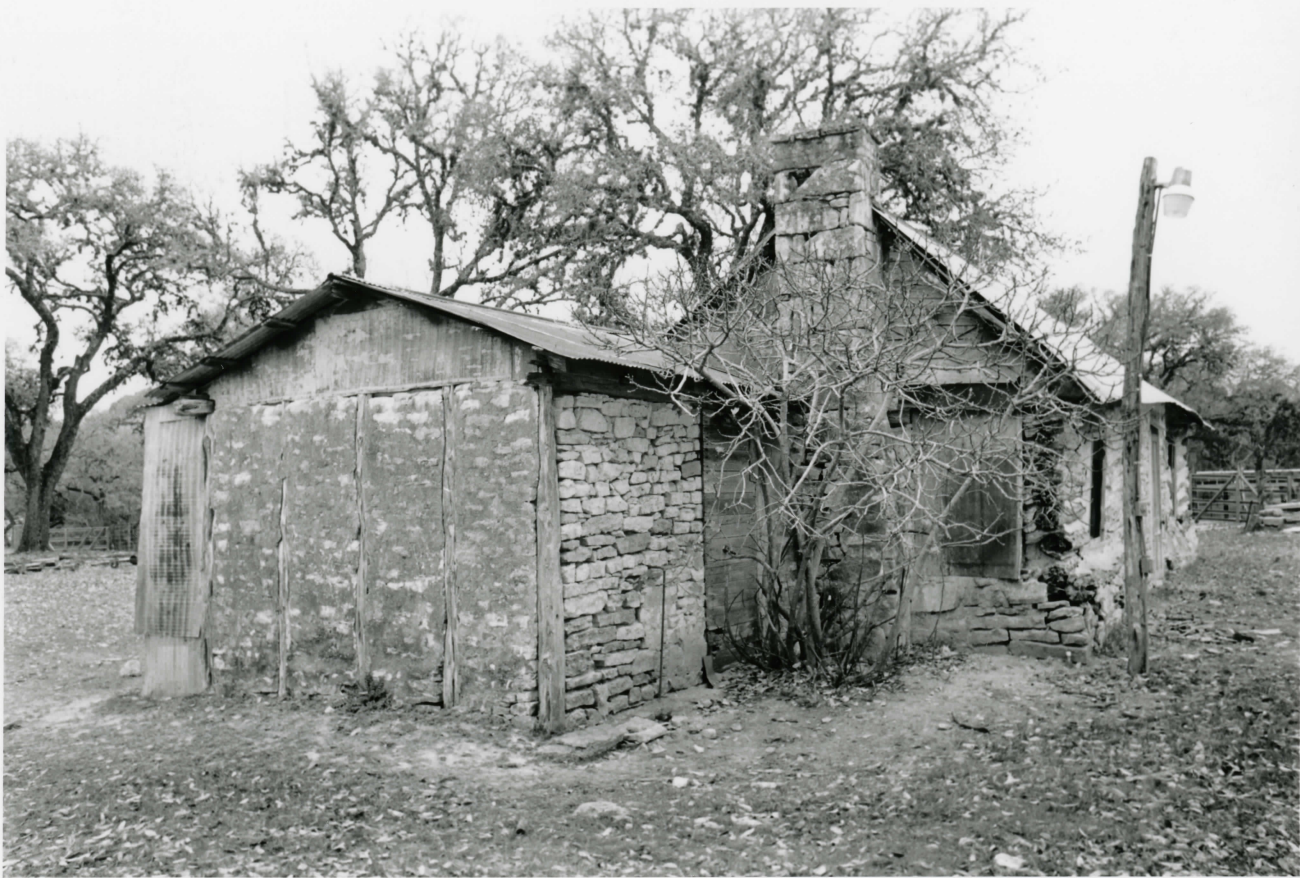
1. Heidemann Log House (Contributing, 1861/1862)

Description: 1-story modified Texas vernacular dog-trot log house. The plan is triple-penned with the middle room being formed by the enclosure of the dog-trot with native limestone rubble on the north side. On the south side under the porch logs were laid in a vertical fashion and filled with mortar and covered with plaster. The house is roofed by a side-gable of corrugated metal over wood shingles, which extends to create a full length shed roof porch on the south elevation. The porch roof is supported by stripped cedar columns. The logs have been chinked-in with plaster, and the wood windows, centered on the end rooms, are six light double hung sash windows. There are three, four-panel wood doors on the south side of the house under the porch. Each provides an entry way to each of the pens. A limestone external chimney is located on the east gable end. An early limestone rubble addition has been added to the southeast corner and was probably used as storage for equipment or woodworking tools. There is a cistern located on the east end of the south porch used for the collecting of water. There are no windows on the north side of the house.

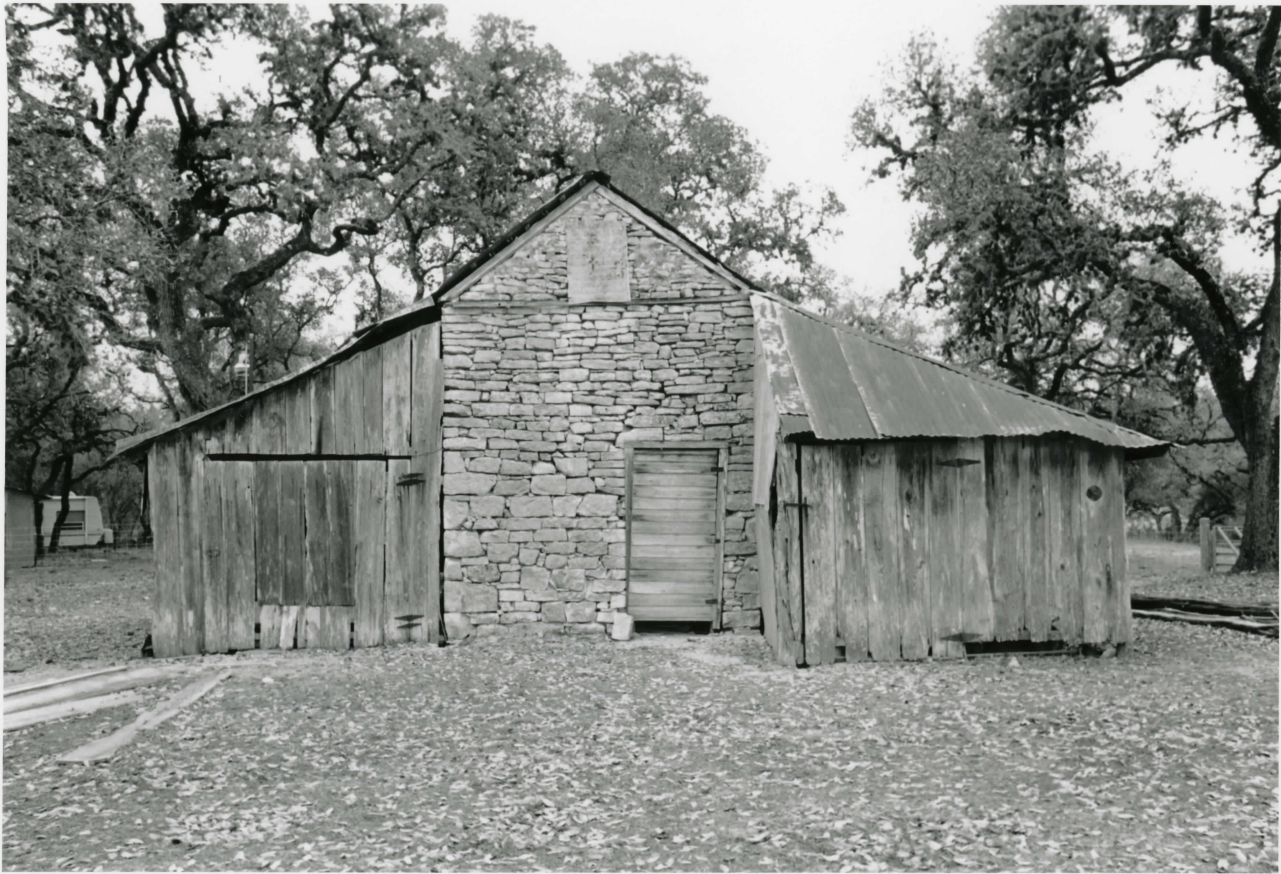
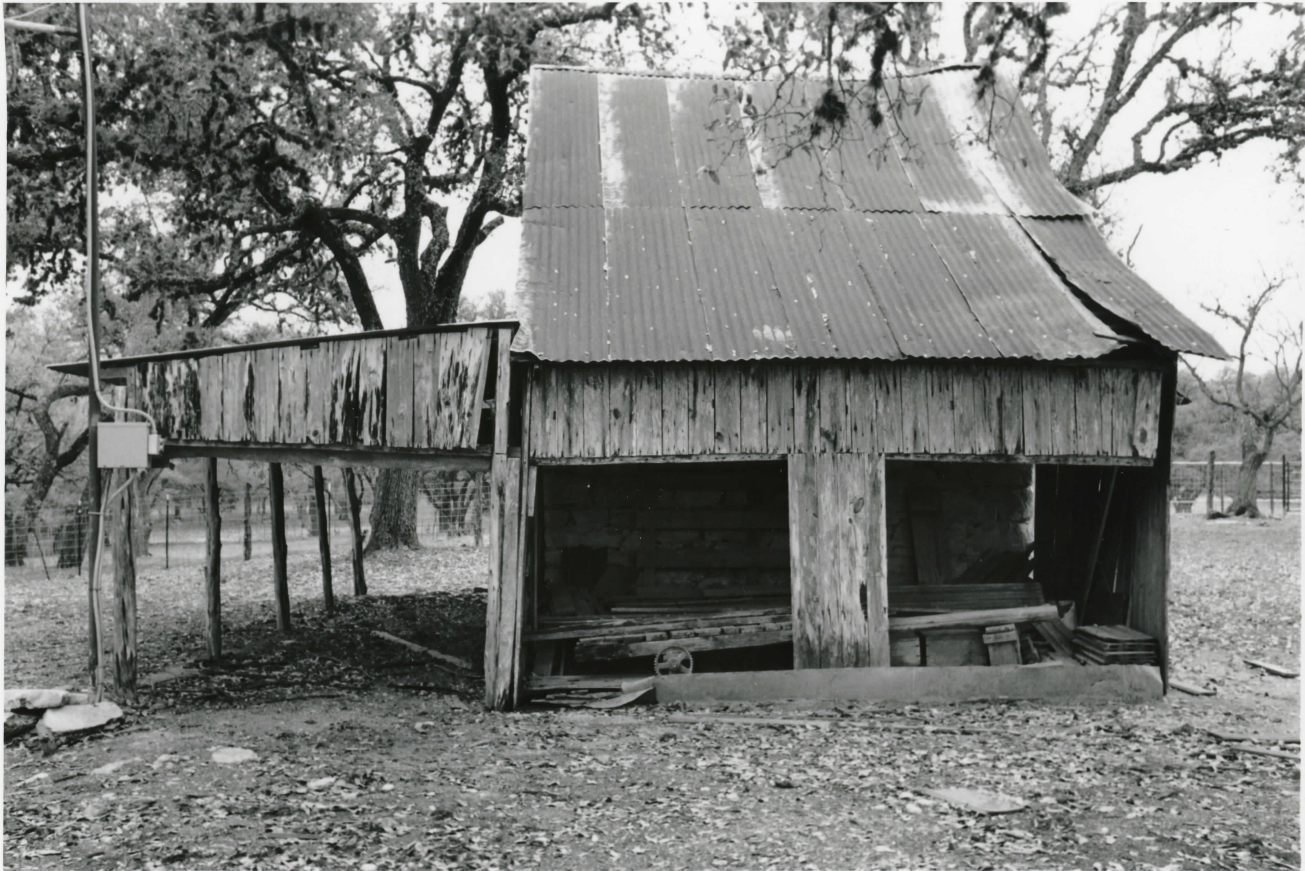
2. Heidemann Barn (Contributing, 1860s)

Description: 1½-story limestone rubble barn, flanked by a wood frame addition to both the east and west elevations. The walls of the upper portion of the barn, which may have been a loft, have been plastered on all four sides. There is a ledge around the inside perimeter of the room that could have supported a floor. There is an upper level door opening on the south elevation as well as a small window on the north gable of the barn. The main entry to the barn is on the north side. An open shed roof addition is located on the south elevation, supported by stripped cedar columns. The roofing is corrugated metal.

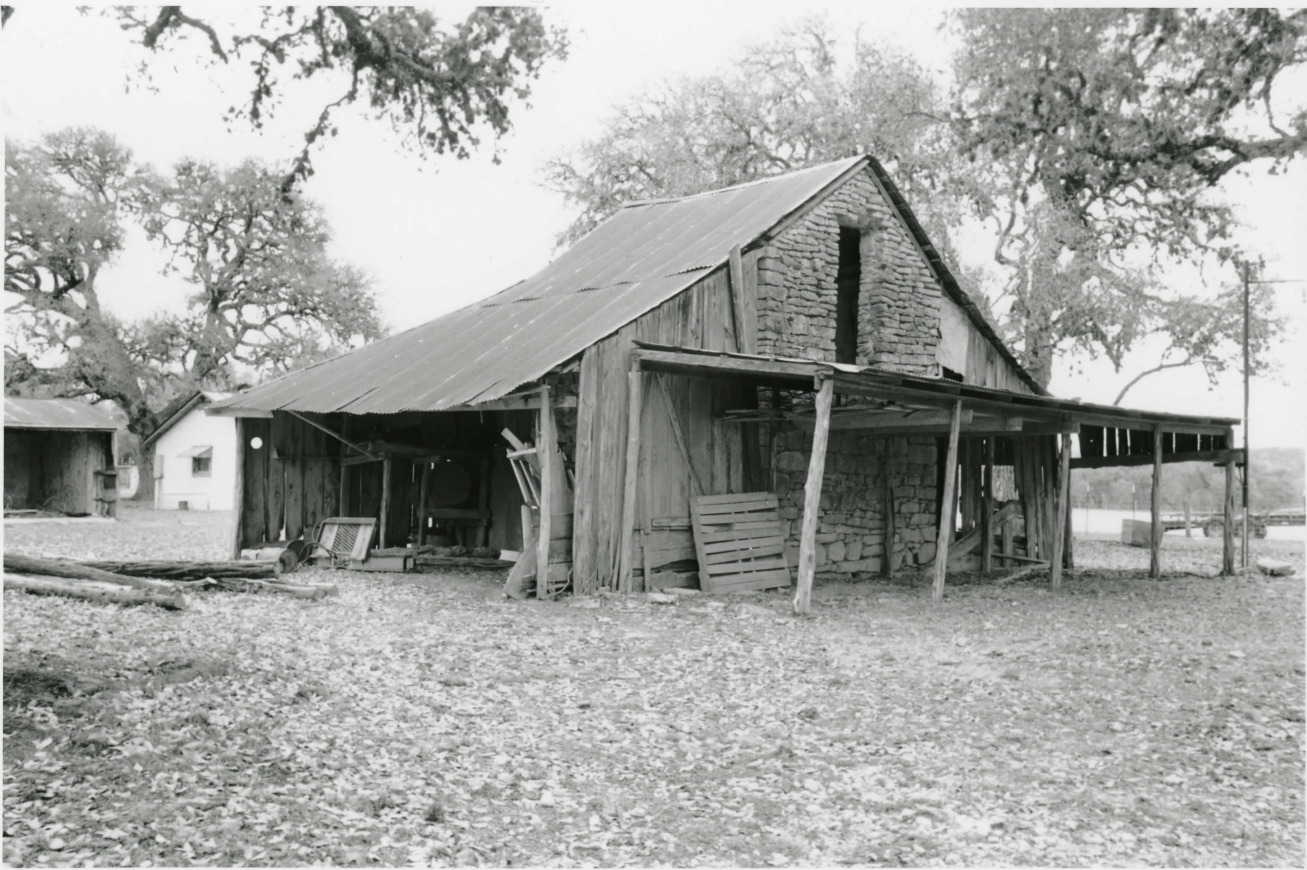
Heidemann Ranch
San Antonio, BEXAR Co. TX
photo 9

Description: A small single-pen structure constructed of native limestone rubble with an off-center door on the front north gable. The roof is corrugated metal and has a small rectangular gable vent on the front gable. There is a small opening in the west wall, possibly for ventilation. The interior has blackened walls and the racks where the meats were hung are intact. The aromatic smell of the smoked meats is still present.

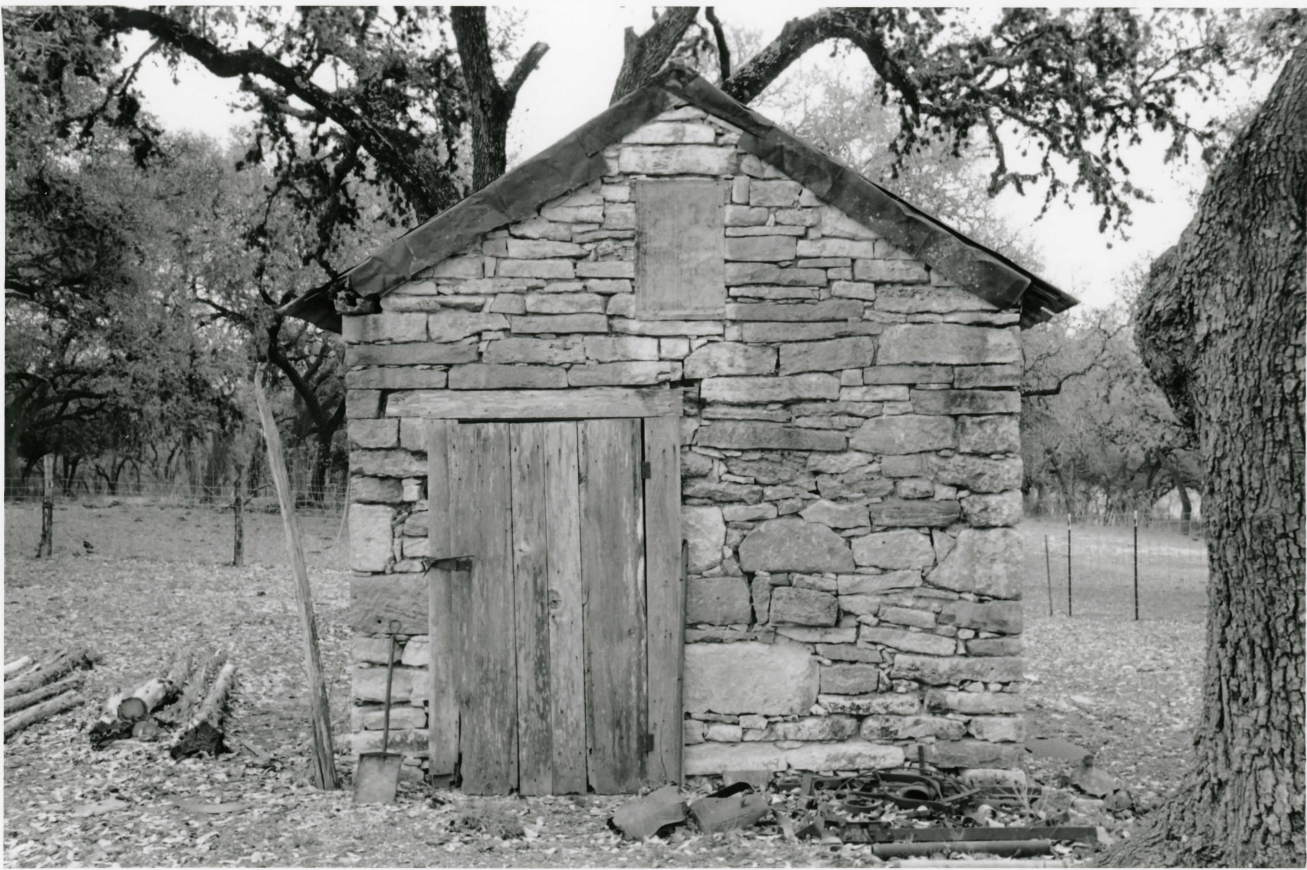
3. Heidemann Smokehouse (Contributing, 1860s)

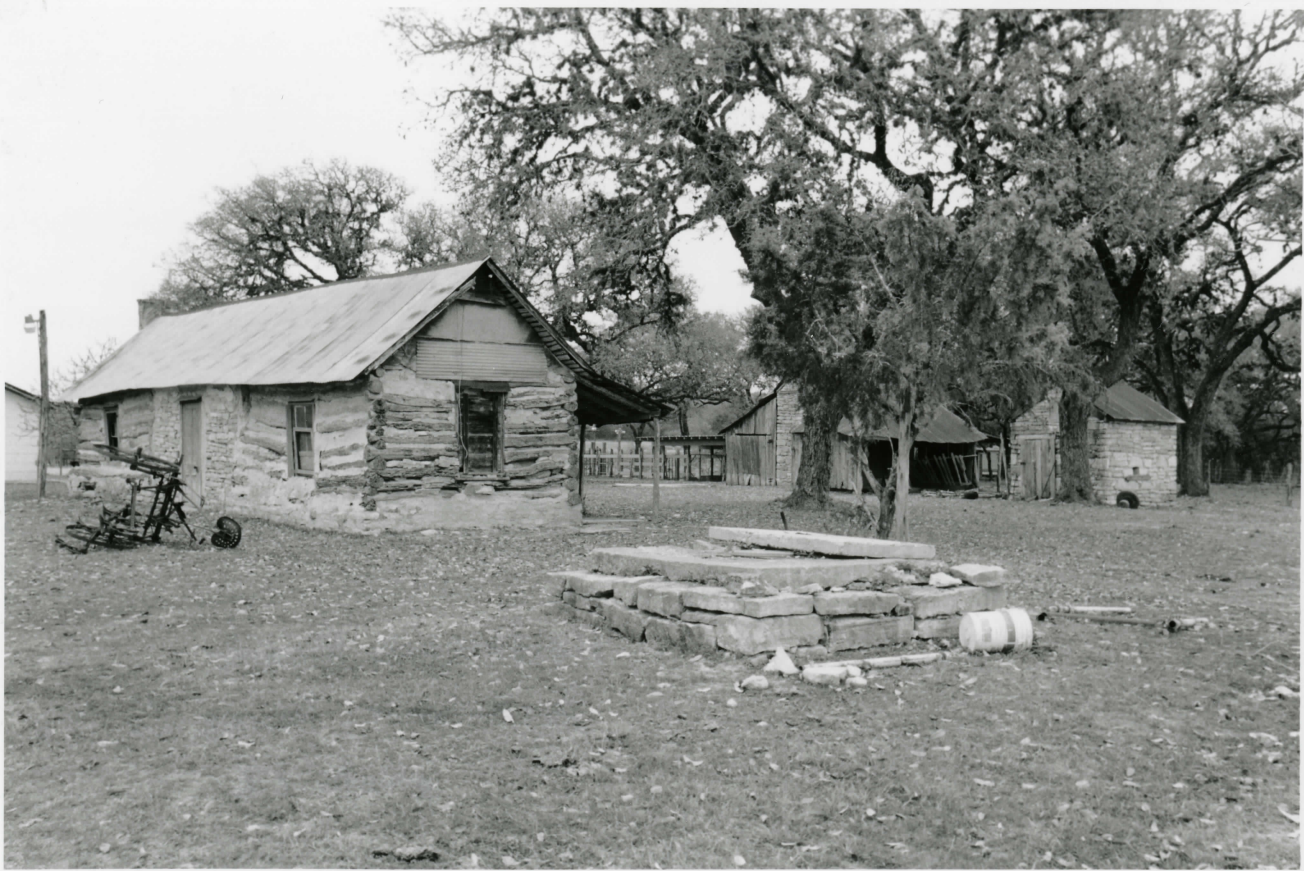
Heidemann Ranch
San Antonio, BEXAR Co. TX
photo 12

4. Water Well (Contributing, 1860s)

Description: Located just west of the log house is a small well with a limestone base. It has a protective covering and hinge with a handle to use in lifting it up. It is covered with a concrete slab. The well is in use. The limestone was likely quarried from the property.

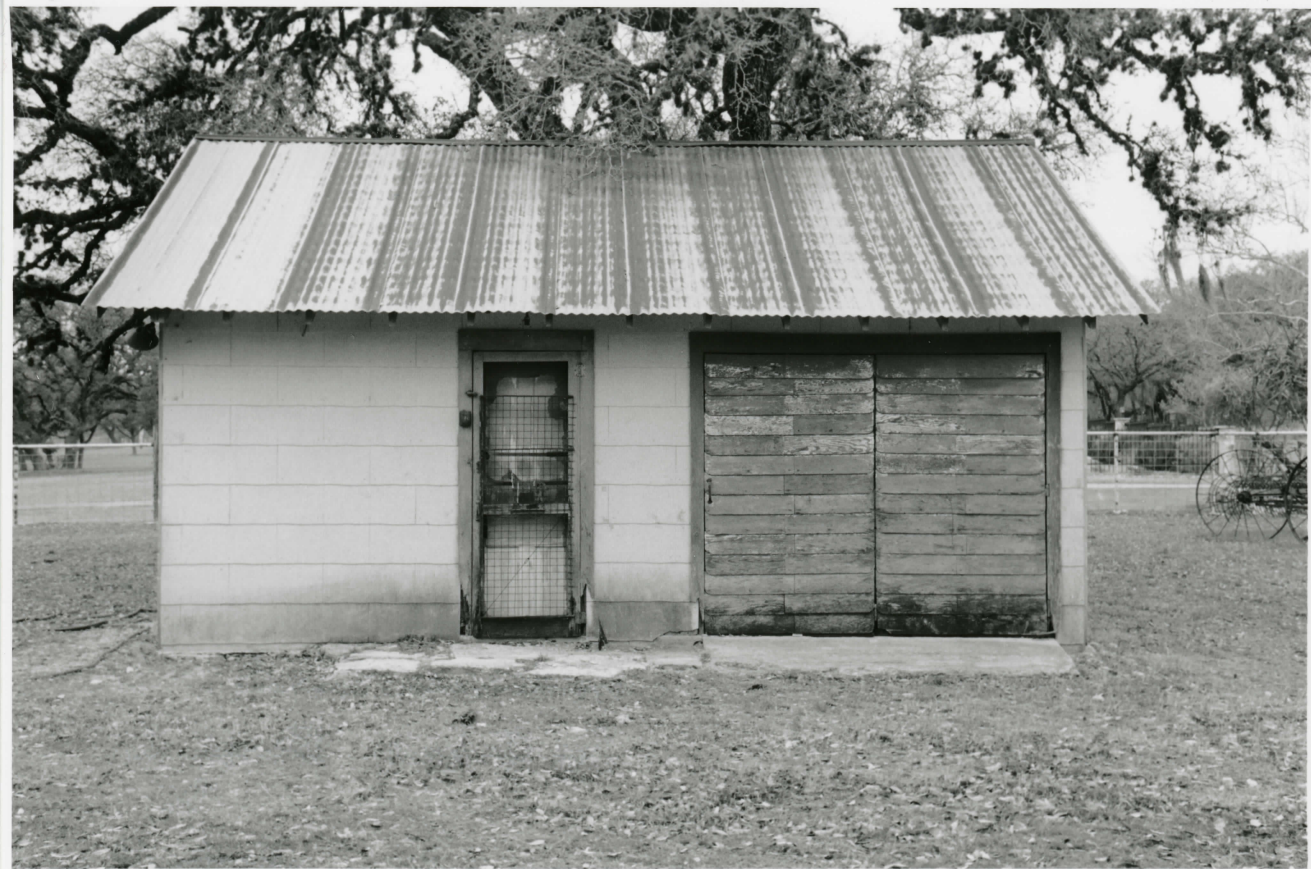
Heidemann Ranch
San Antonio, BEXAR Co
TX
photo 16

5. Heidemann Workshop (Contributing, 1950s)

Description: One room frame structure with walls constructed of stacked salvaged wood ammunition crates. The foundation is concrete slab and the exterior siding is asbestos shingle. The roof is a single gable of corrugated metal over composition shingles. Deer antlers are displayed along the interior walls. Woodworking tools and tables are also present in the interior.

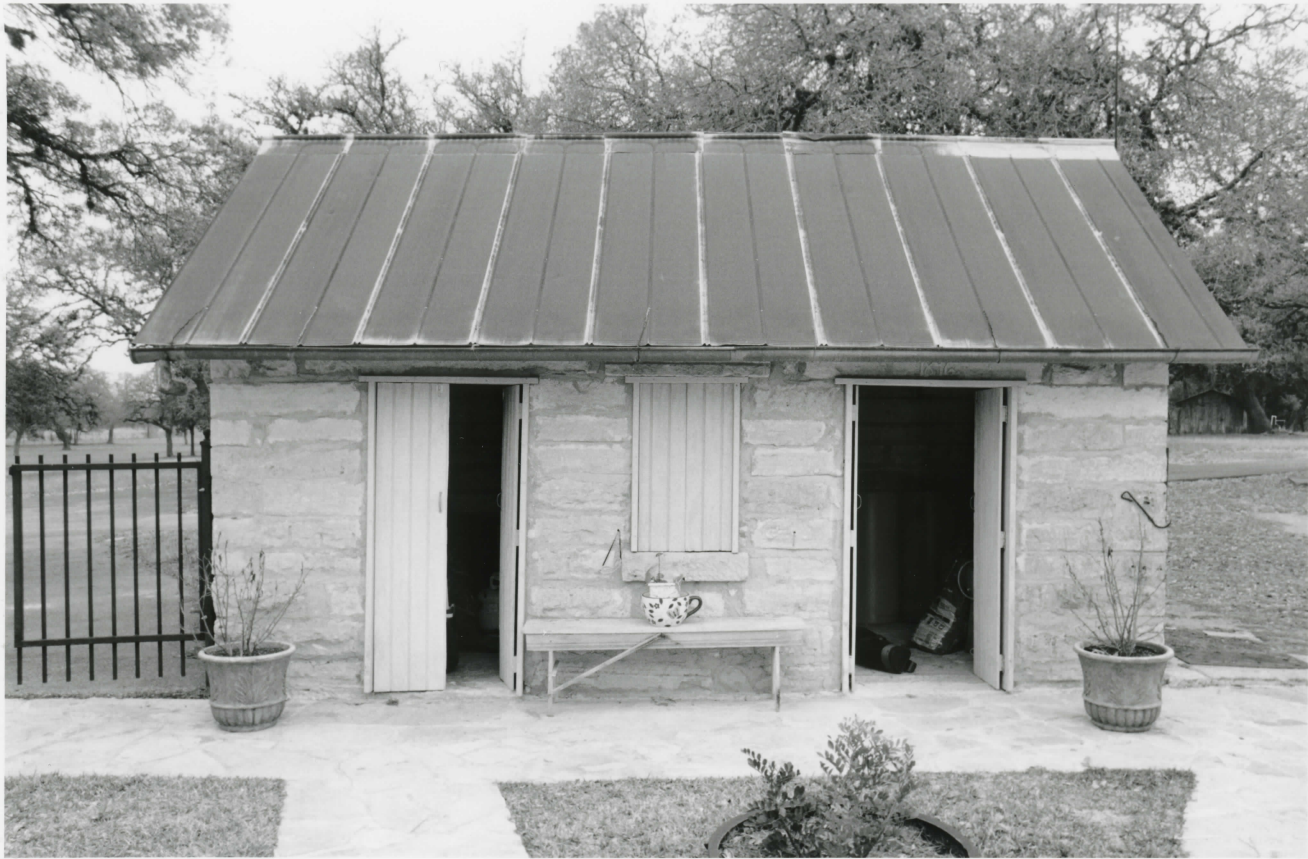
7. Heidemann Storage House/Outbuilding (Noncontributing, 1896; moved at an unknown date)

Description: 1-story quarried limestone single pen side-gabled building. The building dates to 1896 and was moved to its current location from the historic building compound to the south. After being relocated to its present position to the back of the Barrera-Heidemann house, it was outfitted with a shower for family use. The date of 1896 is over the doorway. Efforts to learn the original location of this building and the date it was moved have been unsuccessful. If the relocation of the building confirmed to the period of significance, the building should be characterized as a contributing resource.

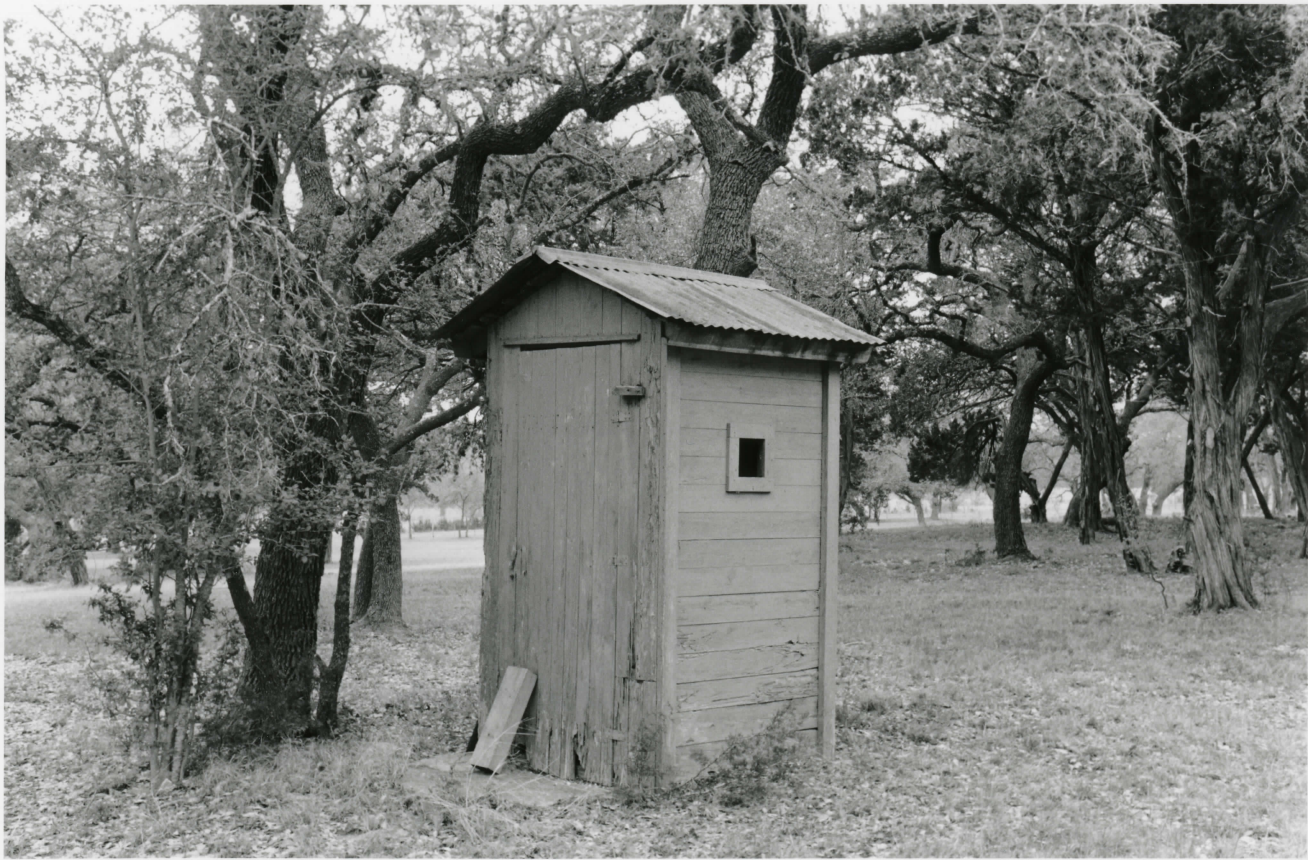
9. Outhouse (Contributing, date unknown)

Description: Small wood frame front-gabled metal roof with vertical and horizontal wood plank siding. This is painted green.

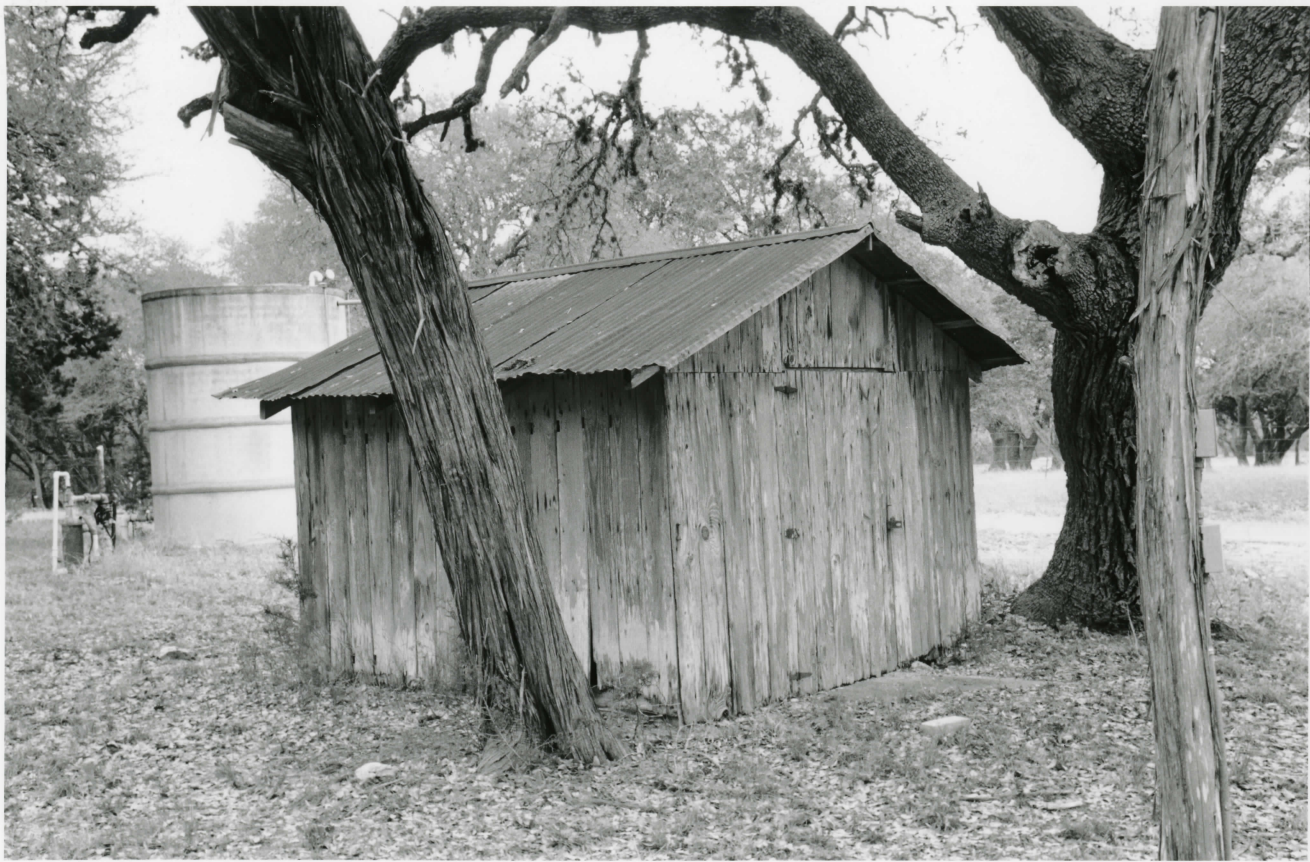
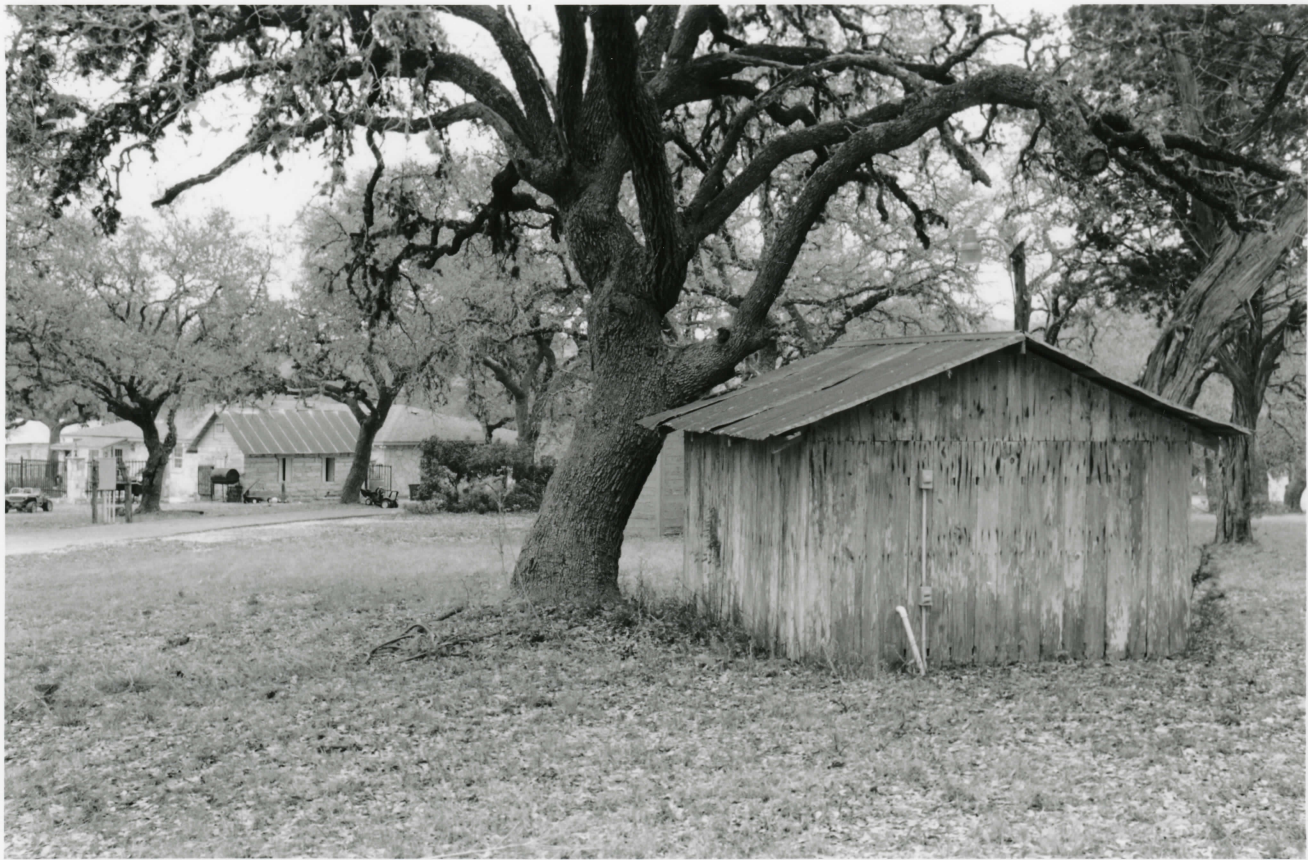
10. Well House (Contributing, date unknown)

Description: Small wood frame front-gabled metal roof and vertical wood plank siding, encloses a pump. For a period of time, a windmill was associated with this structure. The windmill was removed in 1993 and has been relocated to stock tank on another piece of Barrera property.

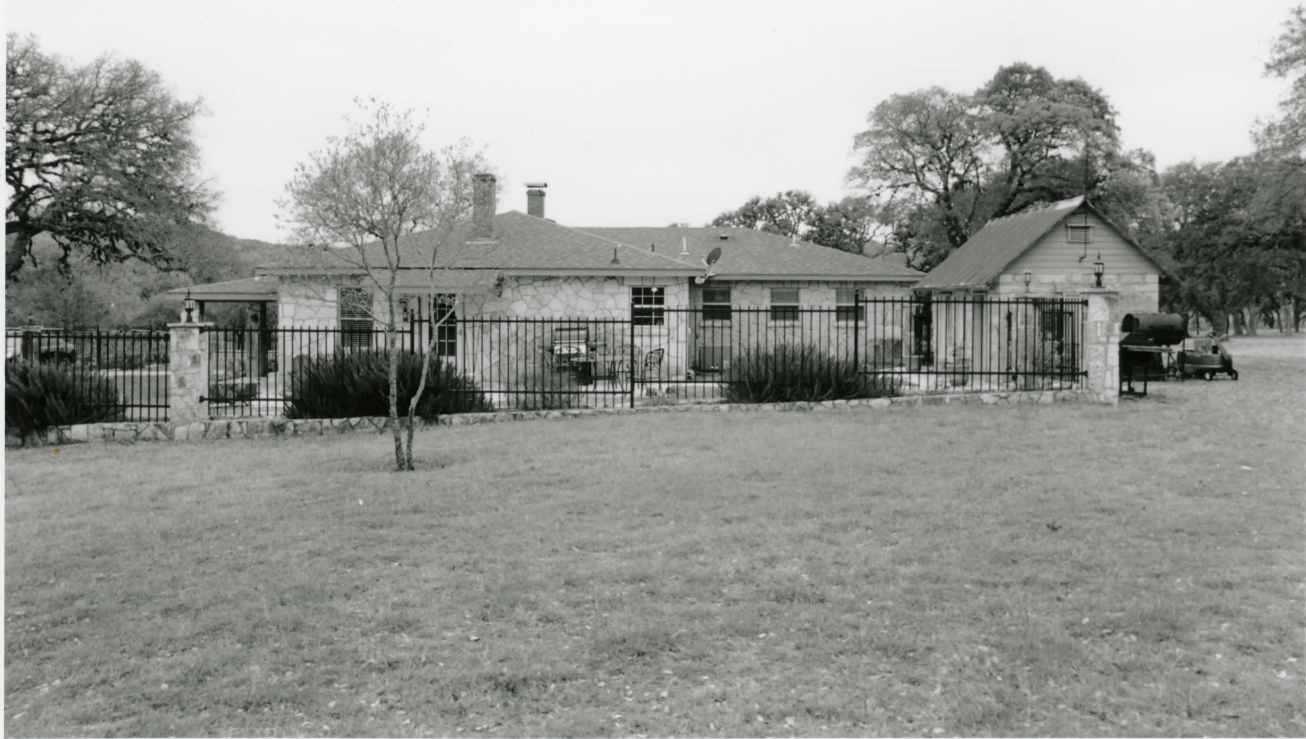
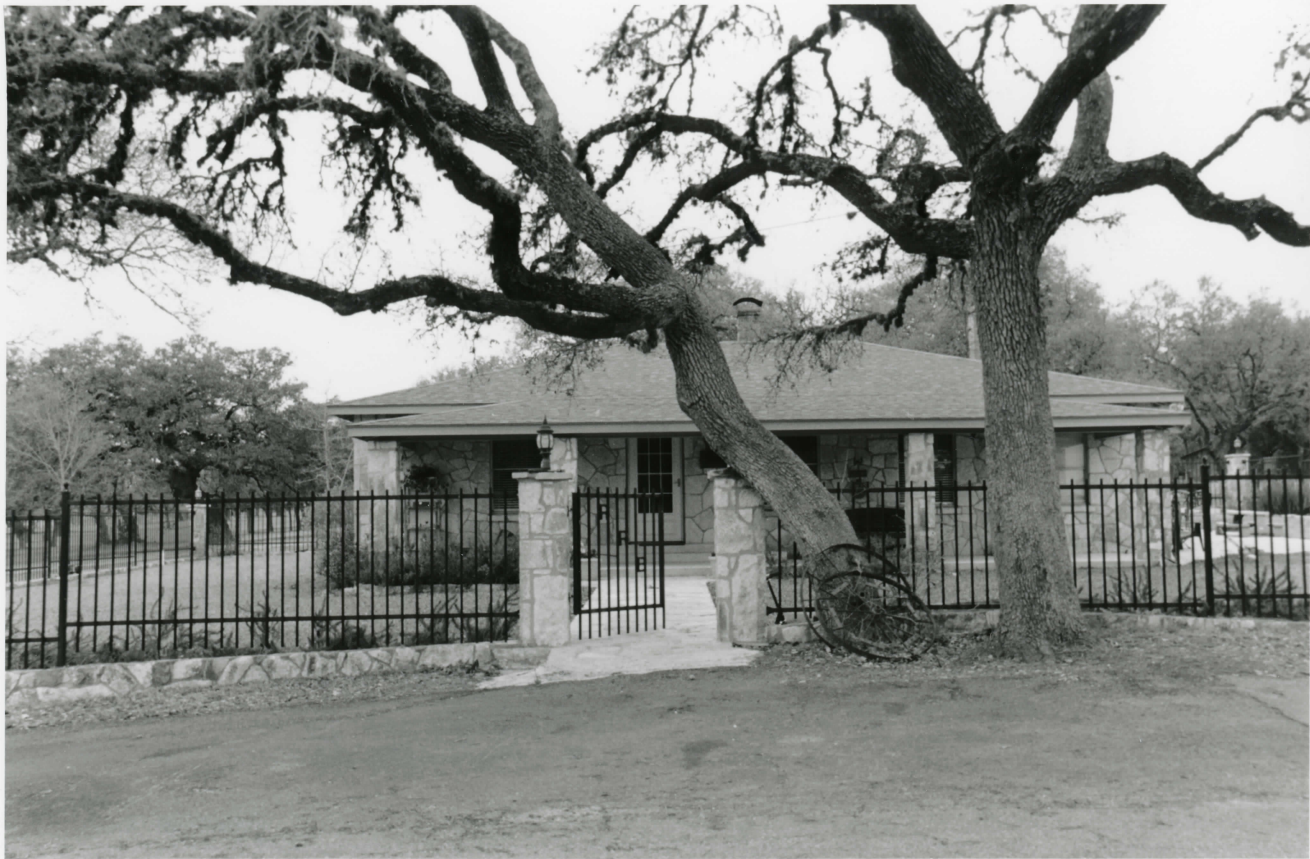
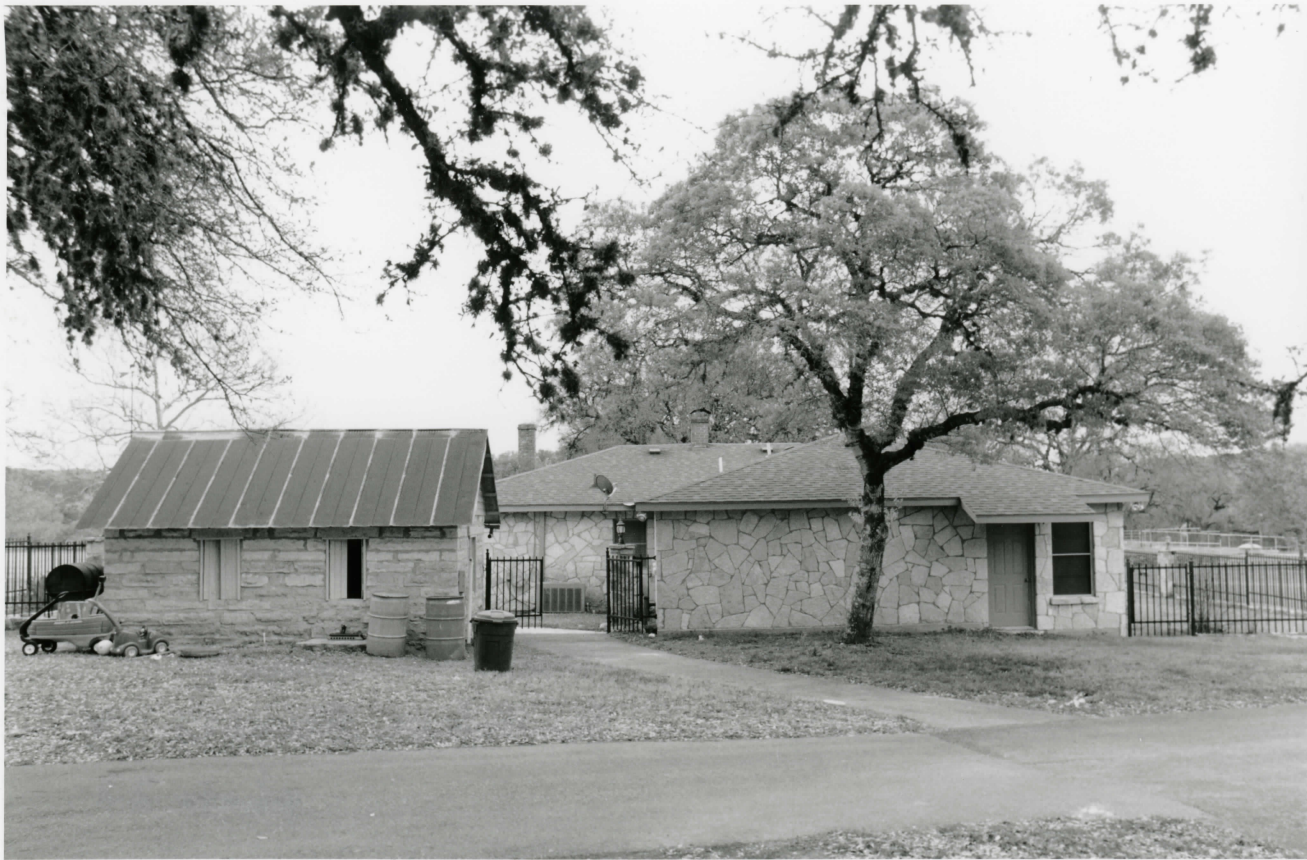
6. Heidemann-Barrera House (1937; remodeled 1950s-1960s, Contributing)

Description: 1-story limestone façade veneer residence built in 1937⁹ and remodeled during the 1950s and 1960s by Emil Heidemann.¹⁰ The interior was remodeled in 2003 by Roy Barrera III.¹¹ The foundation on the original house is concrete pier and beam and the north addition is concrete slab construction. The roof is a low pitched single hip composition shingle with a hipped addition which runs perpendicular to the original roof northward. The roof decking material on the

north slope, as viewed from the limited attic access, is three-inch tongue and groove wood, indicating construction in the 1930's. The decking on the south slope of the house is comprised of newer 1x8 boards.

There are two brick chimney flues which extend through the roof, although there are no visible fireplaces in the house. The chimney flue on the west side appears to be made of brick that is older than the chimney flue to the east side. The windows are single hung mill finish aluminum. The covered front porch on the south elevation extends across the entire length of the house. It has a bead-board ceiling. The front porch columns are stone veneer likely placed over wooden columns in the original constructions. A four-foot-tall decorative wrought iron fence with a stone base surrounds the house.

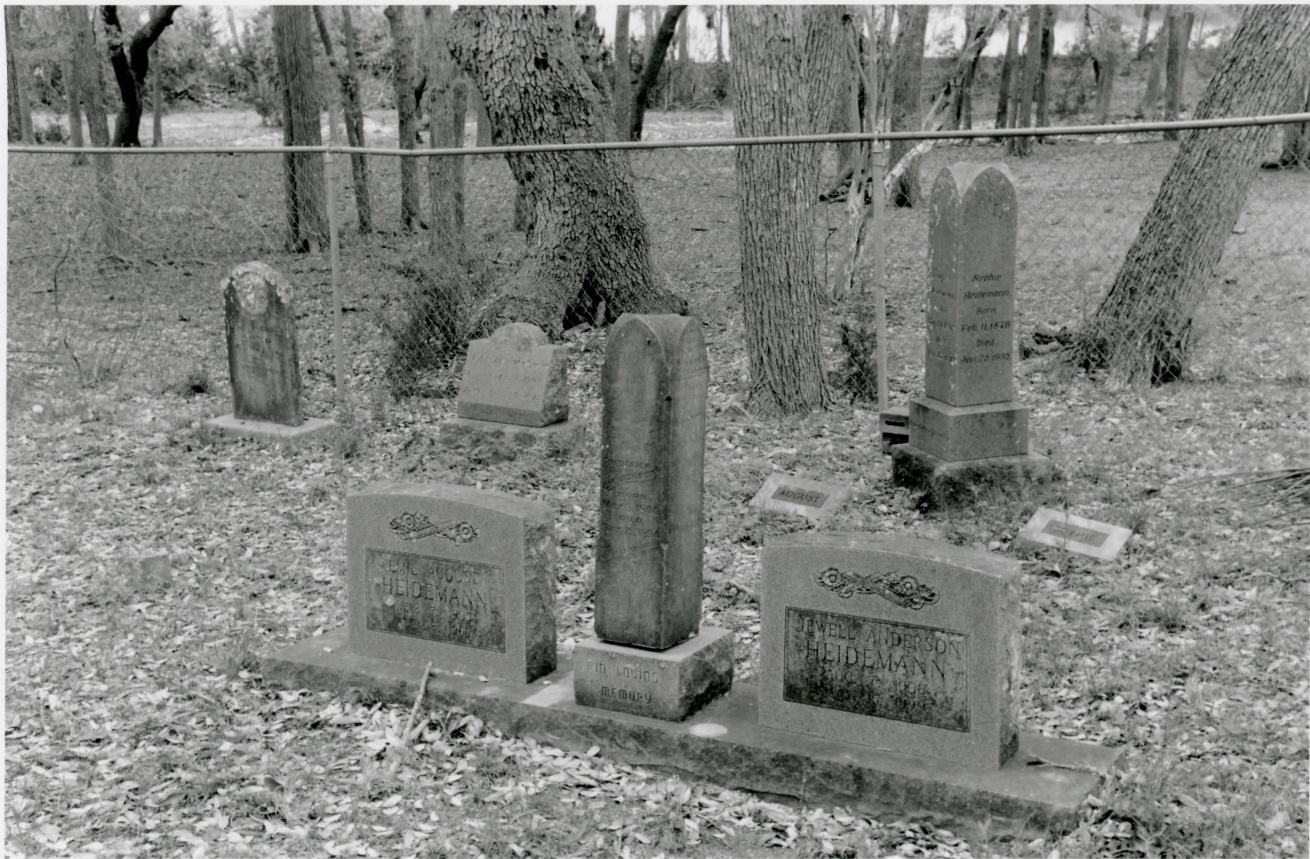
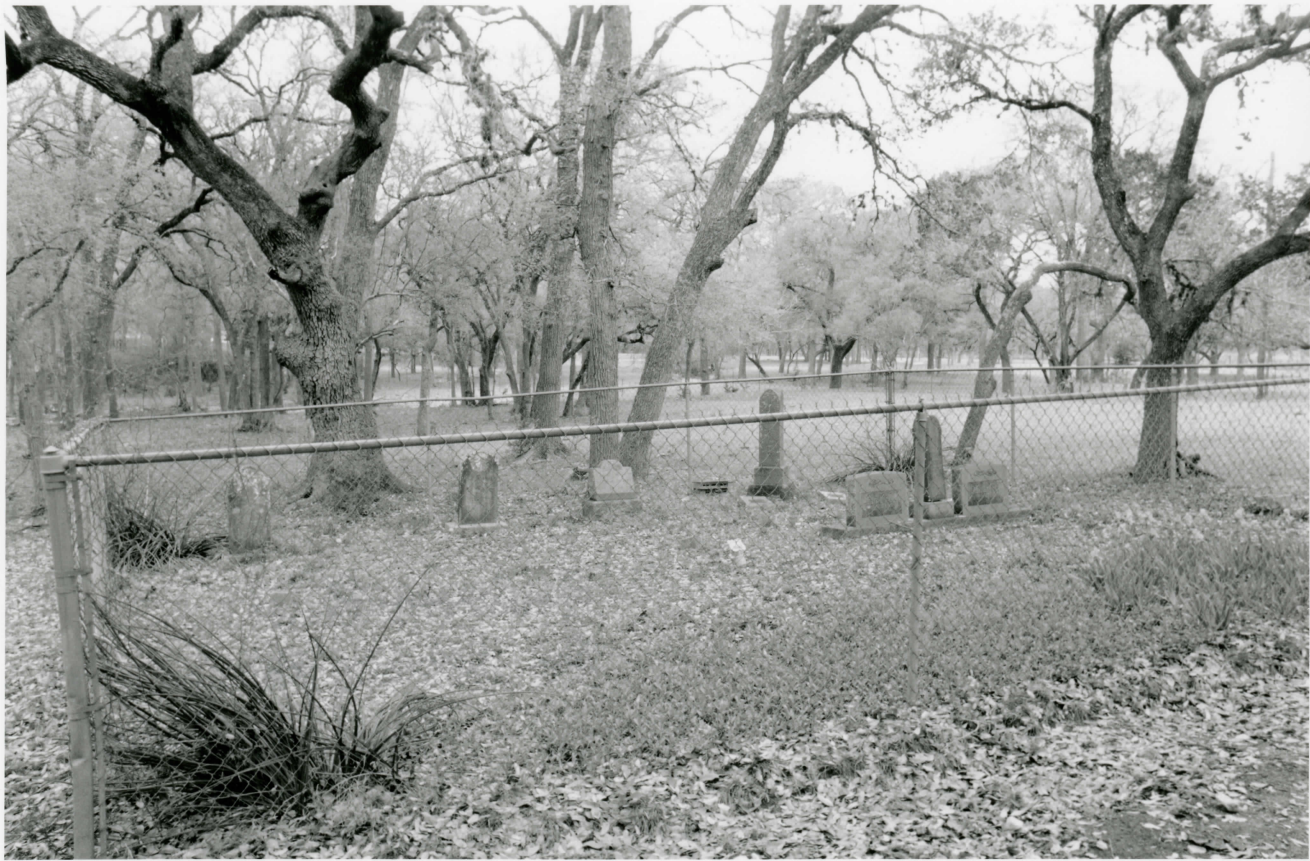
11. Heidemann Cemetery (Contributing, 1893-1999)

Description: Heidemann Cemetery encompasses .0197 acres and is located to the south of the driveway. It is completely enclosed by a chain link fence with a gate. The cemetery contains seven graves of Heidemann family members, including the original settlers, William Heidemann who died c.1893, and his wife, Elsa, who died in 1880. There is a tombstone marker for Frederick Emilienburg (1840- 1894), the father of two of daughters who married into the Heidemann family. The cemetery was dedicated as a family cemetery on March 8, 1974 by Mrs. Jewell Anderson Heidemann.¹²
