USDI/NPS NRHP Registration Form

Heidemann Ranch, San Antonio, Bexar County, Texas

INVENTORY OF PROPERTIES

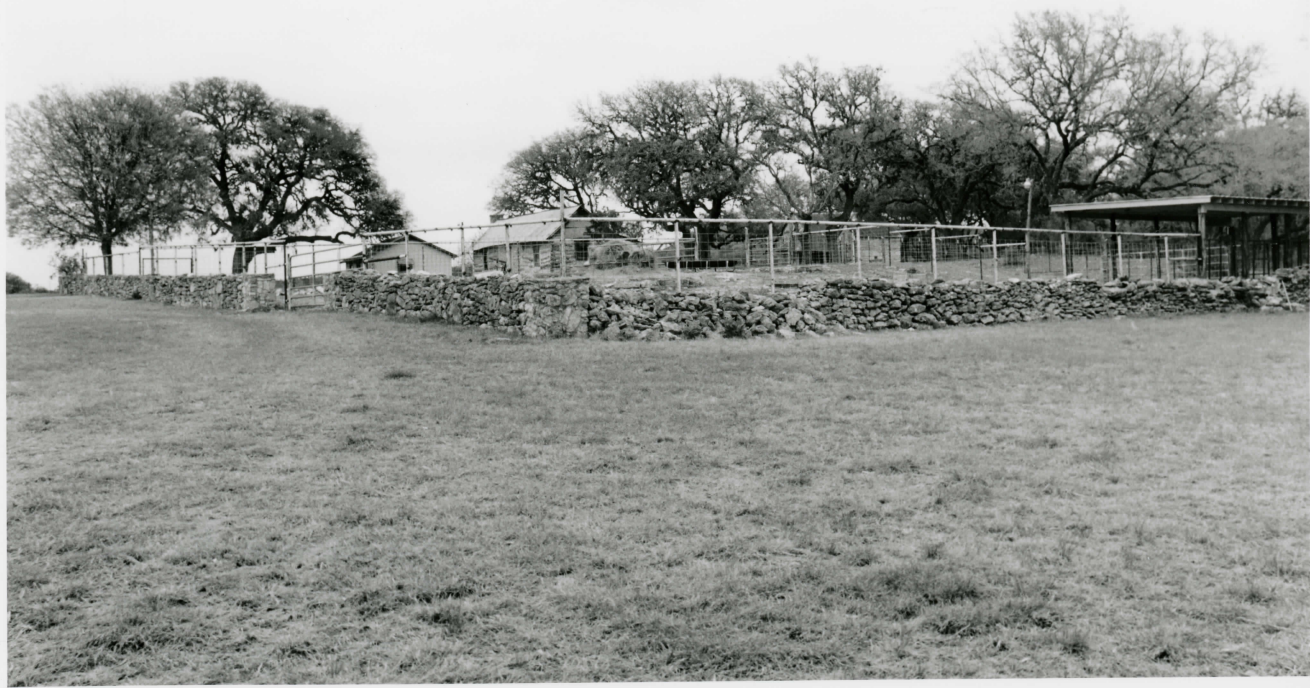
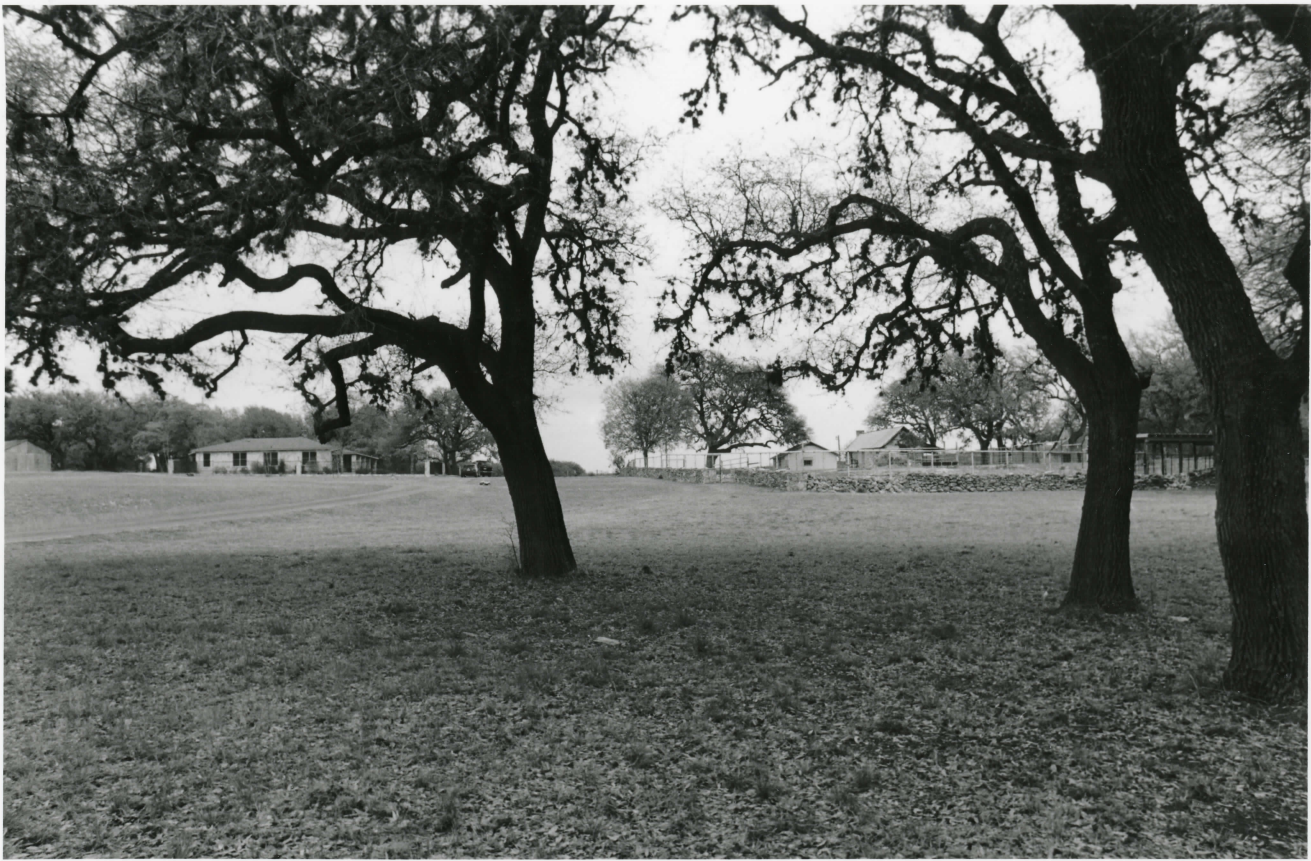
12. Rock Walls (Contributing)

Description: Low dry-stack rock walls are present along the south side of the private asphalt road. Some of these walls were reconstructed to match the original walls.
