**NATIONAL REGISTER OF HISTORIC PLACES  
INVENTORY -- NOMINATION FORM**SEE INSTRUCTIONS IN *HOW TO COMPLETE NATIONAL REGISTER FORMS*  
TYPE ALL ENTRIES -- COMPLETE APPLICABLE SECTIONS**1 NAME**HISTORIC  
\* \* \*  
AND/OR COMMON

McKinney-McDonald House

McDonald-Lee House

926 Winnie

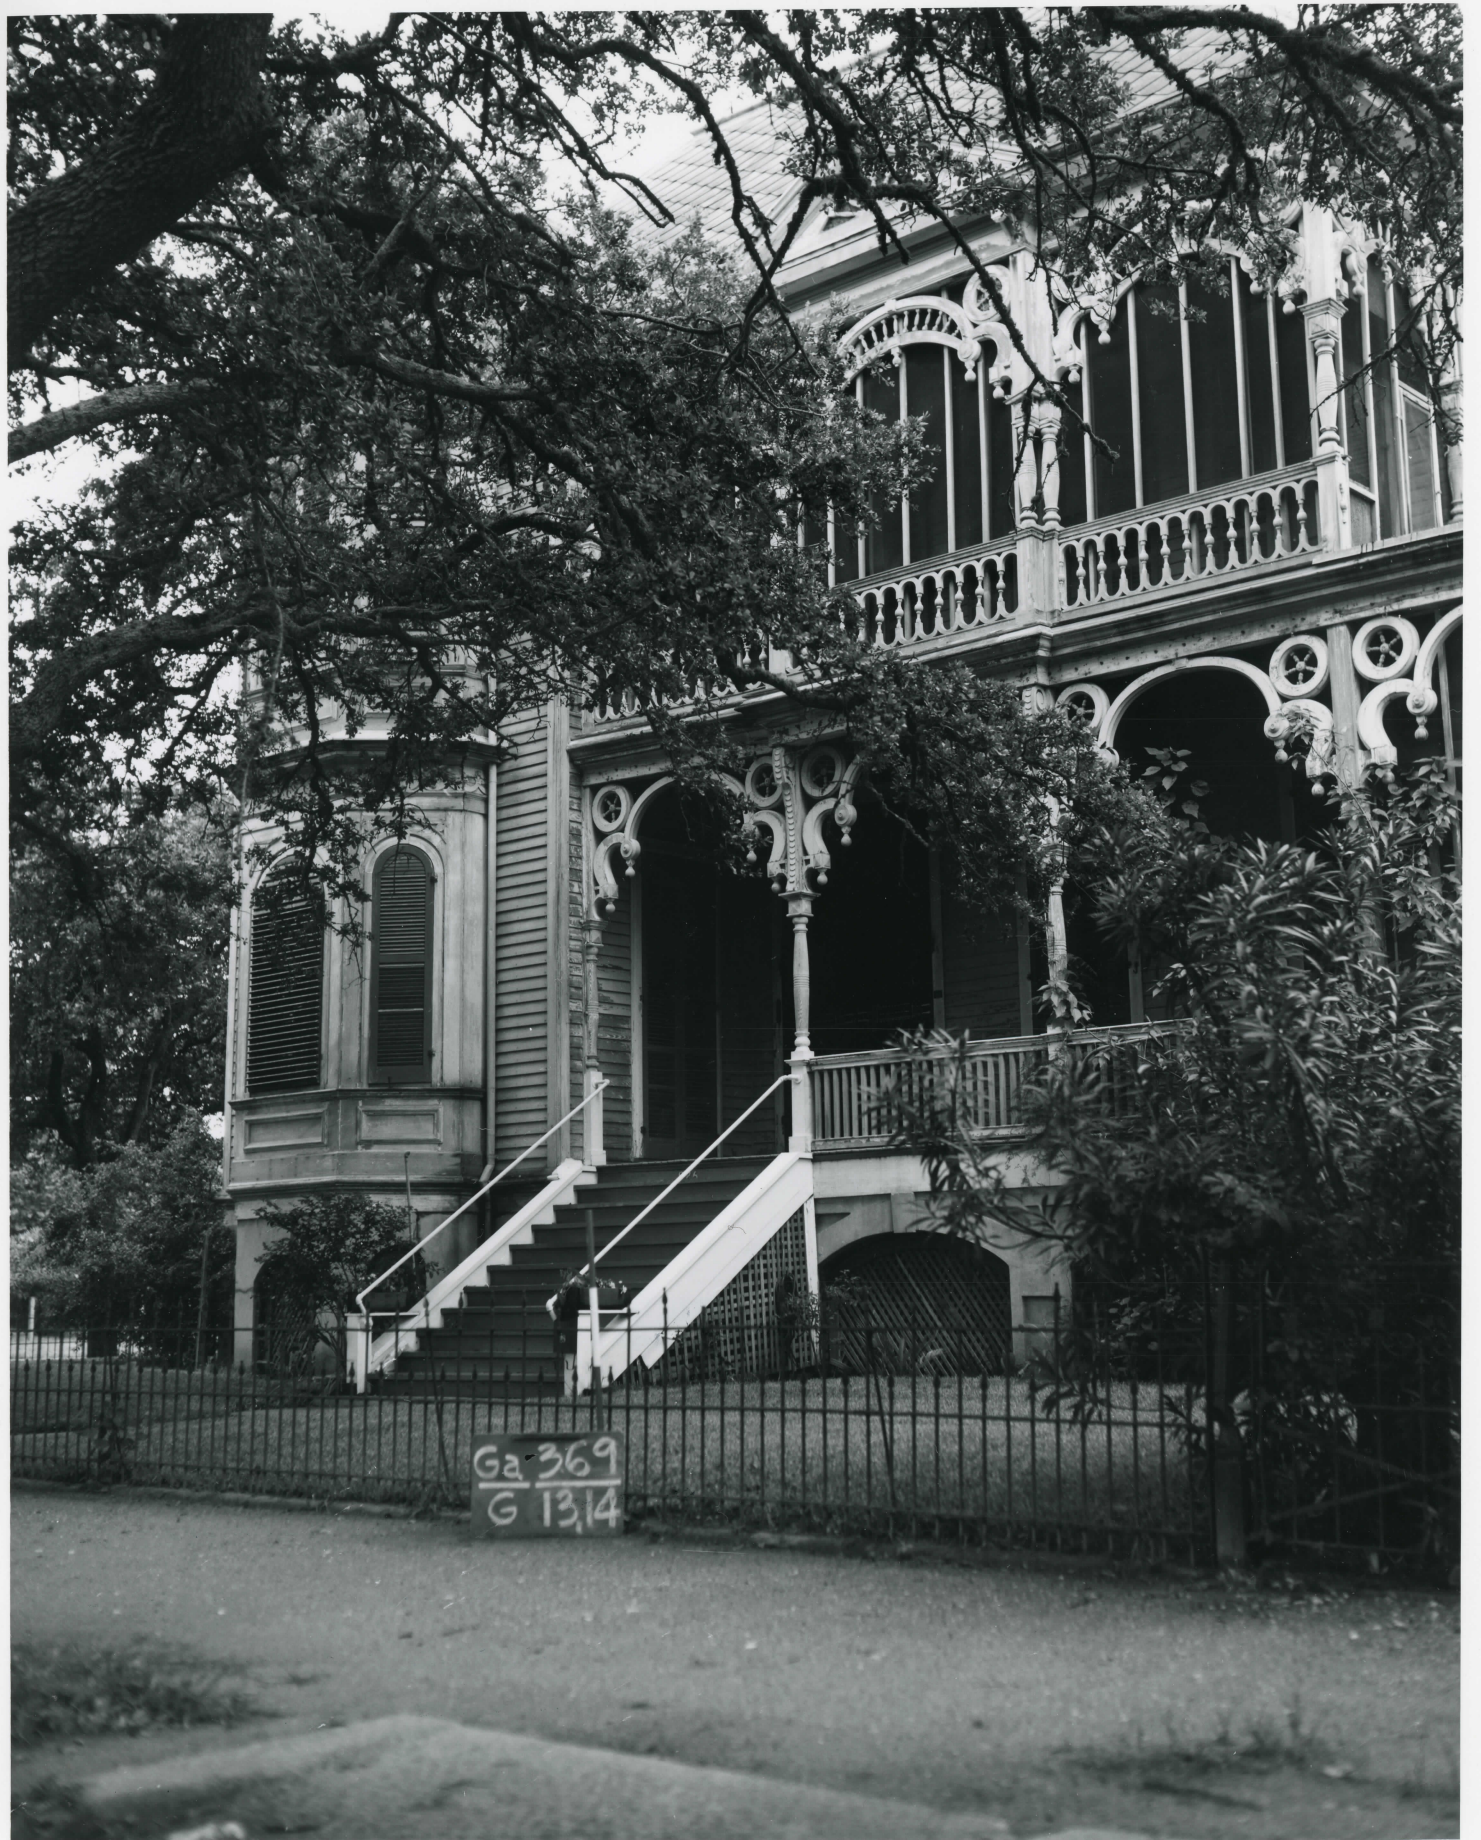
PHOTO NO. 1 of 4

Southeast oblique of the main(south) facade.

The south (main) facade has a slightly projecting gabled end pavilion and an inset double gallery across the remaining three bays. A prominent feature on this main facade is the two-story bay attached to the gabled pavilion. Elegantly detailed in wood, the first floor bay contains round keystone arched windows over molded base panels and is crowned by a frieze of carved fleur-de-lis with cornice above. The upper level of the bay displays identical base panels, straight-topped windows, another carved frieze motif, brackets and a cornice. The double gallery reveals the influence of the Eastlake style in its elaborate three dimensional quality. The gallery balustrade has turned and arched balusters (a recent restoration has replaced the first floor balusters shown in the photograph with a copy of the original balusters of the second floor). Supporting the gallery are short turned posts or spindles with pedestal bases and square caps with architrave moldings. Springing from the top of each post are fanciful ornamented wooden arches with elaborate brackets, spindles, pendants and wheels. The wide flight of wooden steps leading to the raised entrance has recently been replaced with brick steps.

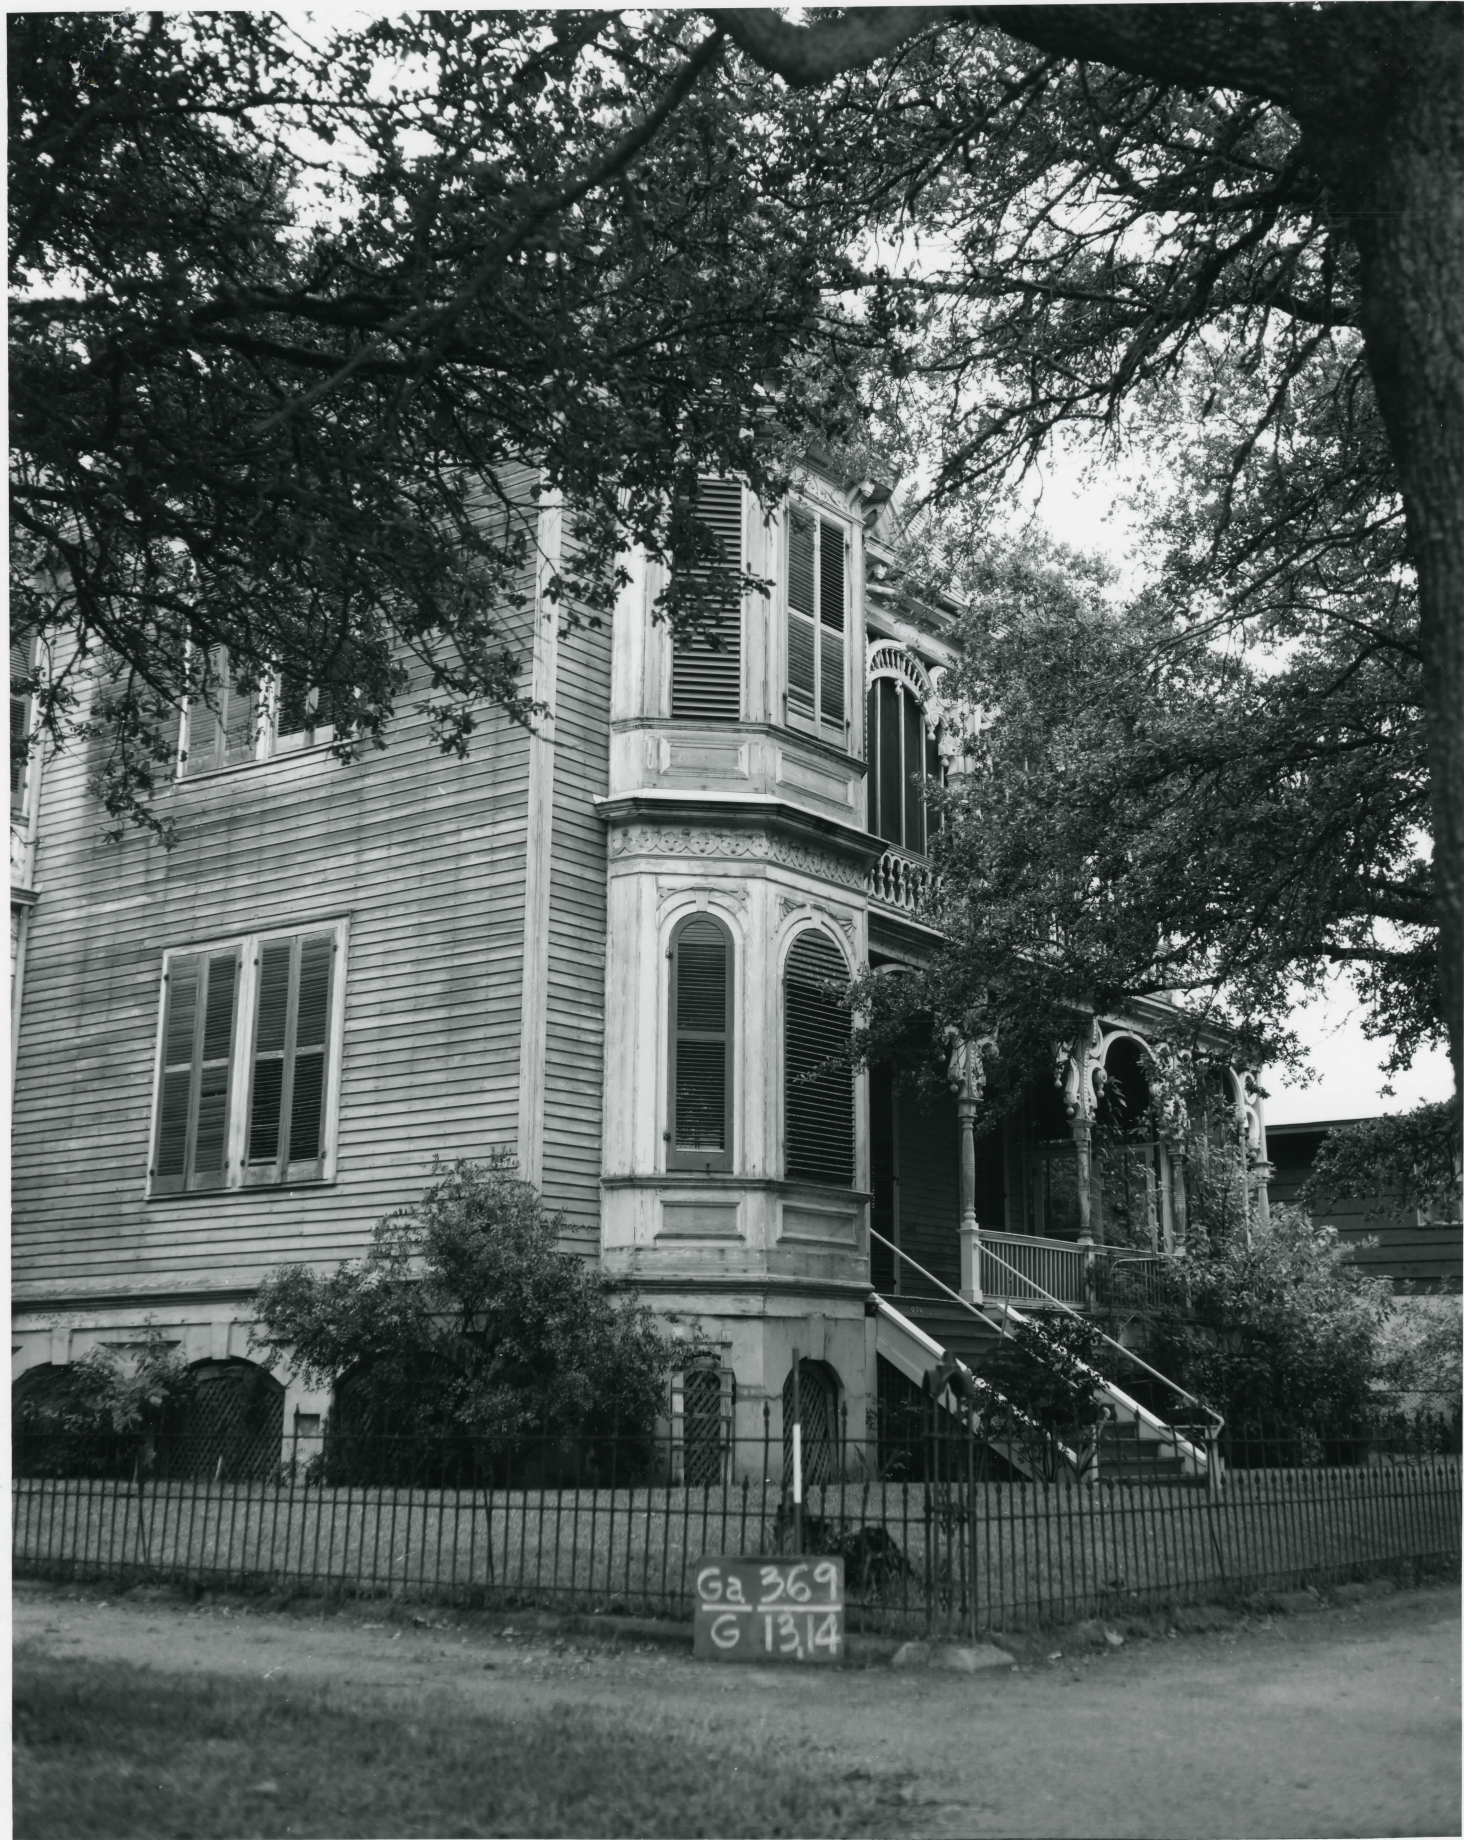
PHOTO NO. 2 of 4

Southwest oblique

The first floor gallery wraps around the east side of the house intersecting with the wing on the northeast corner. The west facade contains another slight gabled projection with a two-story bay. Similar to the front, this bay has base panels, frieze and cornice.

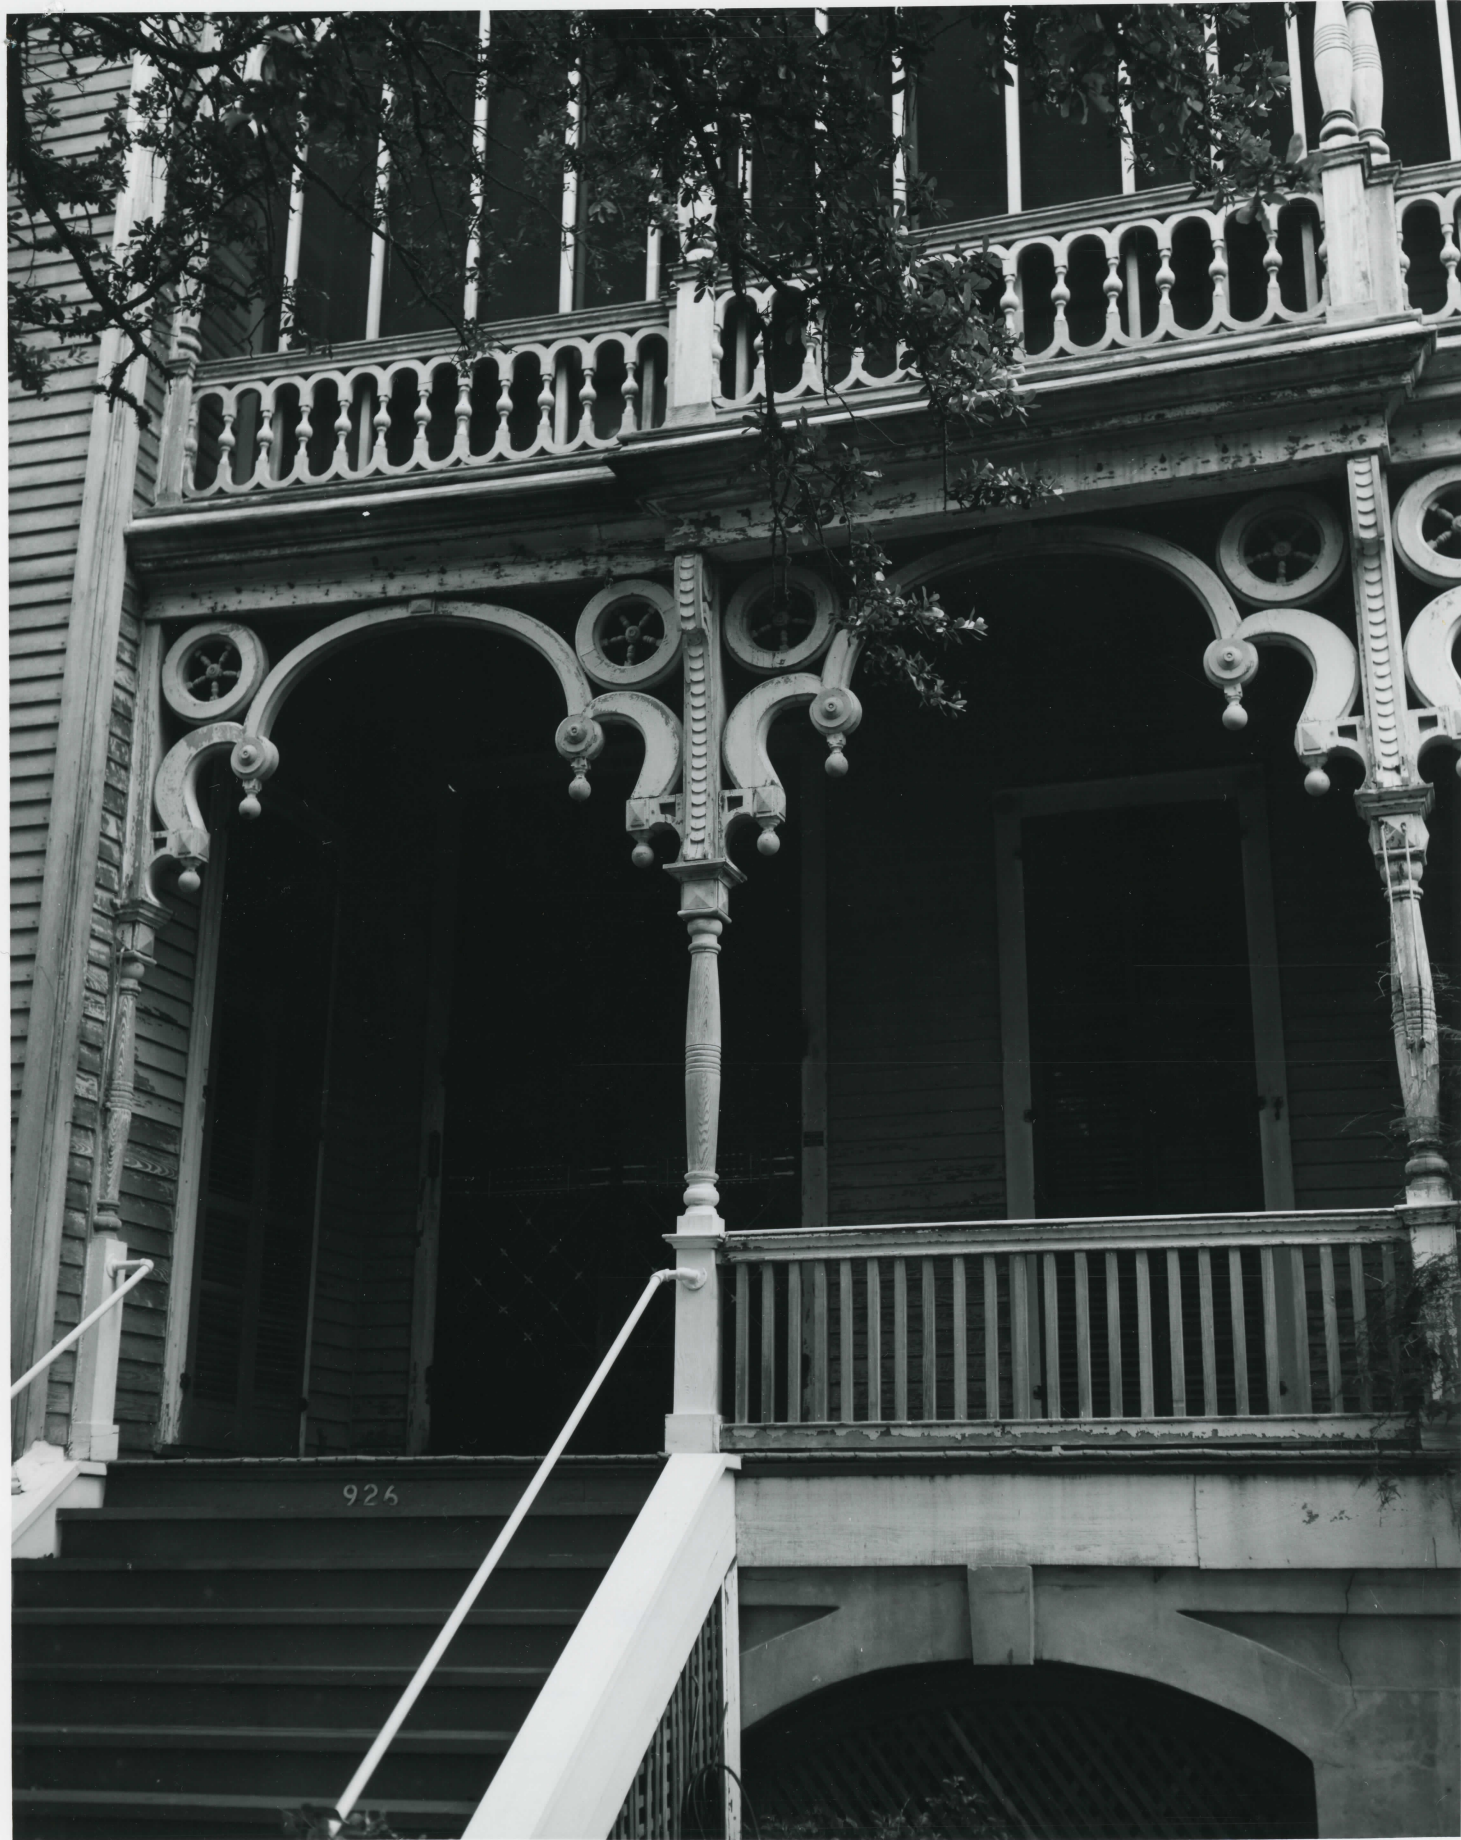
PHOTO NO. 3 of 4

Detail of gallery embellishments

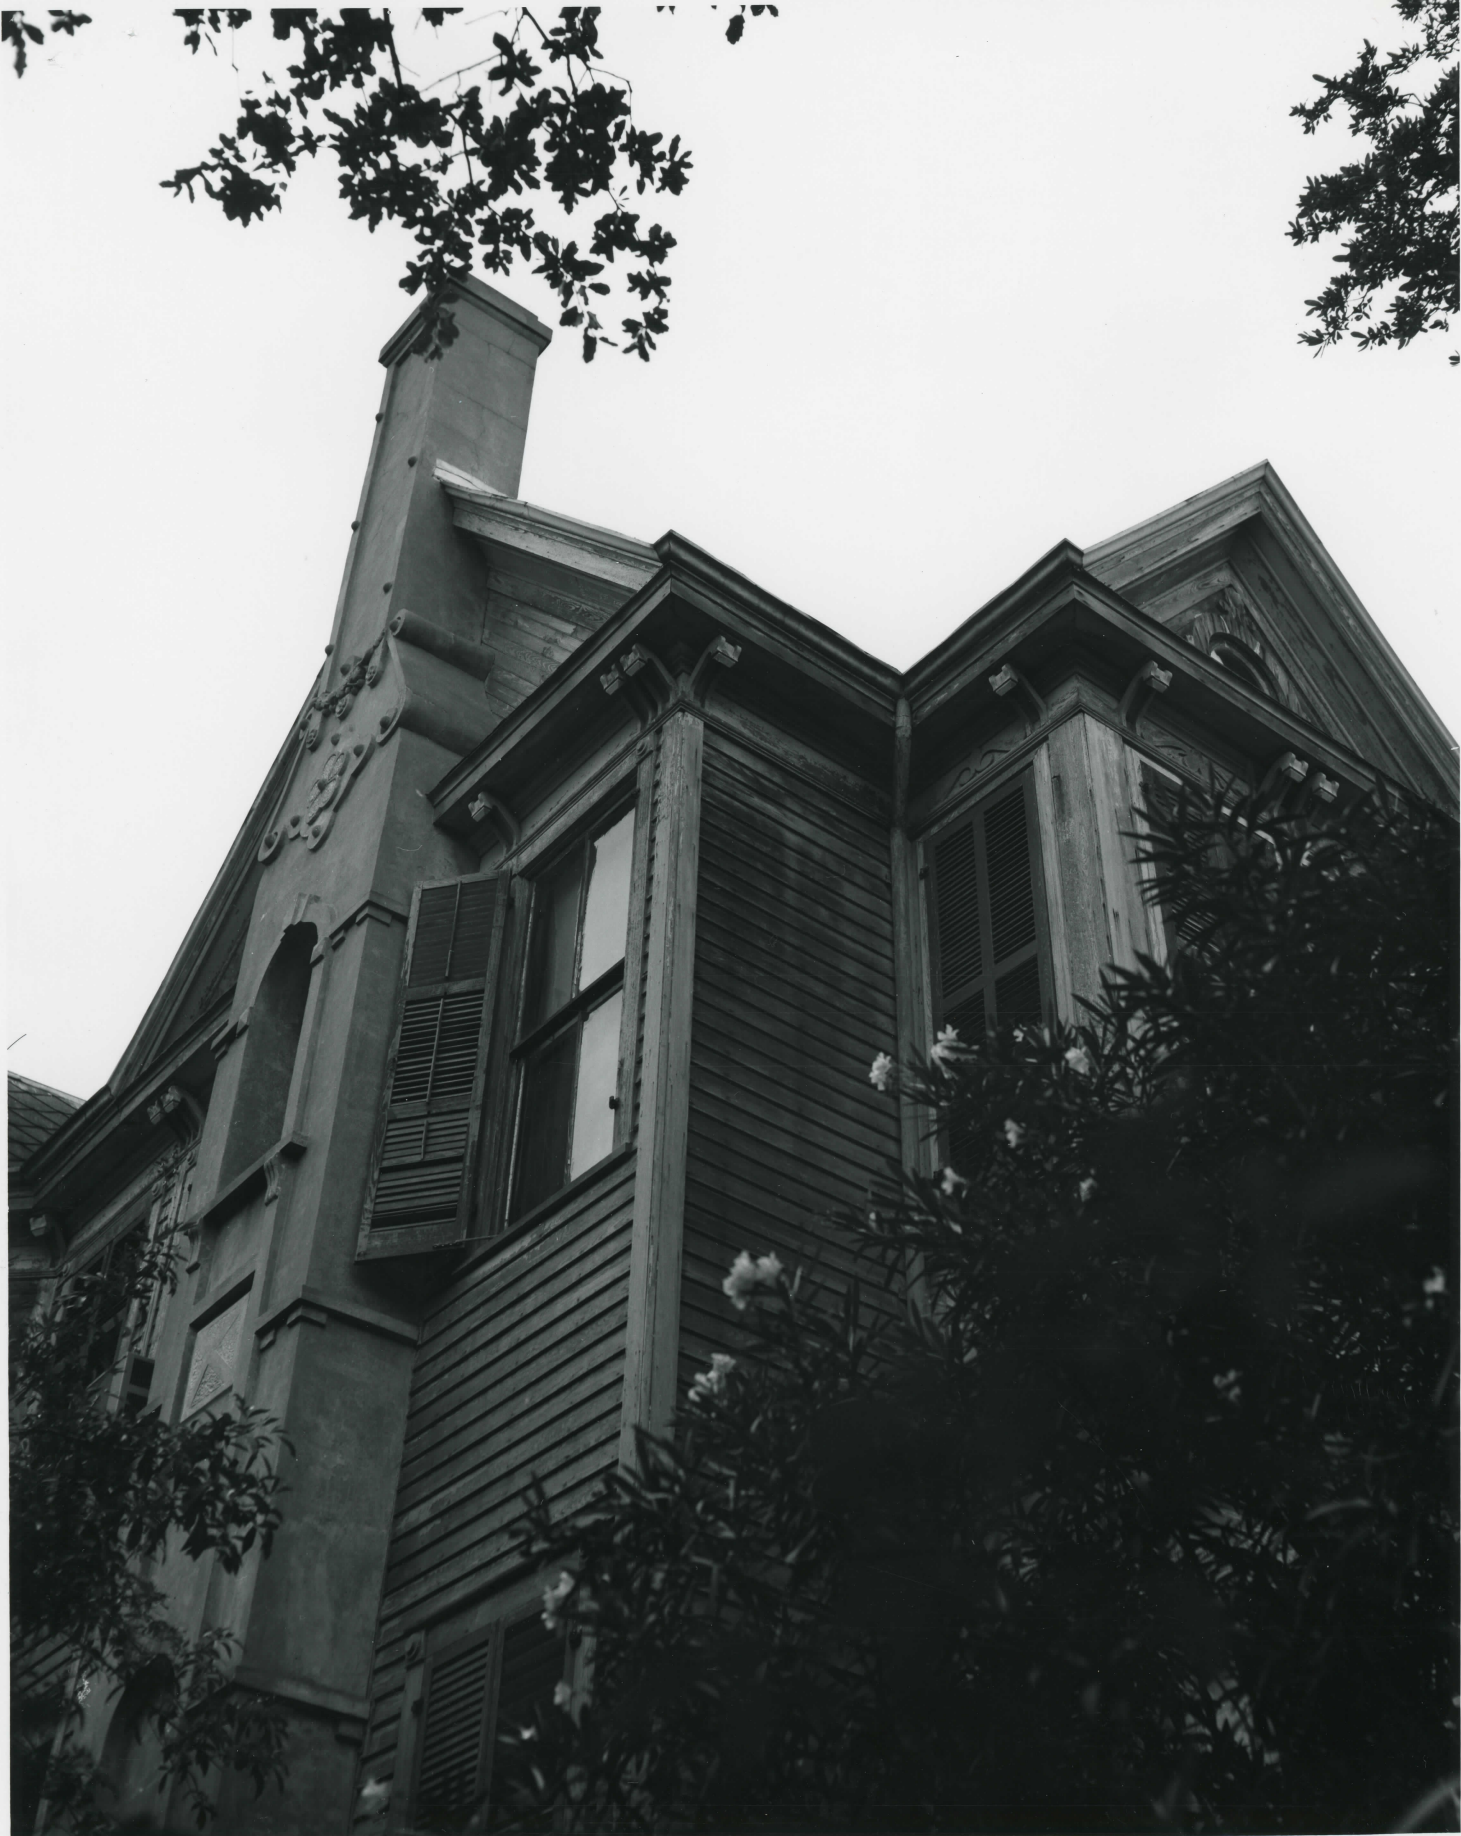
PHOTO NO. 4 *aly*

Detail of chimney ornamentation

The prominent feature on the north (rear) facade is the elaborately detailed stuccoed brick chimney. Rising from the center of a rear gable is the tall slender double flue chimney. Round keystone arches, resting on sills supported by consoles, are joined by an inset panel of vermiculated stone and mark the division of the chimney into two flues. The chimney is further embellished by decorative relief work in the form of a lyre motif as the chimney narrows at the gable.
