NATIONAL REGISTER OF HISTORIC PLACES INVENTORY -- NOMINATION FORM

HISTORIC St. Joseph's Church
AND/OR COMMON

STREET & NUMBER
2202 Avenue K
CITY, TOWN
Galveston
STATE Texas
VICINITY OF
COUNTY Galveston
CONGRESSIONAL DISTRICT 9
CODE 048
CODE 167

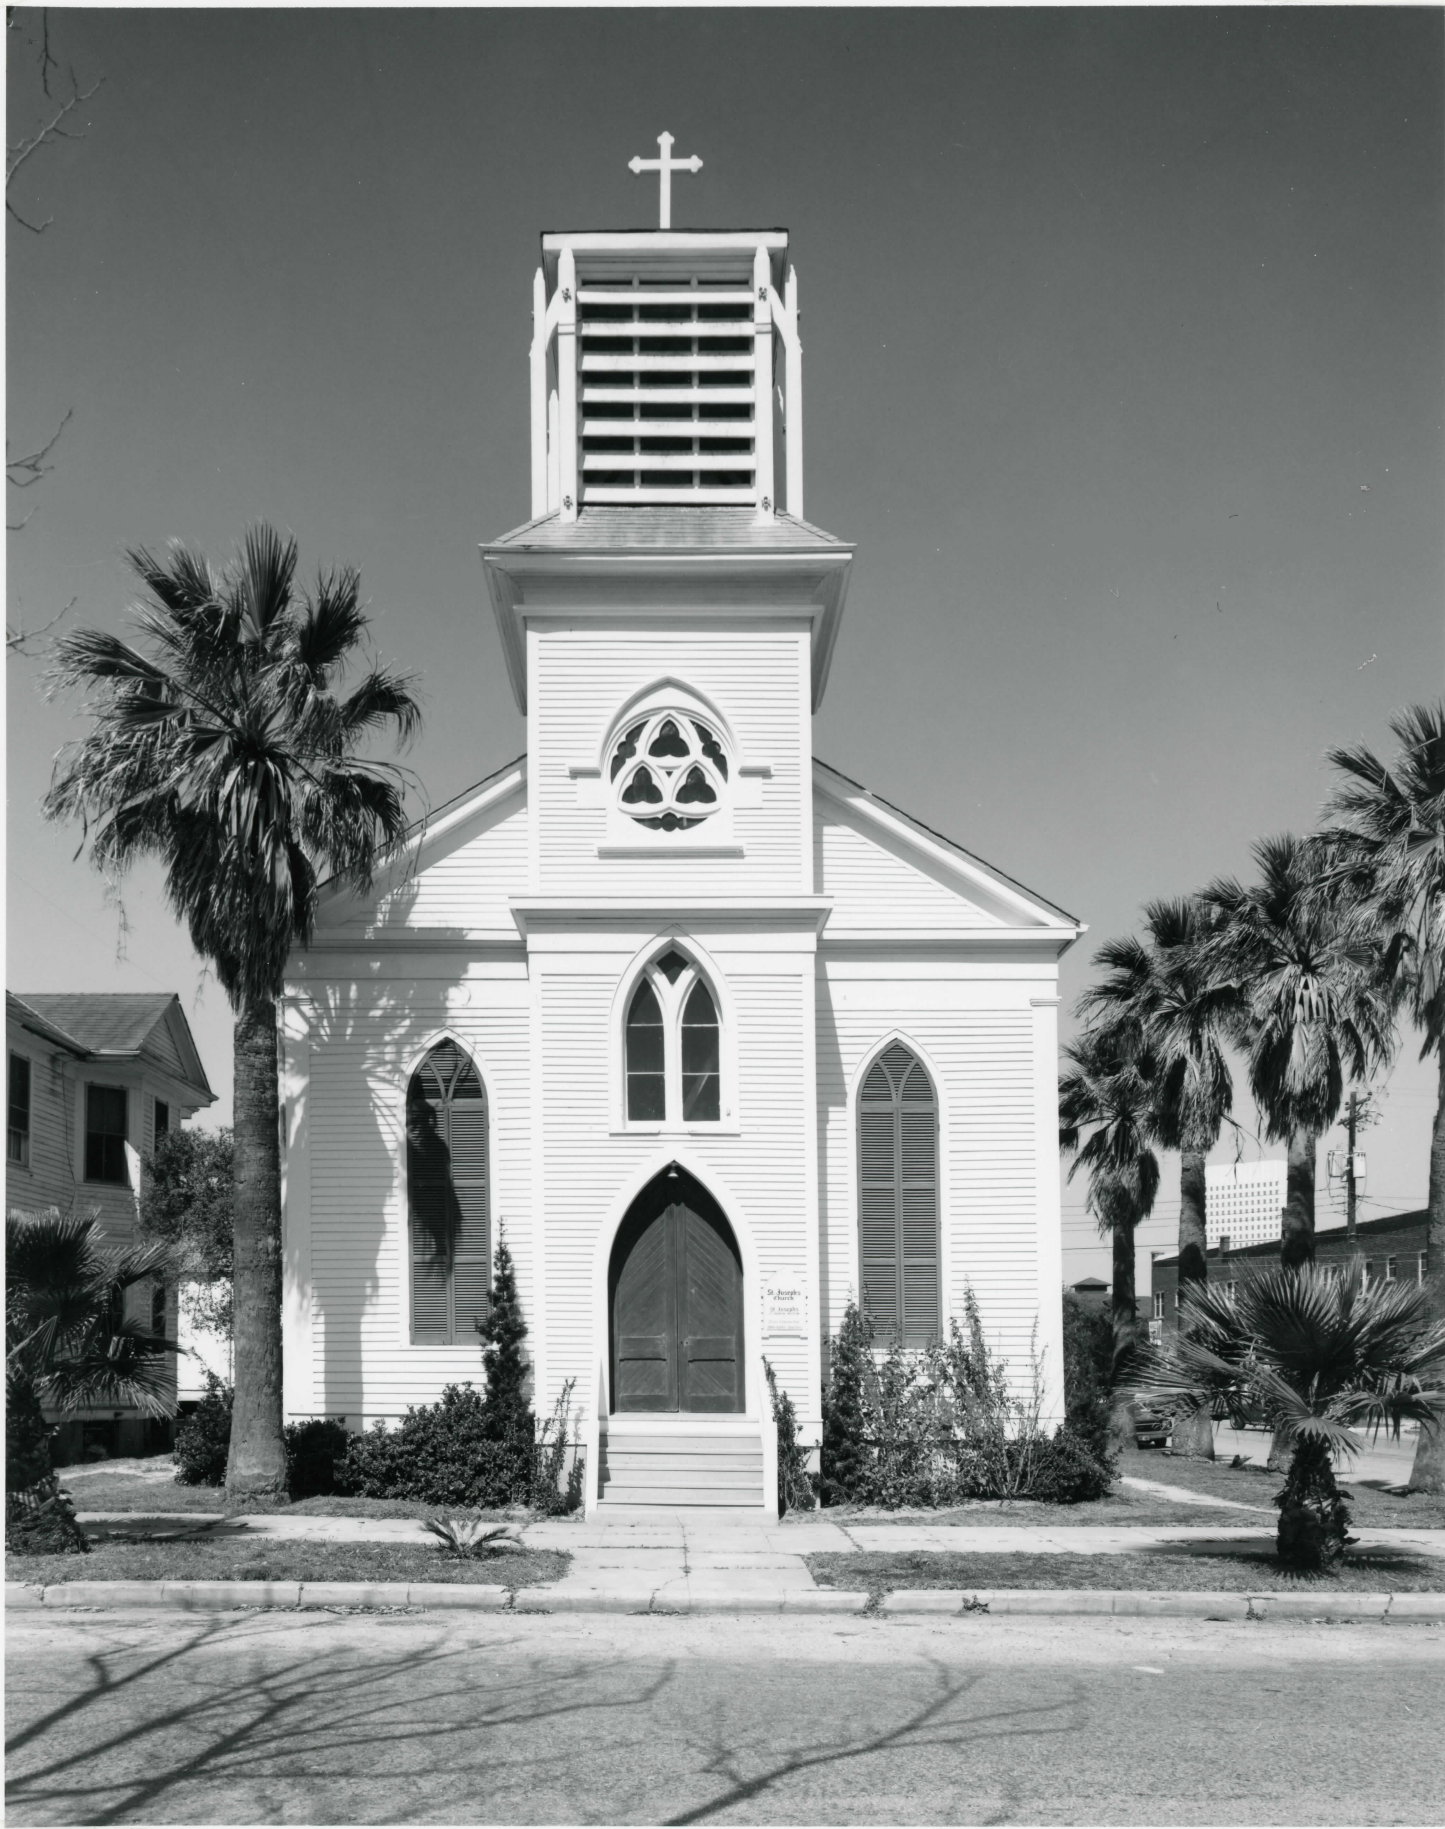
Photo #1 ^{of 4}
St. Joseph's Church
Galveston, Galveston County, Texas
Photo by Marilyn Marshall Jones, Spring 1976
Negative filed at Photographer, 2233 Welch,
Houston, Texas

View: taken from Avenue K, looking north
toward front door, or the main
entrance.

St. Joseph's Church is located on the northwest corner of Avenue K and 22nd Street just one short block from Broadway, the main east-west thoroughfare in Galveston. It is a simple wood Gothic Revival structure, rectangular in shape with a central squared bell tower. The windows and doors are pointed; the windows are protected by shutters; the double door is unadorned.

A trefoil window is placed in the tower which intersects the gable end of the pitched roof. Wooden steps flanked by a plain balustrade lead to the main entrance. At the rear of the building is a small frame attachment. When restored in the 1960's, an overhang supported by brackets was removed from above the main entrance. Although perhaps not original to the structure, the overhang in all probability was an early addition to the building. The present appearance of the tower also suggests that at some time alterations were made, specifically to the louvered portion.

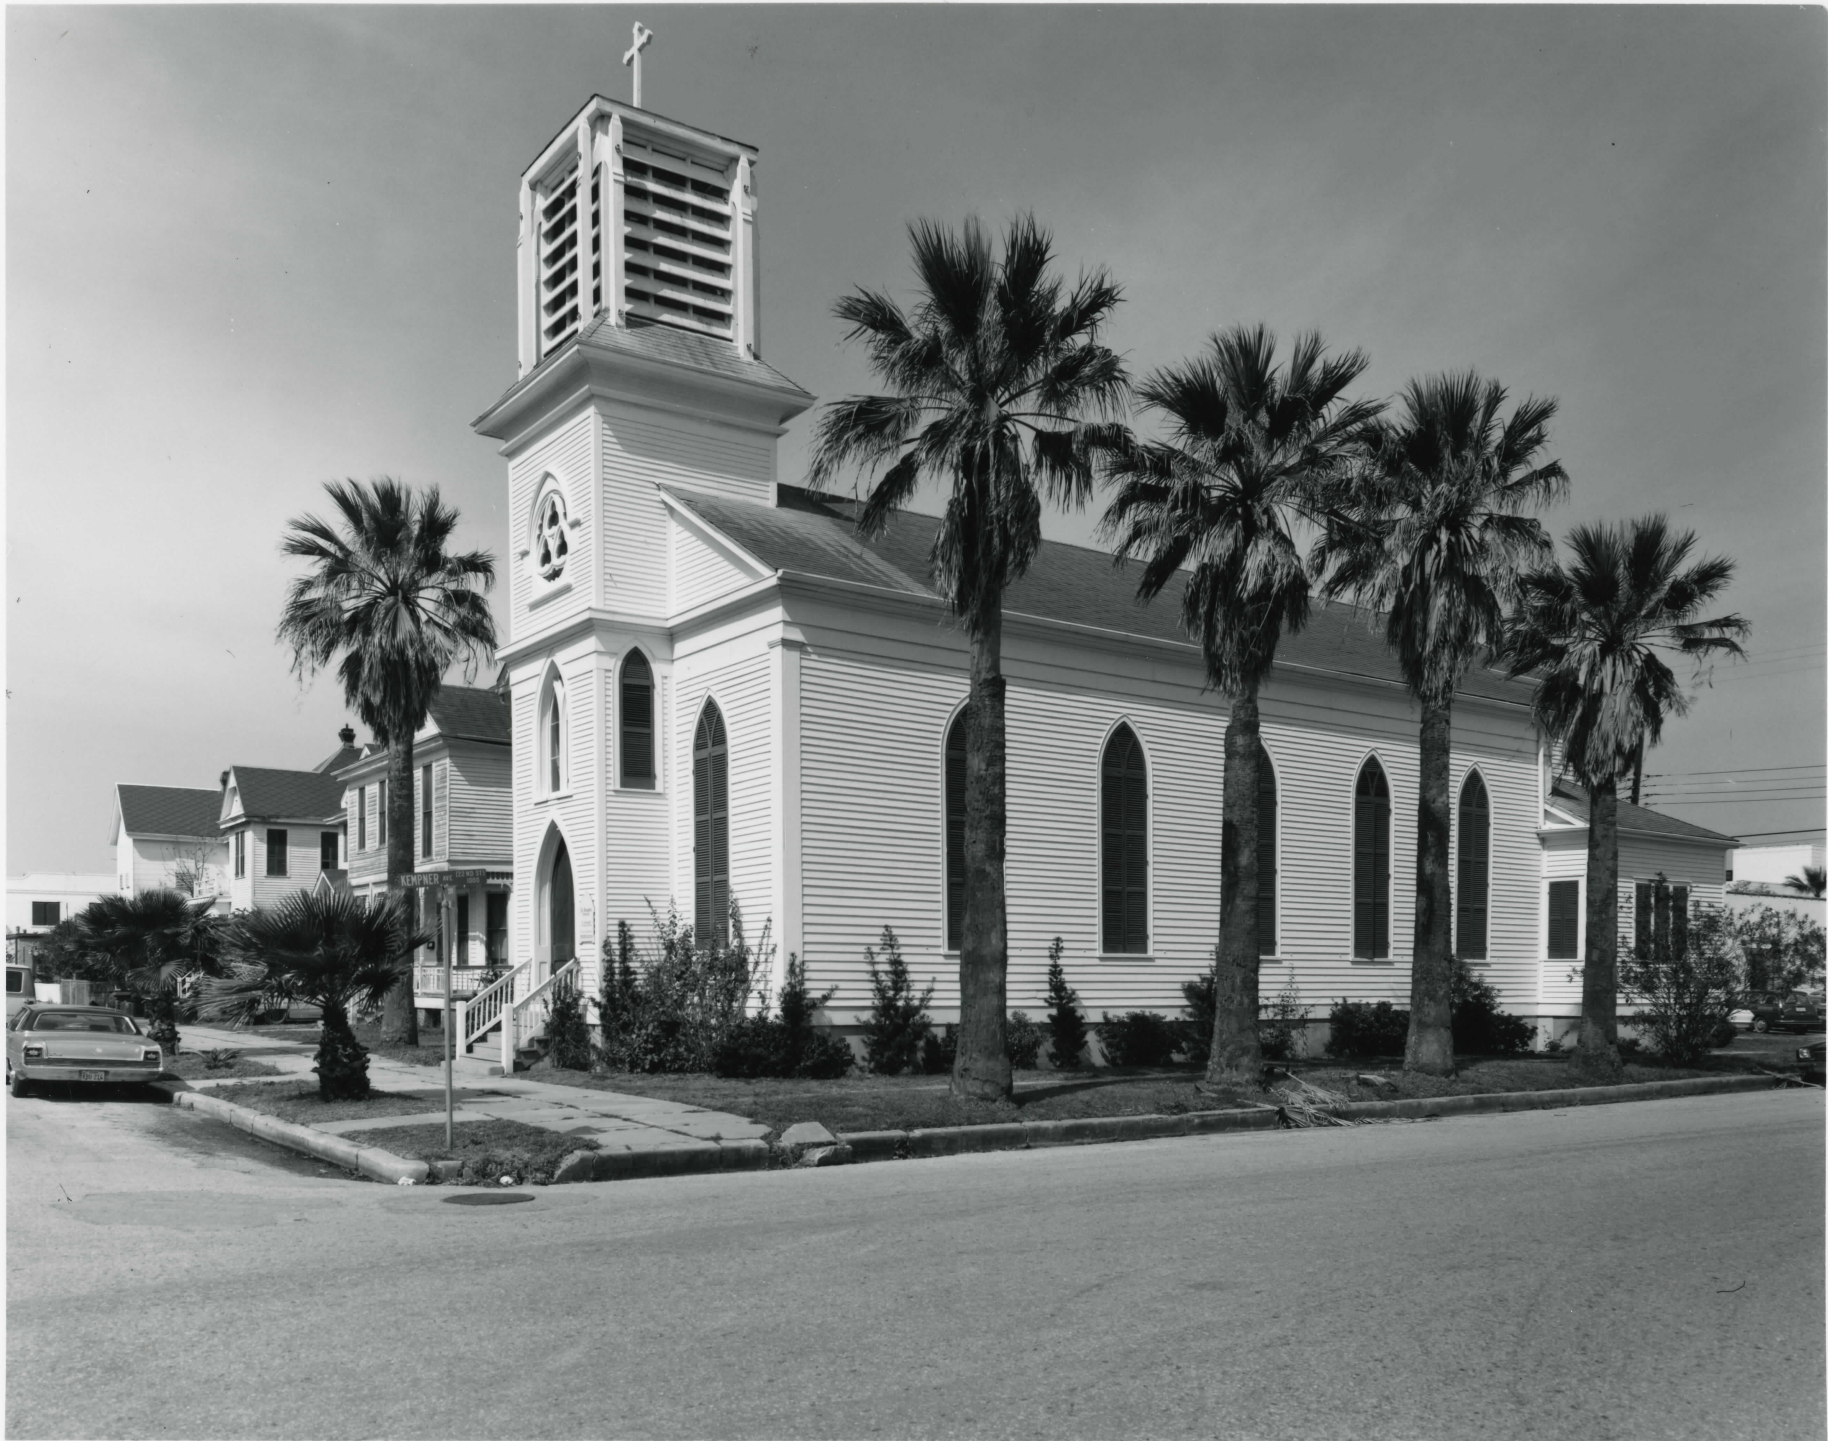
Photo #2 *of 4*
St. Joseph's Church
Galveston, Galveston County, Texas
Photo by Marilyn Marshall Jones, Spring 11 1976
Negative filed at Photographer, 2233 Welch,
Houston, Texas

View: Taken from NE corner of Avenue K and
22nd Street, looking NW.

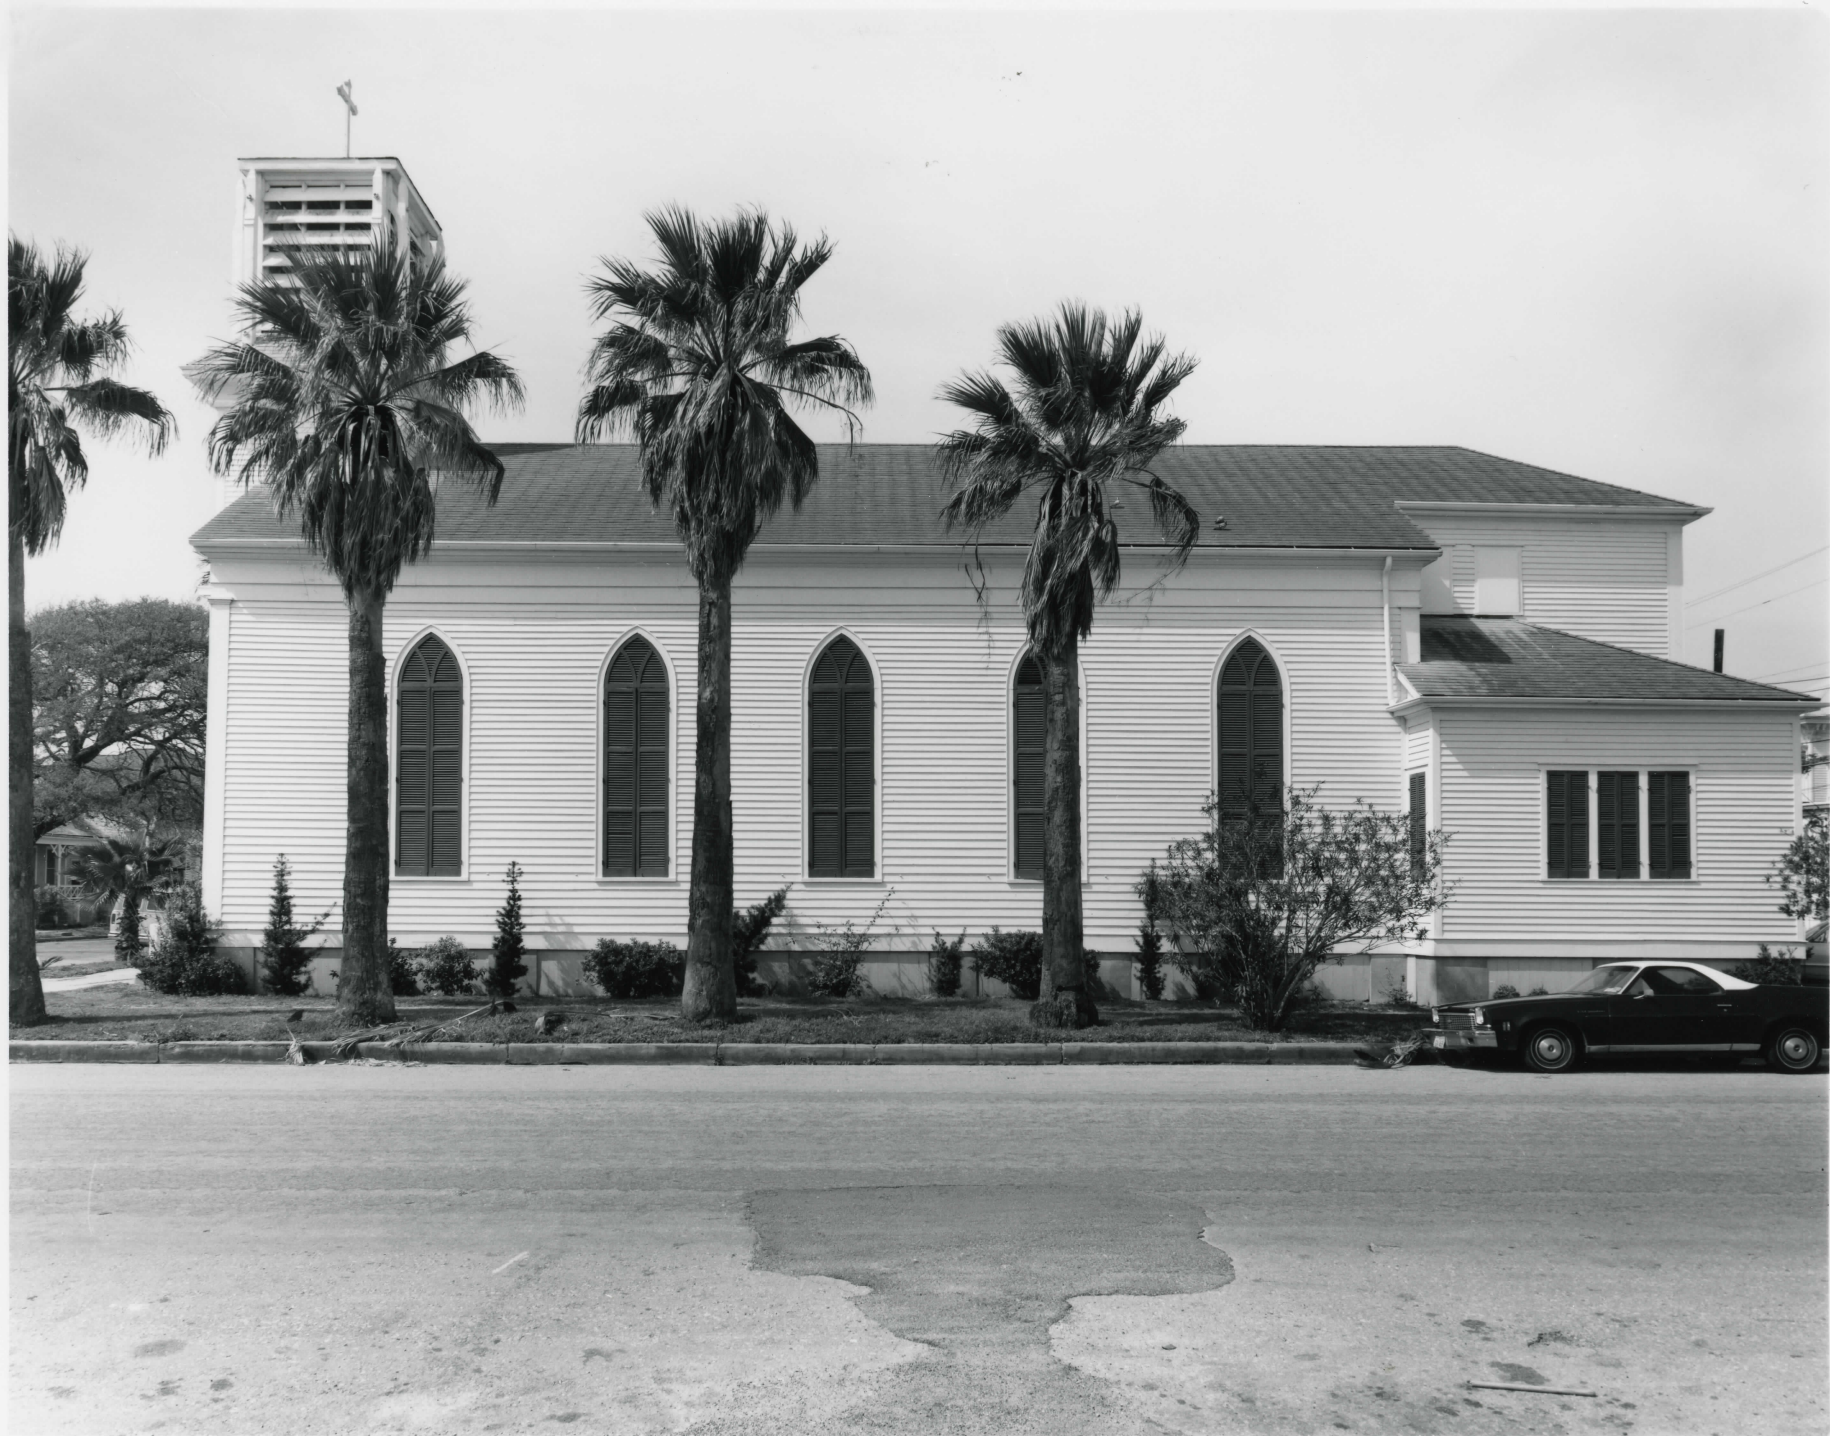
Photo #3 *af*
St. Joseph's Church
Galveston, Galveston County, Texas
Photo by Marilyn Marshall Jones, Spring 1976
Negative filed at: Photographer, 2233 Welch,
Houston, Texas

View: Taken from 22nd Street, looking west
at side facade.

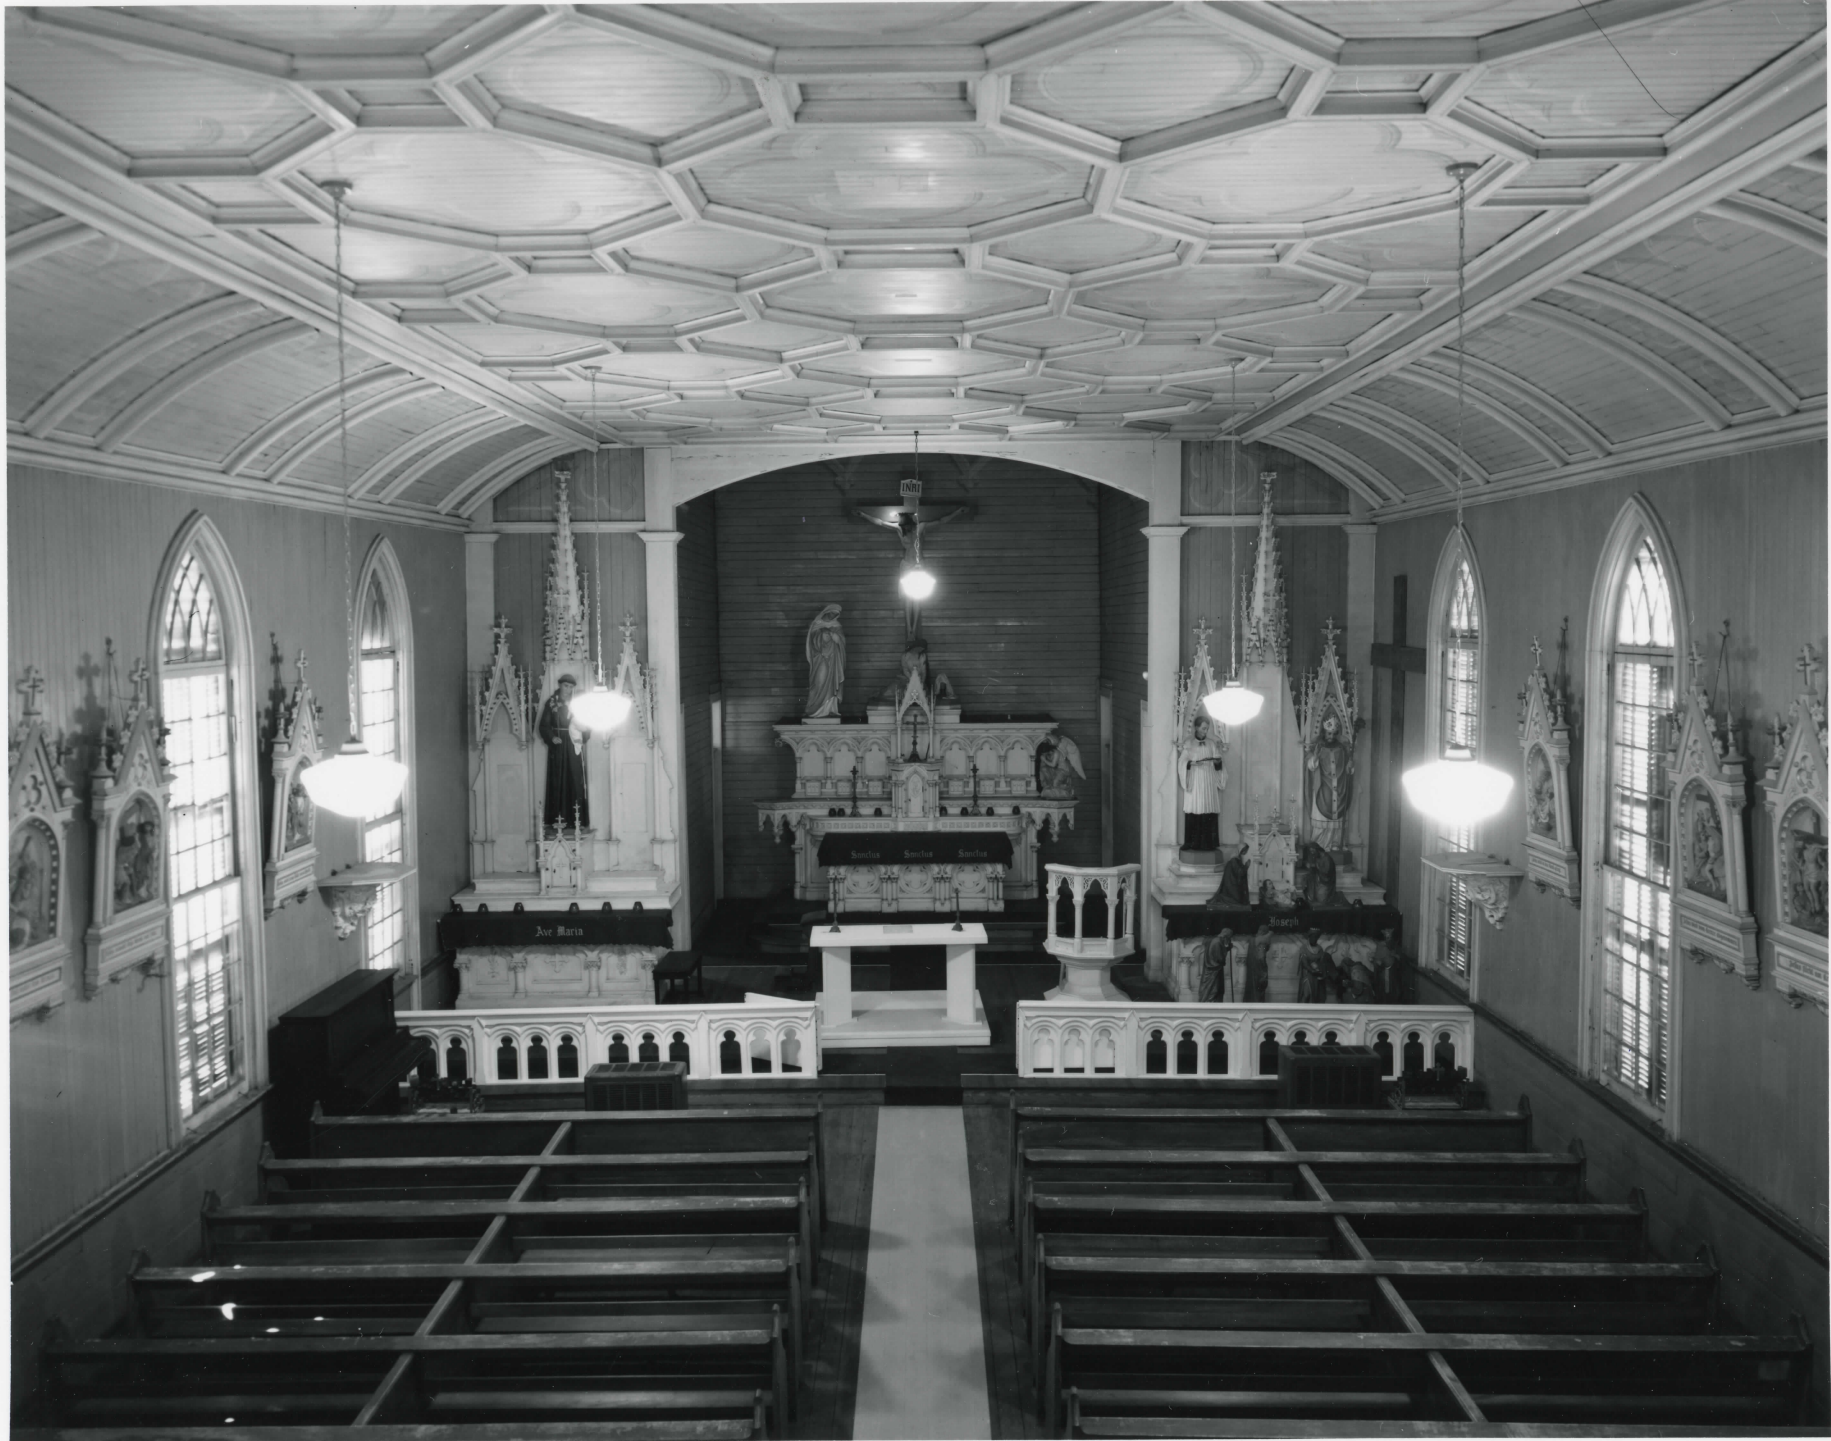
Photo #4 ^{2/4}
St. Joseph's Church
Galveston, Galveston County, Texas
Photo by Marilyn Marshall Jones, Spring 1976
Negative filed at Photographer, 2233 Welch,
Houston, Texas

View: Interior view taken from balcony
looking north, toward altar.

The interior of St. Joseph's Church is unique, and after seeing the exterior, unexpected. The rectangular space has painted wood walls. A central aisle separates the original pews, which are made of cedar and grained. An altar rail carved in Gothic Revival motif divides the sanctuary from the congregation. Adorning the walls of the nave are the Stations of the Cross which are made of plaster with German lettering. The ceiling is coffered and painted with quatrefoils and other Gothic Revival symbols in soft, muted colors. The pulpit, the altars and the reredos are also believed to be original.

The interior of St. Joseph's, with its painted and coffered wood ceiling is unique in Galveston, and one of very few in the state of Texas. In the church are the original cedar pews, poor box, Baptismal Fount, pulpit, and Stations of the Cross with German wording. The altars are believed to be original.

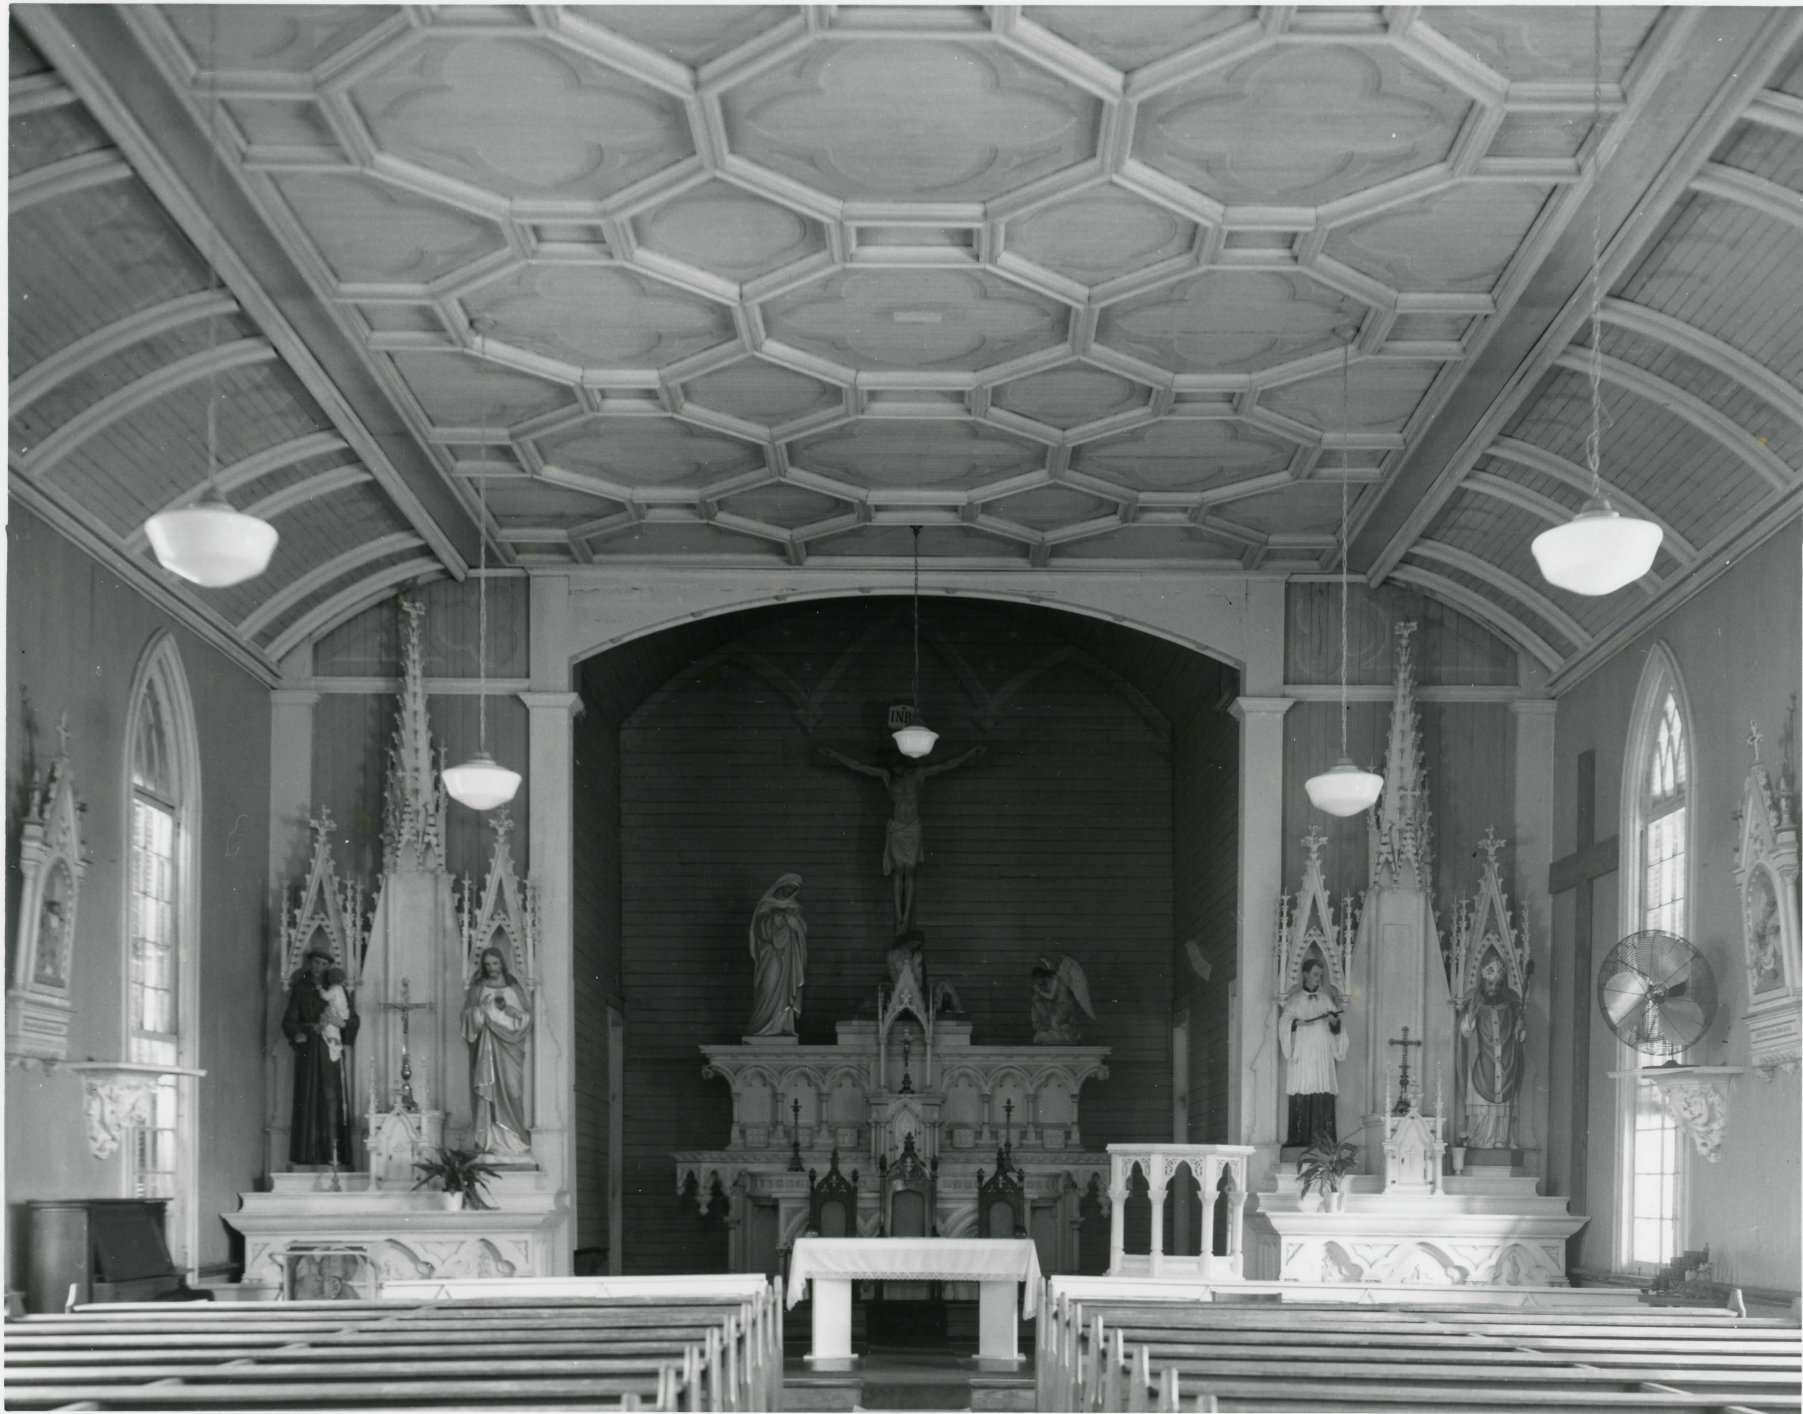
Photo #44 of 98

St. Joseph's Catholic Church
Churches in Texas with Decorative
Interior Painting
Galveston, Galveston County, Texas
Linda C. Flory
September, 1980
Texas Historical Commission,
Austin, Texas
Interior, overall view toward altar

The interior is finished with beaded boards, is open, and has a rectangular plan. The ceiling is coved along the side walls. A coffered appearance is achieved by the application of moldings in a pattern of hexagons, octagons, and squares. Further embellishing the ceiling are painted trompe l'oeil trefoils, quatrefoils, and pointed

arches in muted colors of blue, beige, and white. They create an illusion of additional depth within the coffers. Similarly, the back wall of the apse and its flanking walls are painted with these Gothic motifs. Small five-pointed stars in metallic gold are painted at uniform intervals on the blue apse ceiling. The original cedar pews, are adorned with painted graining.

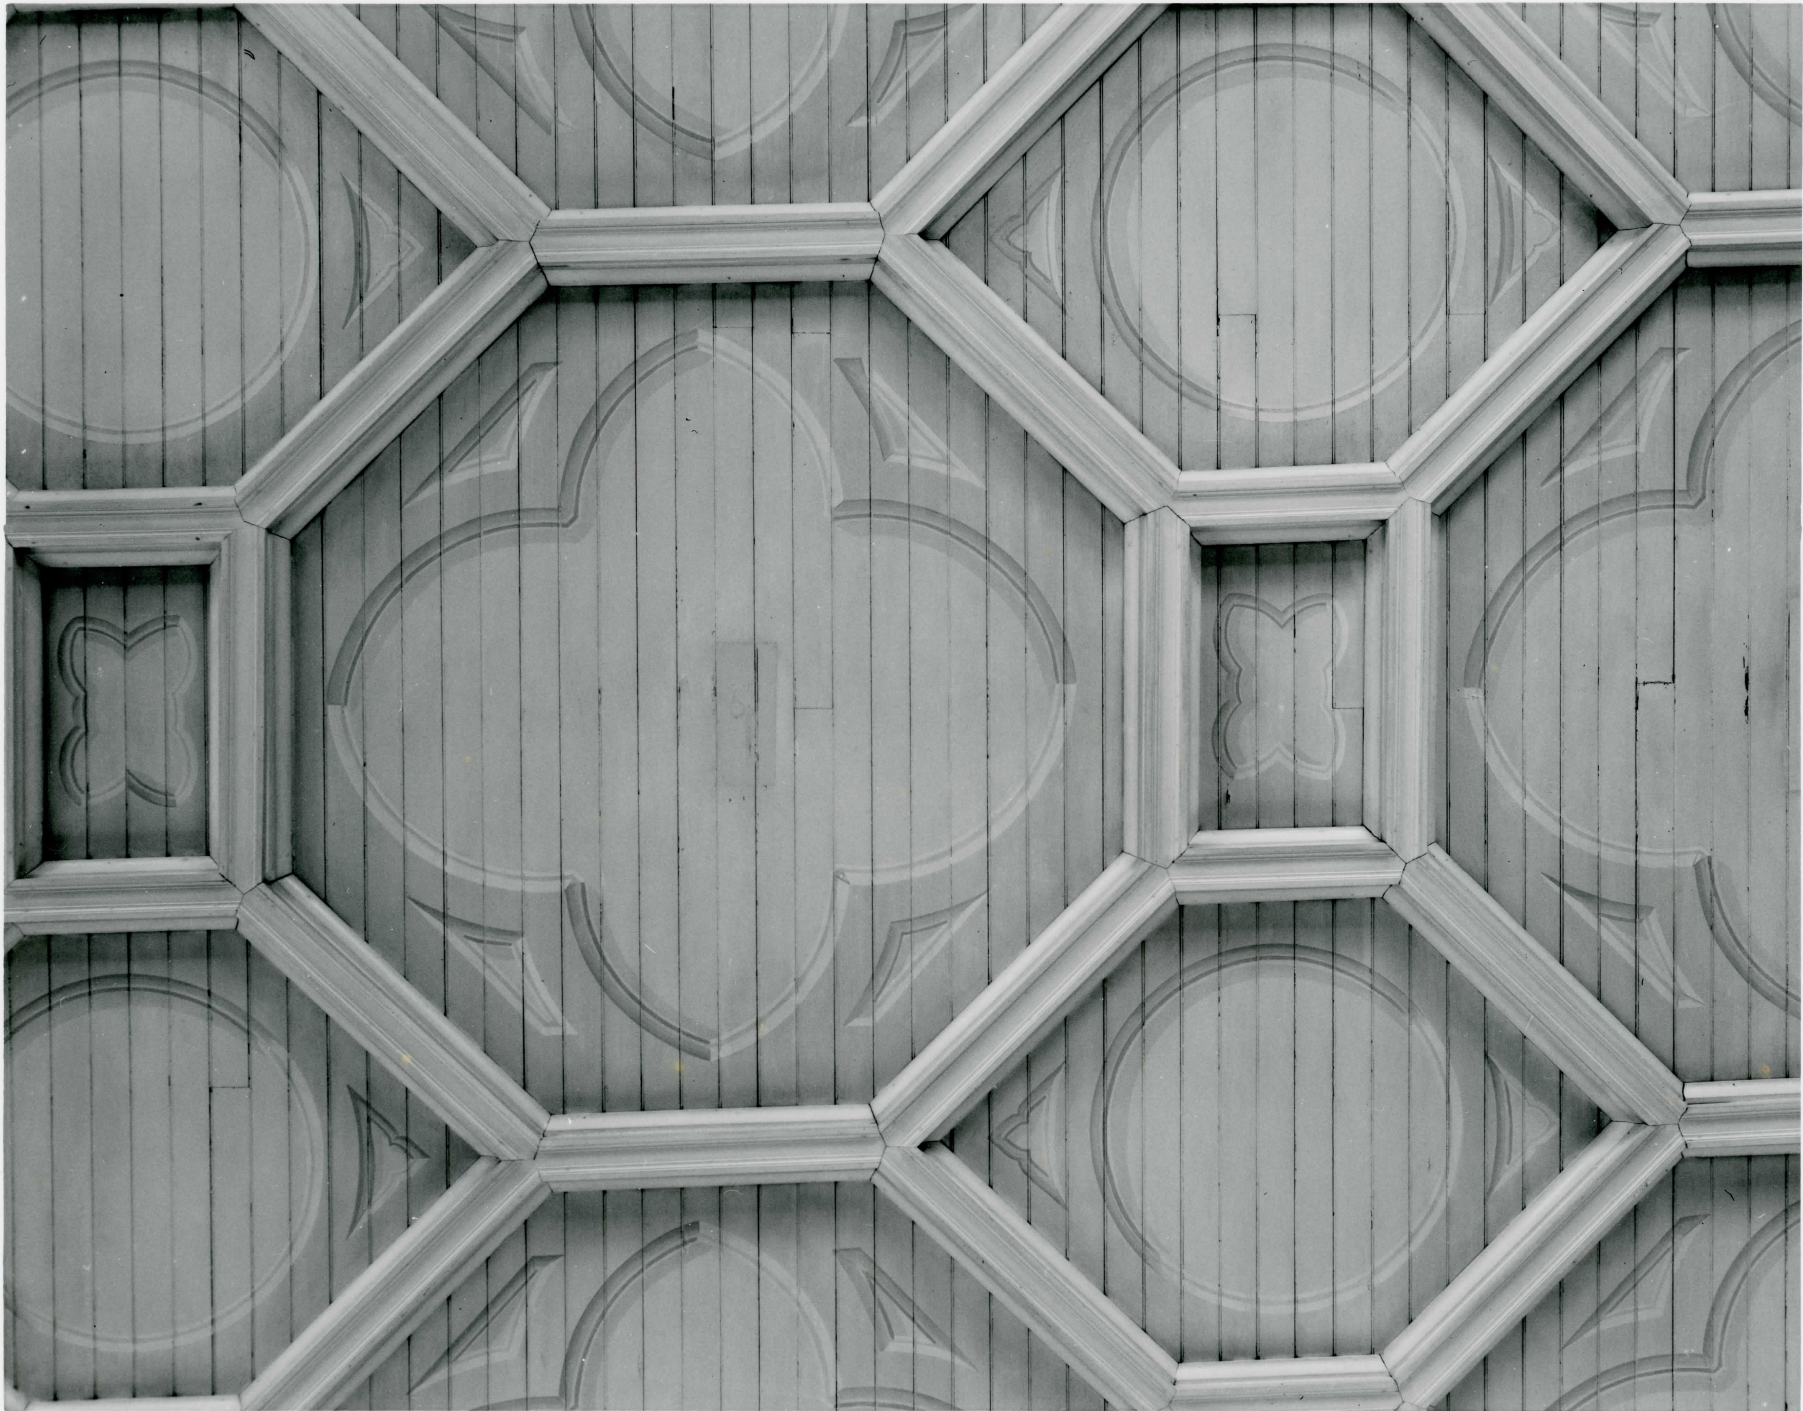
Photo #45 of 98

St. Joseph's Catholic Church
Churches in Texas with Decorative
Interior Painting
Galveston, Galveston County, Texas
Linda C. Flory
September, 1980
Texas Historical Commission,
Austin, Texas
Interior, detail of ceiling panels

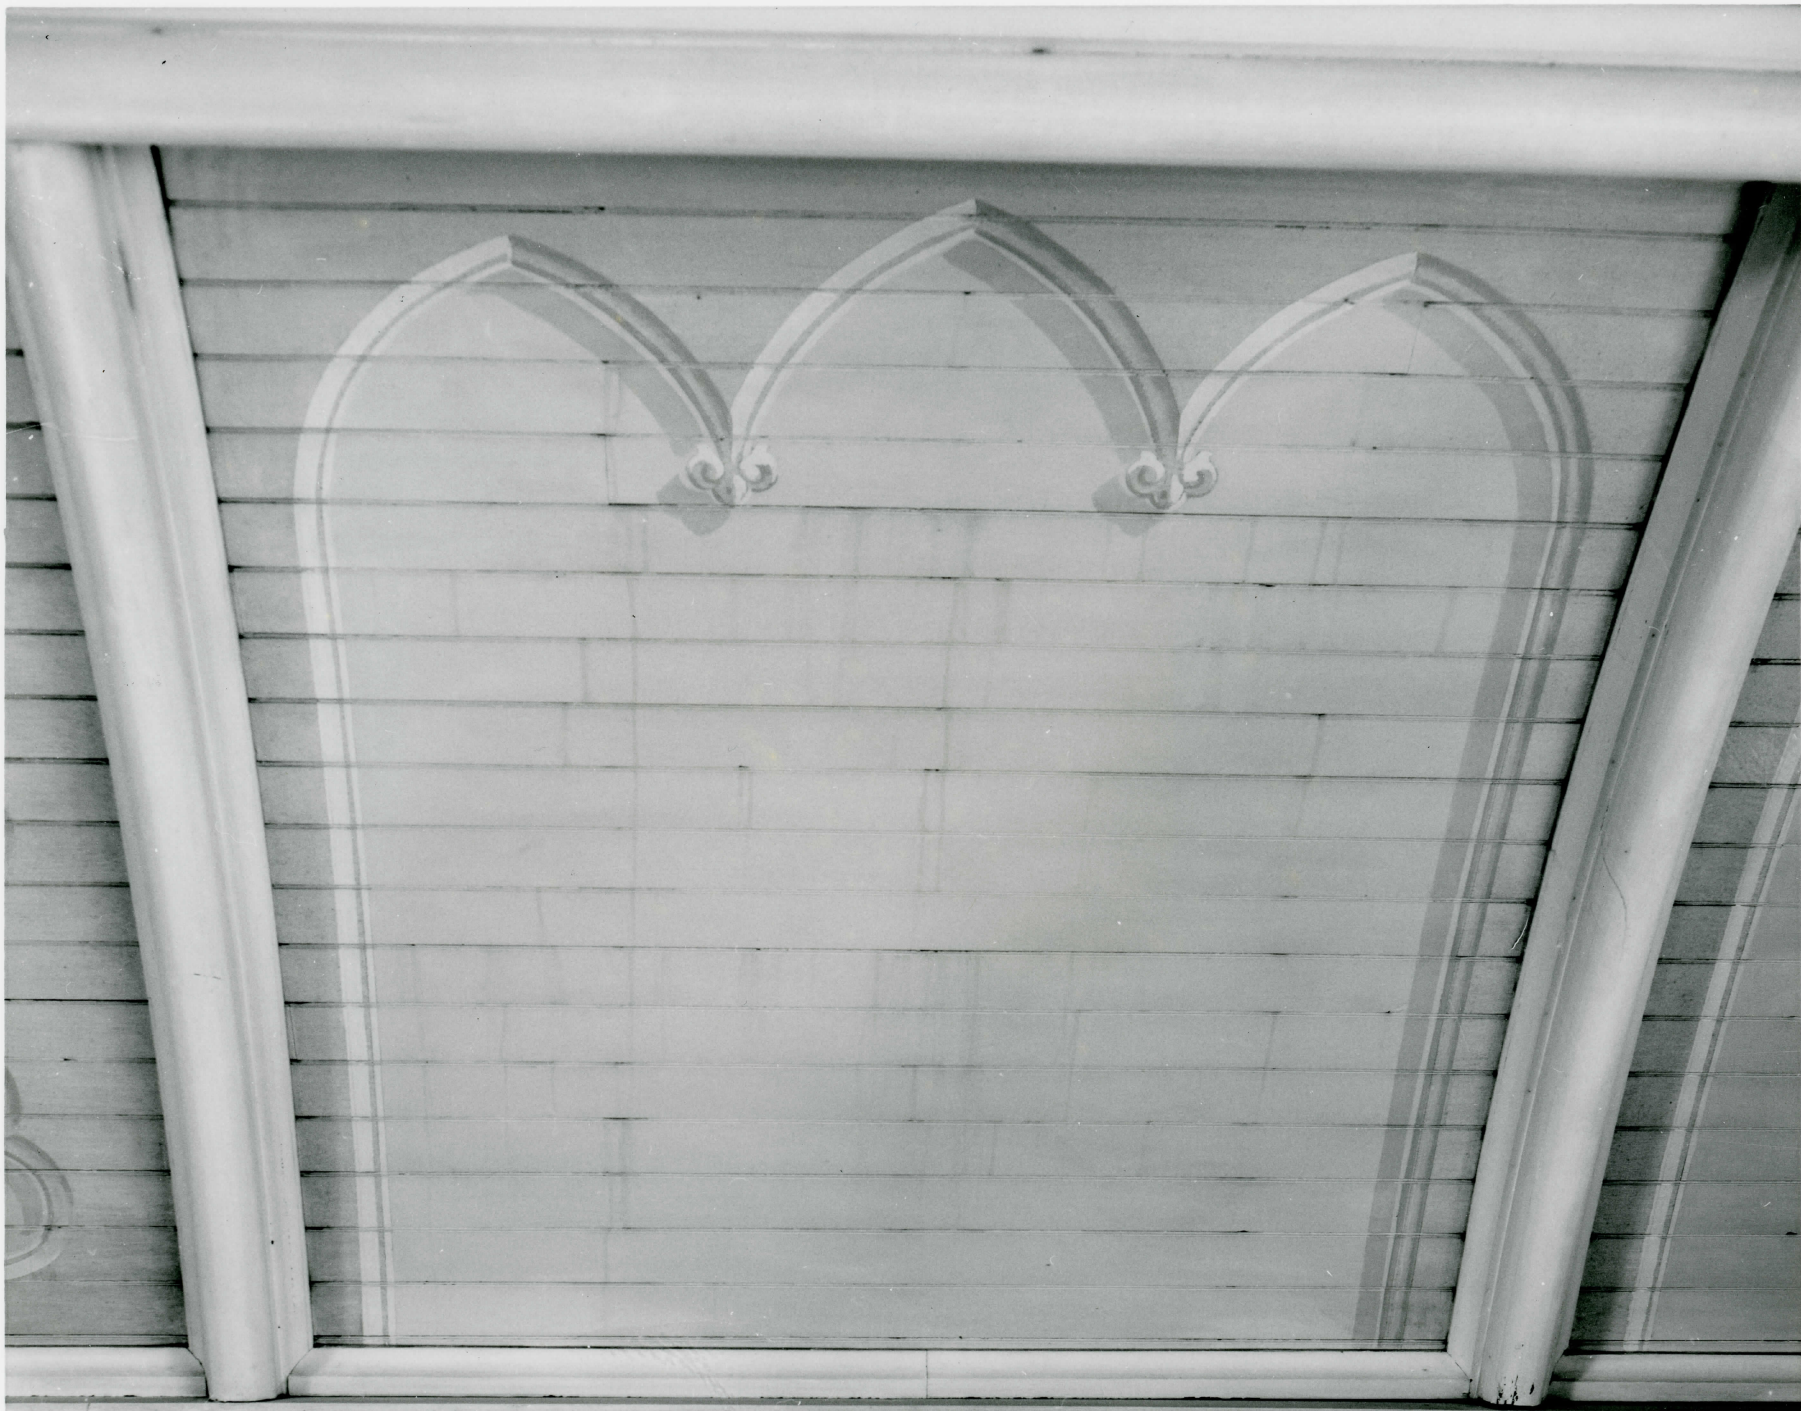
Photo #46 of 98

St. Joseph's Catholic Church
Churches in Texas with Decorative
Interior Painting
Galveston, Galveston County, Texas
Linda C. Flory
September, 1980
Texas Historical Commission,
Austin, Texas
Interior, detail of ceiling at side wall
