United States Department of the Interior
National Park ServiceNational Register of Historic Places
Inventory—Nomination Form

SITE NO. 30

Brandhagen houses

FM 182, ⁹~~5 1/2~~ miles west of Clifton, Bosque
County, Texas, on A. Kuykendall survey

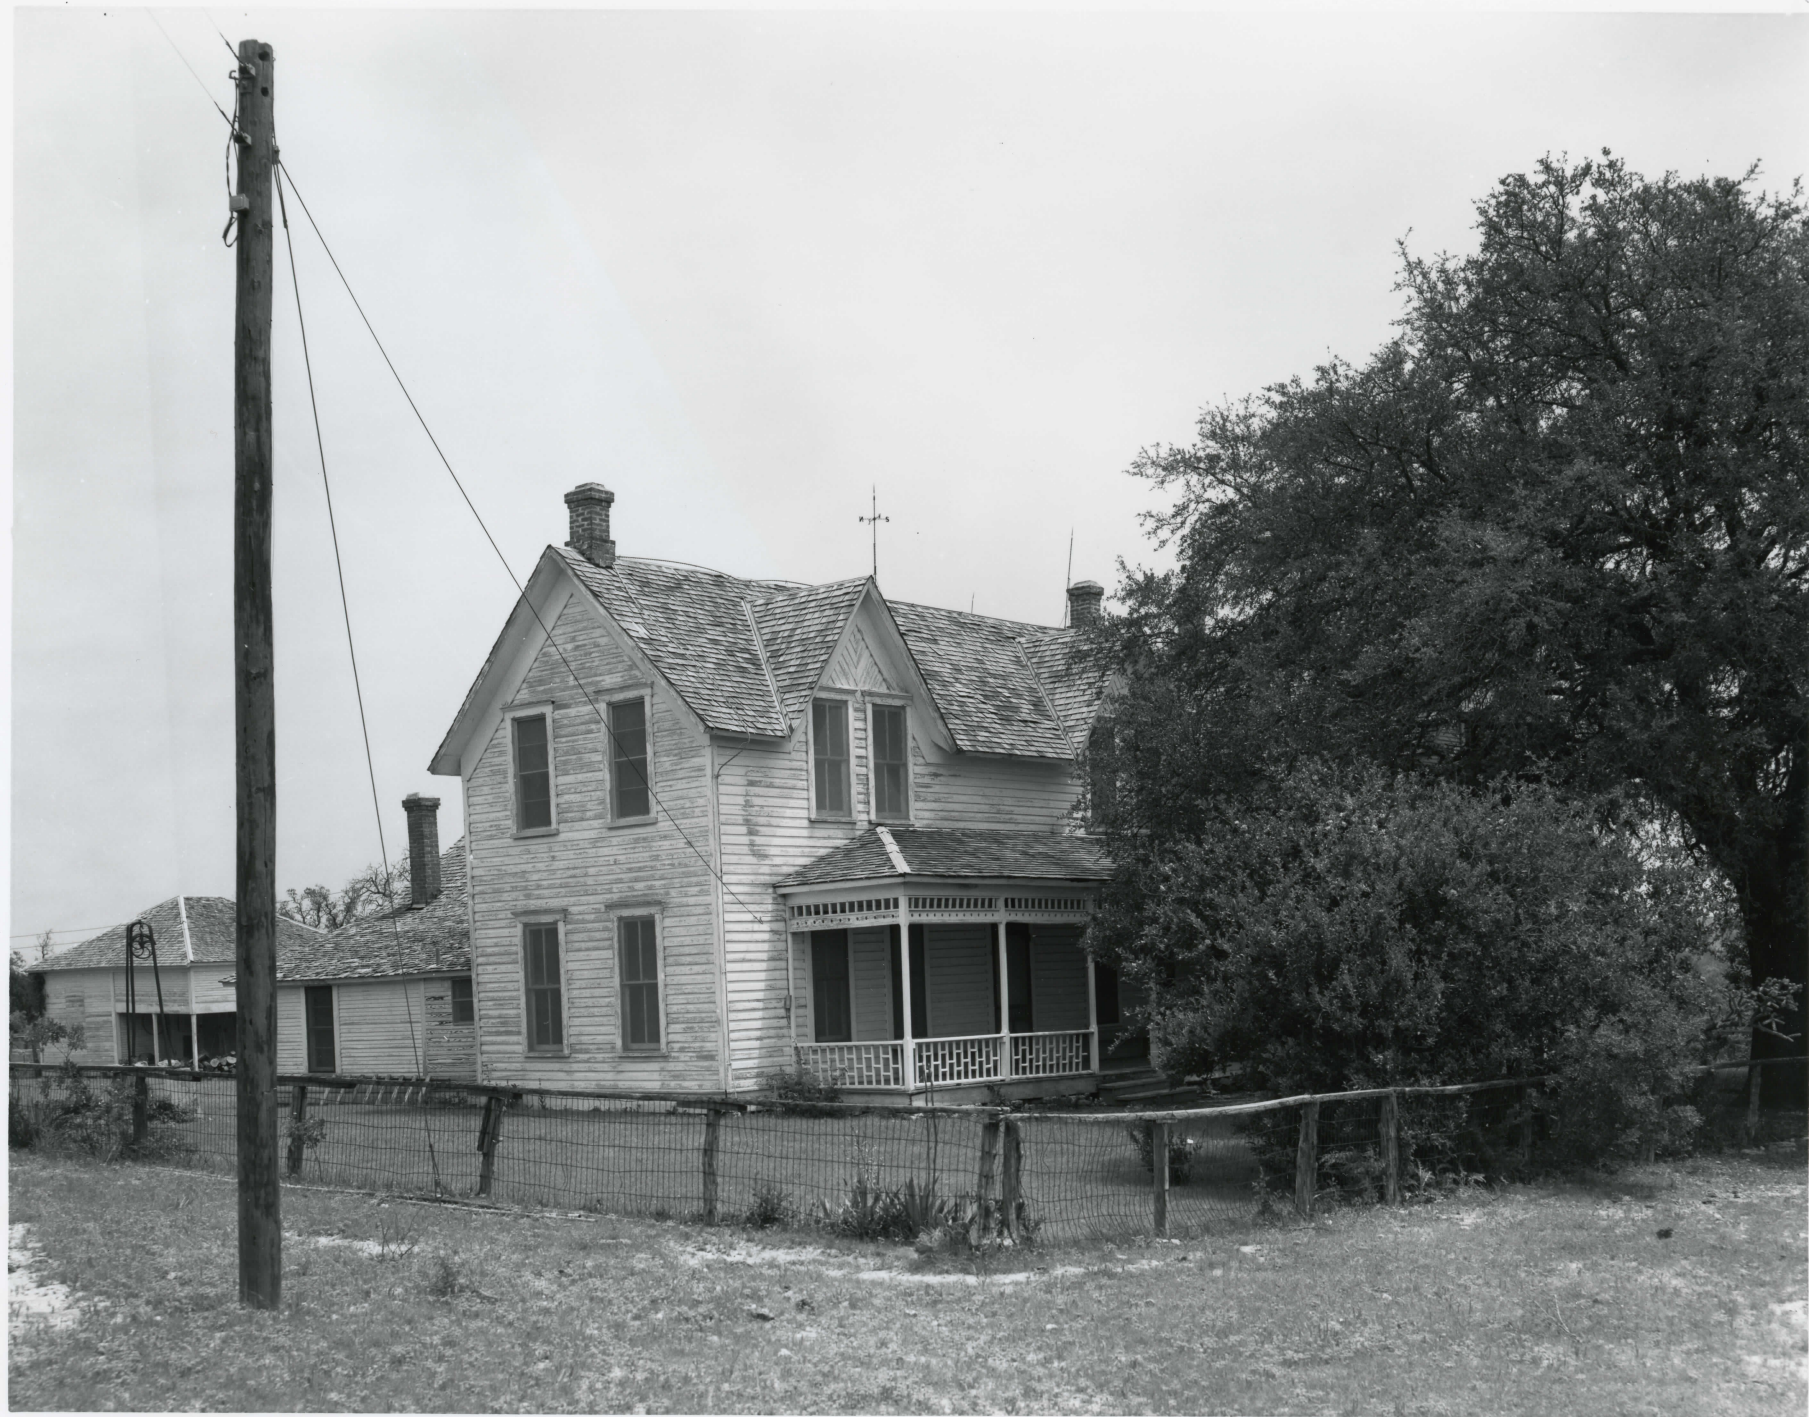
Photo 45 of 72

double-hung windows as well as siding in a herringbone pattern at the apex. With few exceptions, the windows are double hung with two-over-two lights and vertical muntins. Interior brick chimneys rise from the cross-gabled roof. The east facade is also symmetrically arranged, and has two dormer-like gables. Minor shed additions of frame construction have been built onto the rear side of the house. The entire house is in good condition. An early 20th-century, wood-frame garage with hipped roof, as well as two wood-frame barns with gabled roofs are also included within the nominated property, and contribute to its historic character.

View of front facade, looking northeast

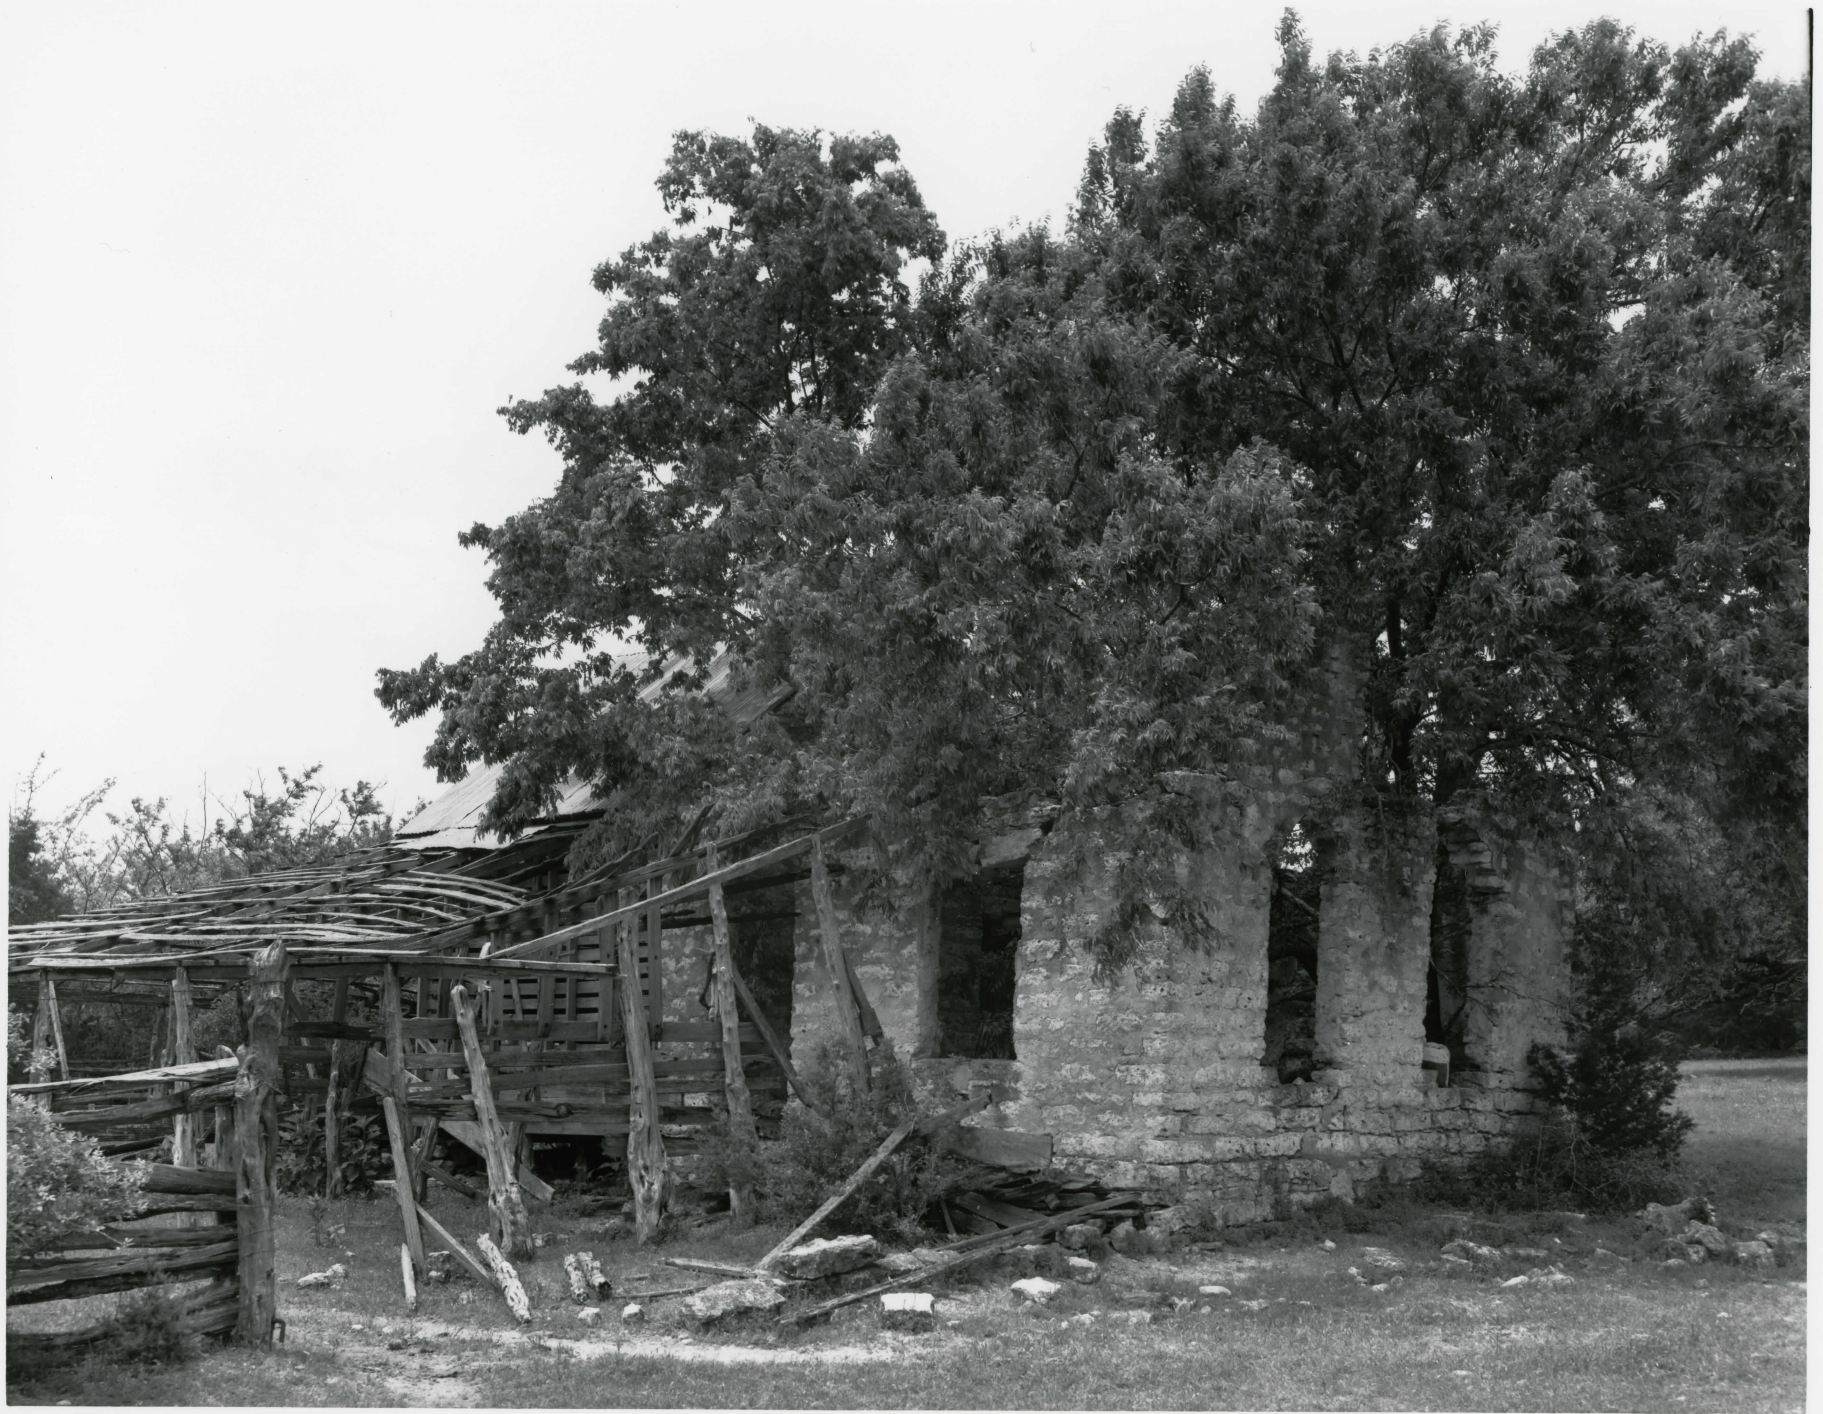
The ruin of an earlier residence, built about 1873, is located about 250 feet south of the present house. Of limestone construction, this structure retains very little of its original detailing. The presence of a tree within the stone walls indicates that the gabled roof has been missing for many years. This structure appears to have been used as a barn after the 1883 house was completed.

Site No. 30, Brandhagen Farm, FM 182
5½ miles west of Clifton, Bosque County, Texas
Photograph: June 1979, by David Moore
On file, Texas Historical Commission
View of ruins, looking southwest
Photo 46 of 72
