United States Department of the Interior
National Park ServiceNational Register of Historic Places
Inventory—Nomination Form

SITE NO. 22

John and Mary Colwick, farm

The Norwegian Settlement of Bosque County

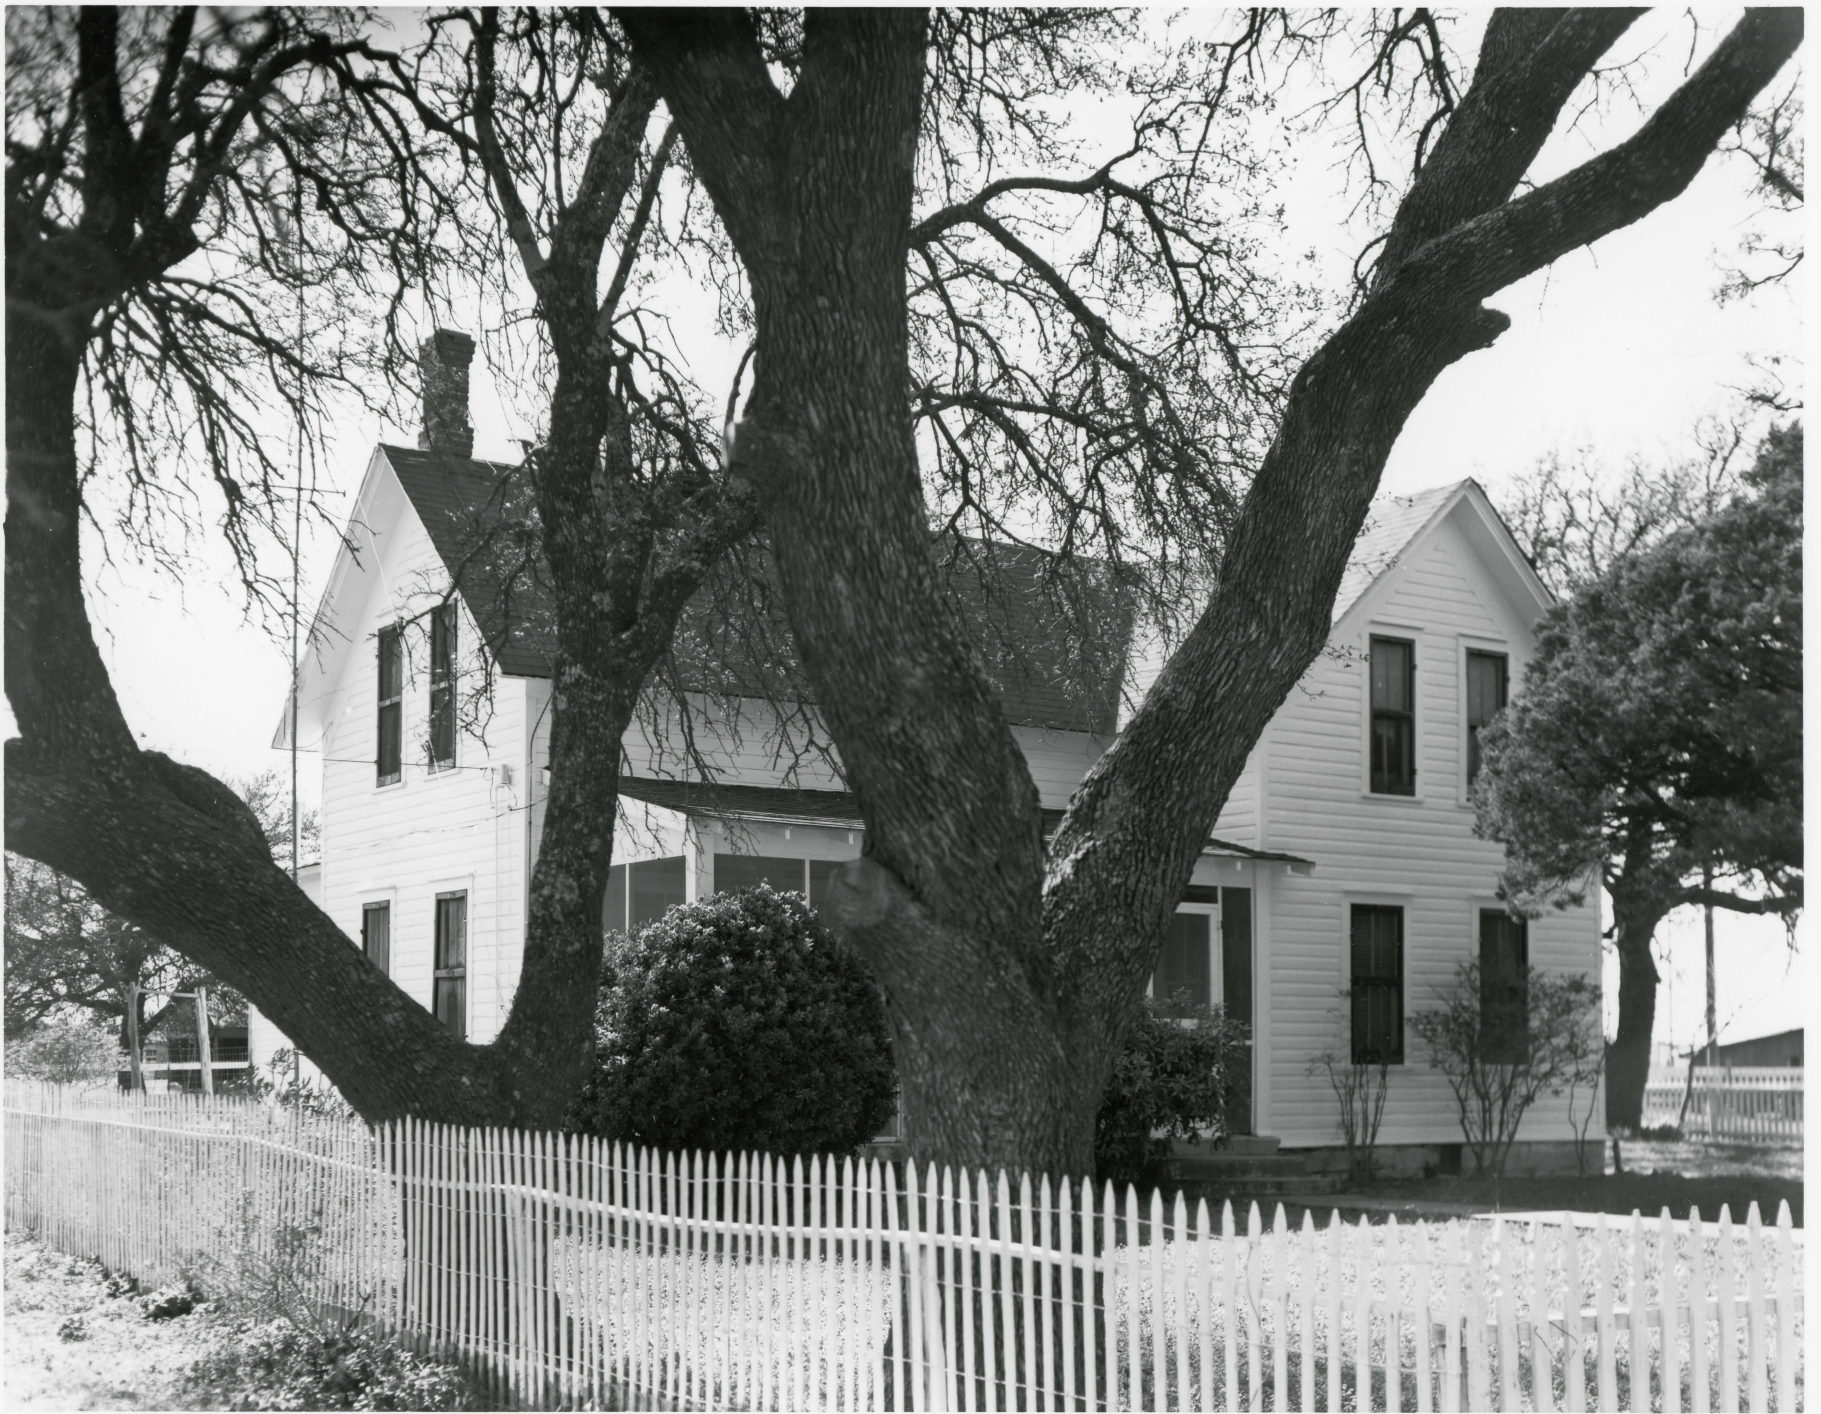
Photo 34 of 72

Site No. 22, John and Mary Colwick Farm,
8 3/4 miles southwest of Clifton, Bosque
County, Texas

View of front facade, looking northwest
