National Register of Historic Places Inventory—Nomination Form

SITE NO. 23

Tom and Martha Rogstad, farm

The Norwegian Settlement of Bosque County

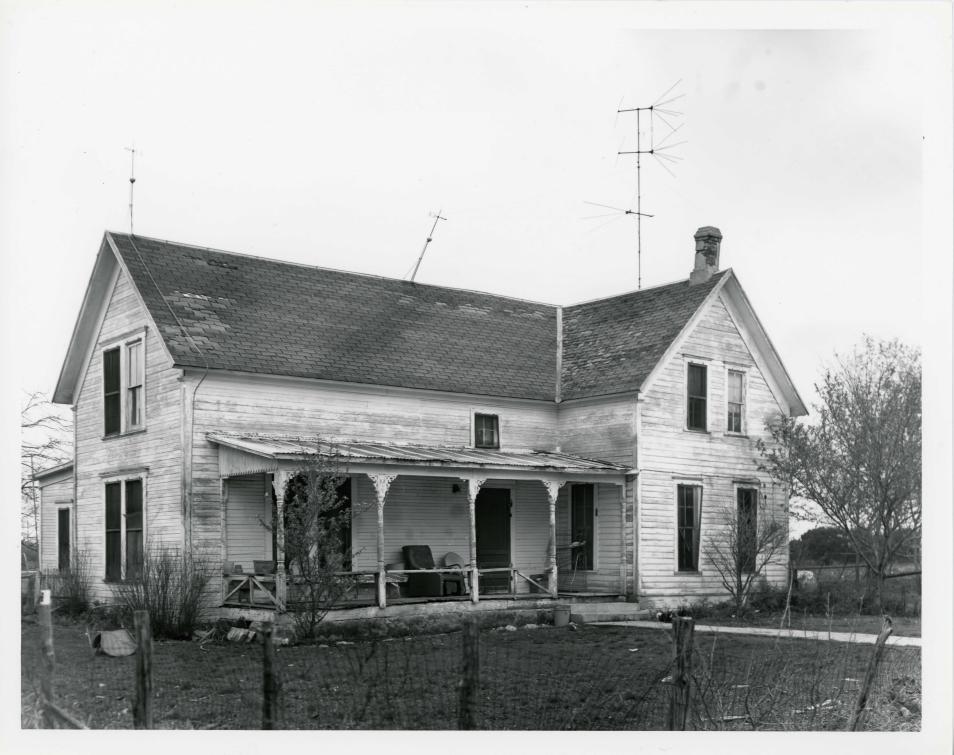
Site No. 23, Tom and Martha Rogstad Farm, $11\frac{1}{2}$ miles west of Clifton, Bosque County, Texas

Photograph: March 1979, by Daniel Hardy On file, Texas Historical Commission View of front facade, looking northwest Photo 35 of 72

The Tom and Martha Rogstad farm includes a one-and-a-half-story frame house that is similar to the Colwick house (no. 22). It stands on level terrain at the top of Rogstad Mountain. Presently unoccupied, it is in only fair condition. The house is virtually unaltered, and retains its integrity to a remarkable degree. The plan of the house is T-shaped, although a small addition has been built onto the rear. A shed-roof porch, with turned wooden posts and jig-cut wooden brackets, extends across the front, or east, elevation. Windows with both two-over-two and four-over-four-lights pierce the walls. A small and square window with four lights is found above the porch roof, centered over the single front door. A composition-shingle roof with intersecting gables shelters the structure, and a corbeled brick interior chimney rises

from the east gable end. A one-room stone structure, which is believed to have been used as a smokehouse, stands a few feet north of the house. Other outbuildings that contribute to the historic character of the farm include two barns, one of board-and-batten construction, and the other with metal covering.
