National Register of Historic Places Inventory—Nomination Form

11. Name: Cemetery Chapel,

Location: San Marcos Cemetery, on State Highway 12, northwest of central San Marcos.

Historic Resources of San Marcos San Marcos, Hays County, Texas #11. Cemetery Chapel

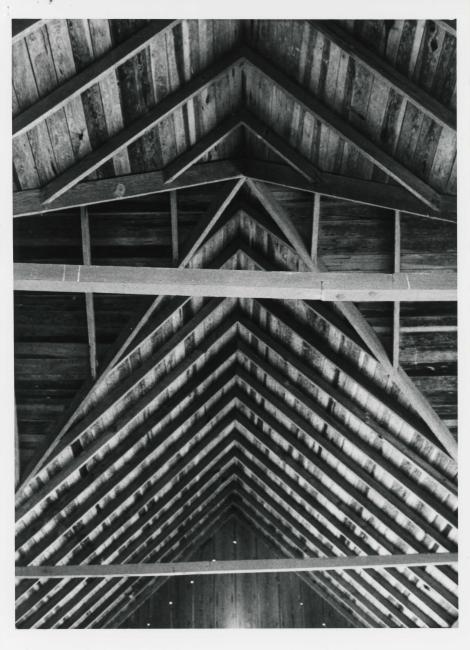
Detail of interior truss and roof system. Photo 53 of 150.

The Chapel's construction is of single boards with exterior battens on a frame of heavy square posts. Rough logs fastened with iron spikes form the foundation. There is no ceiling; the truss system is visible and creates an attractive pattern against the roof boards.
