National Register of Historic Places  
Inventory—Nomination Form

19. Name: Heard House

Location: 620 West San Antonio Street

#19. Heard House

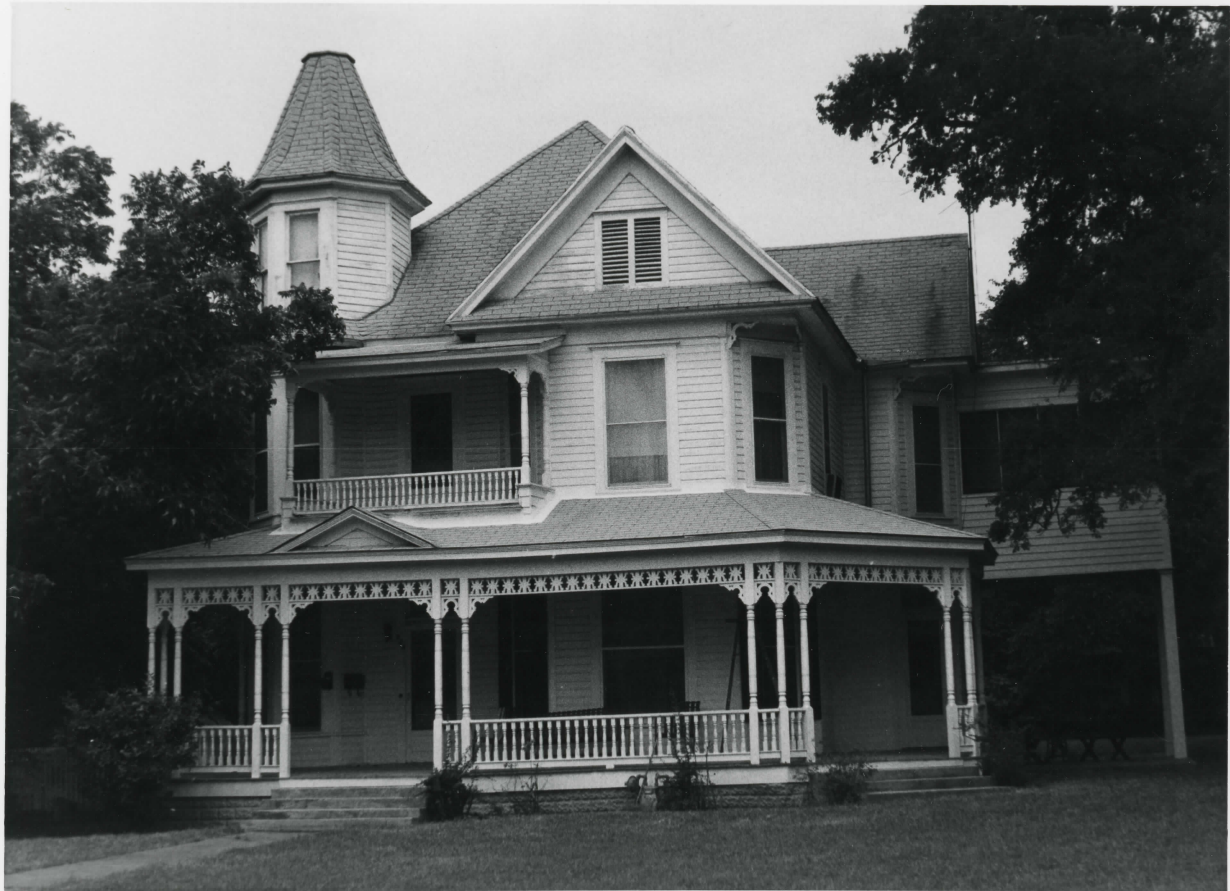
Southeast facade, camera facing northwest.  
Photo 77 of 150.

Typical of Texas Victorian houses is the Heard House, a white frame structure of two stories plus attic under a complex hipped roof with crossed gables and a bell-shaped turret. Across the front and around the east corner is a one-story porch. A second-floor porch is inset between the octagonal turret and an ell. During the 1920s, a sleeping porch was added to the northeast second floor. A one-story addition to the kitchen was made in 1954.

Detail is concentrated on the San Antonio Street facade. The main porch is enlivened with stylized lyres under the eaves, sawn brackets, turned posts, and spindle rails which are repeated on the second floor. Sawn brackets adorn the diagonal corners of ells extending from the southeast and northeast walls.

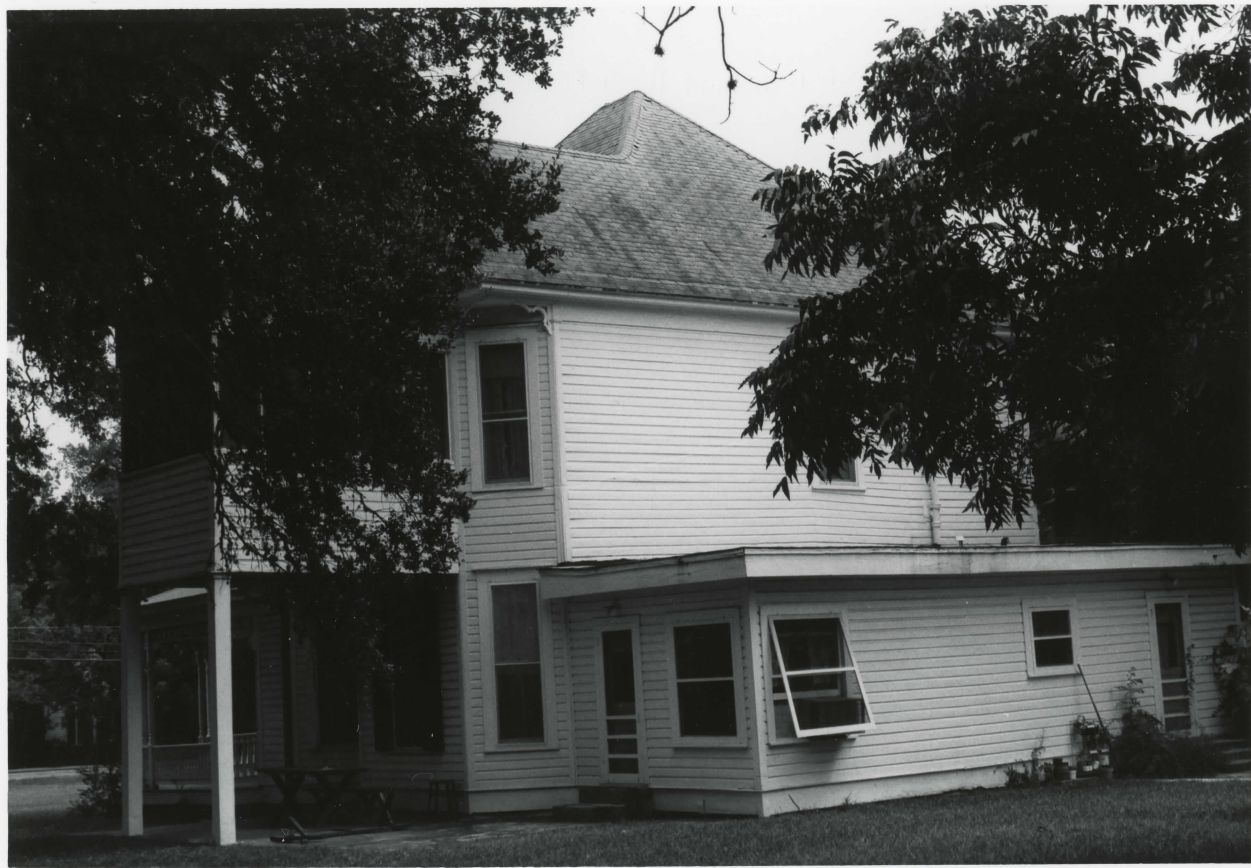
#19. Heard House

North oblique, camera facing south.  
Photo 78 of 150.

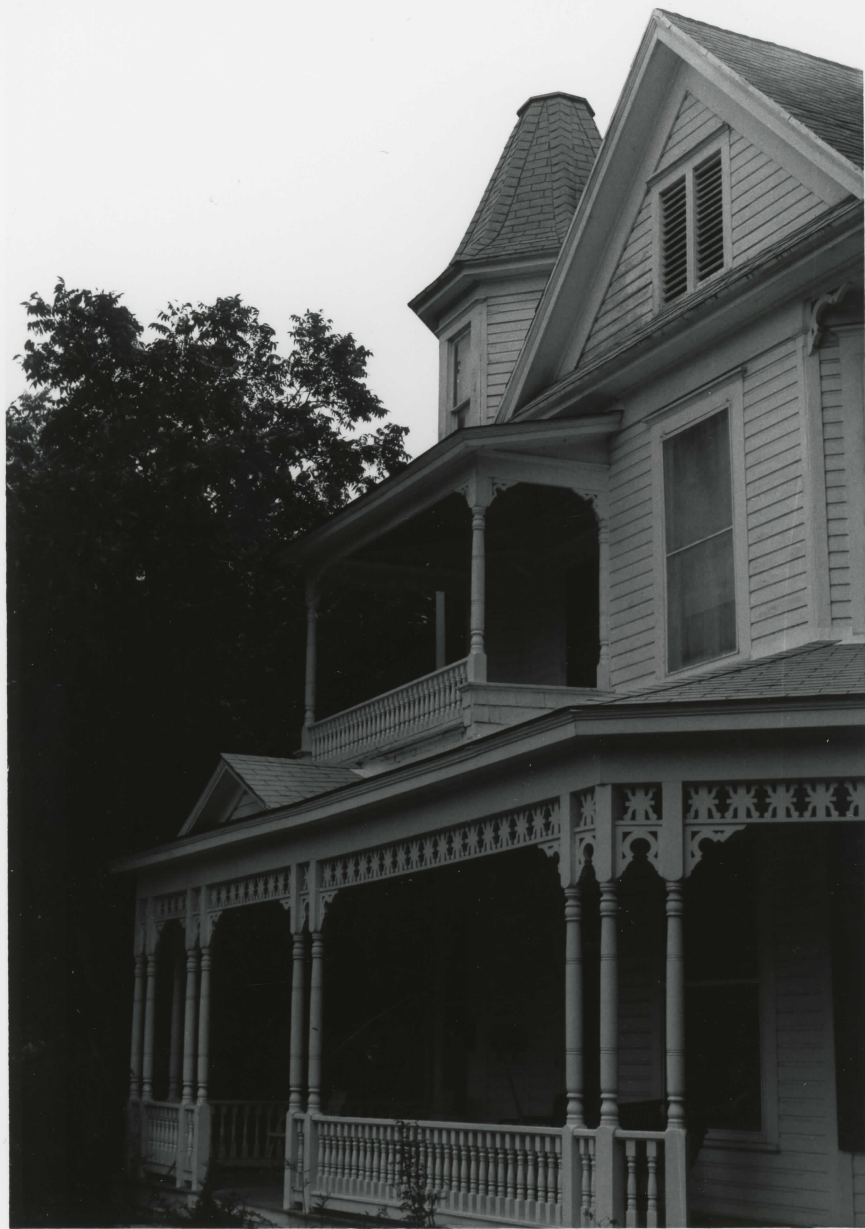
#19. Heard House

Detail of southeast facade, camera facing west  
Photo 79 of 150.
