### National Register of Historic Places Inventory—Nomination Form

Date: ca. 1885; 1913

Wame: Farmers National Bank

Address: 68 West Elm 57,

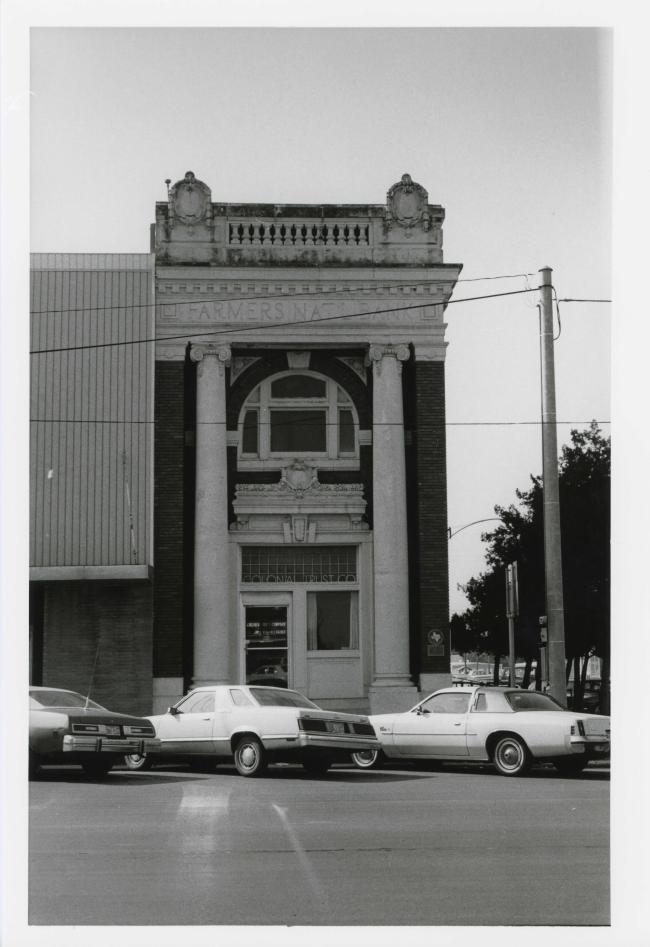
Photo 2 of 23

Historic Resources of Hillsboro
Hillsboro, Hill County, Texas
Site No. 2, Farmers National Bank, 68 W. Elm
Photographer: Ellen Beasley, Spring 1982
Negative on file, Texas Historical Commission,
Austin

View: west elevation, camera facing south

This Classical Revival, two-story, rectangular, commercial building, constructed of kiln-dried brick, stone, and concrete features two monumental, cast-concrete Ionic columns with smooth shafts between the wide entrance. Additional cast-concrete ornamentation graces the front facade with its single-arched window opening extending across the width. Window sills and frames are of white limestone. A full limestone entablature with large dentils and a slightly projecting cornice crowns the building. The built-up (composite) roof is topped with a decorative stone balustrade extending around the west side. Imported marble was used for trim, walls, and wainscoting in the interior. Many old and attractive interior furnishings have been retained. The building was remodeled about 1913 with the application of a new brick covering and the addition of a classical facade. The basement was also enlarged and two additional vaults added. The original, angled, street entrance was eliminated by structural changes.
