**National Register of Historic Places
Inventory—Nomination Form**

Name: Skelton Building

Historic Name: Tarlton Building

Address: 110 East Franklin Street

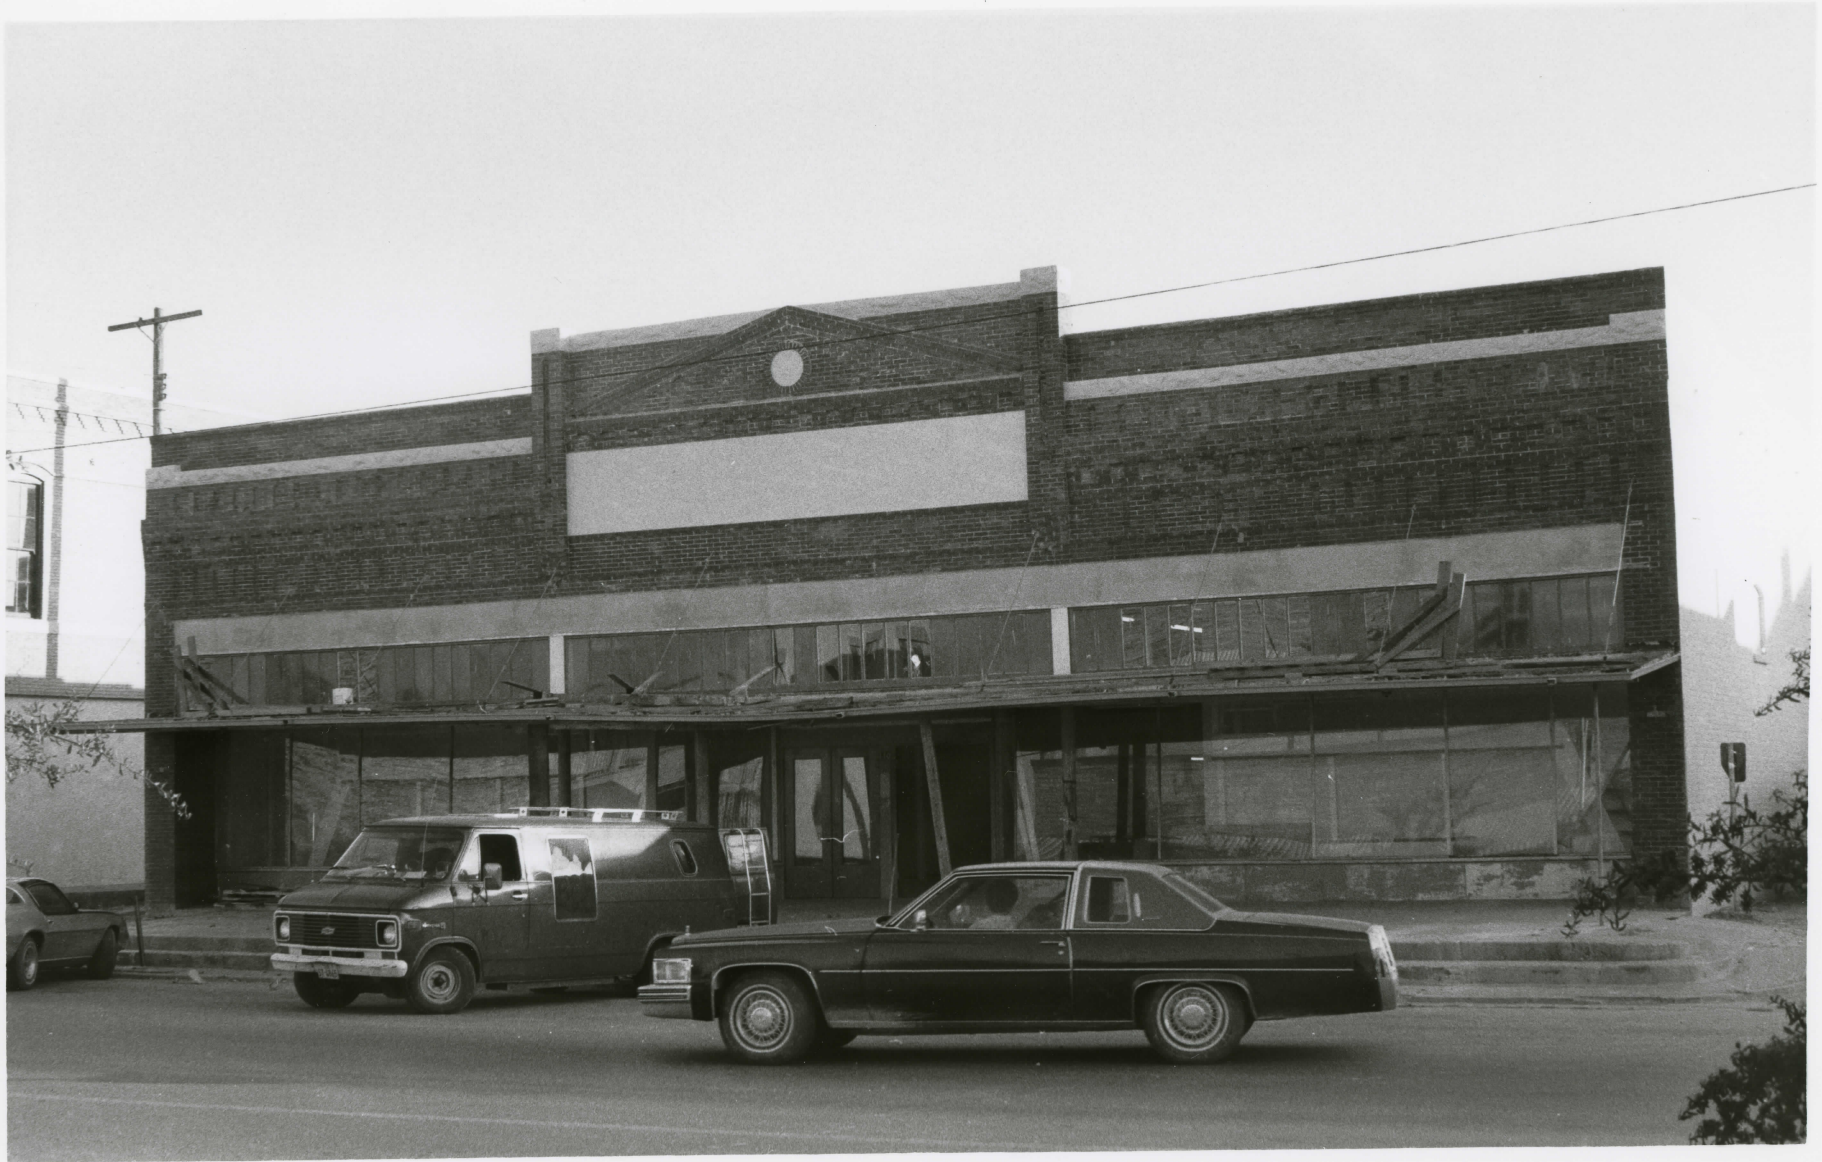
Photo no. 11

Historic Resources of Hillsboro
Hillsboro, Hill County, Texas
Site No. 11, Tarlton Building, 110 E. Franklin St.
Photographer: Kent Collins, November 1983
Negative on file, Texas Historical Commission, Austin
View: north facade, camera facing south
Photo 11 of 23

The Tarlton Building is a one-story, brick commercial structure with a high, corbeled, brick parapet set over a 20th-century, glass display window. The center of the parapet is accented with a low-pitched classical gable, supported by blind corbeled-brick machicolations, and set between several layers of corbeled entablatures of brick and cast stone. The ground floor was "modernized" with large plate-glass display windows sometime in the early 20th century.
