**National Register of Historic Places
Inventory—Nomination Form**

Name: Bailetti House

Address: 1006 Waller Street

Historic Resources of East Austin
Austin, Travis County, Texas

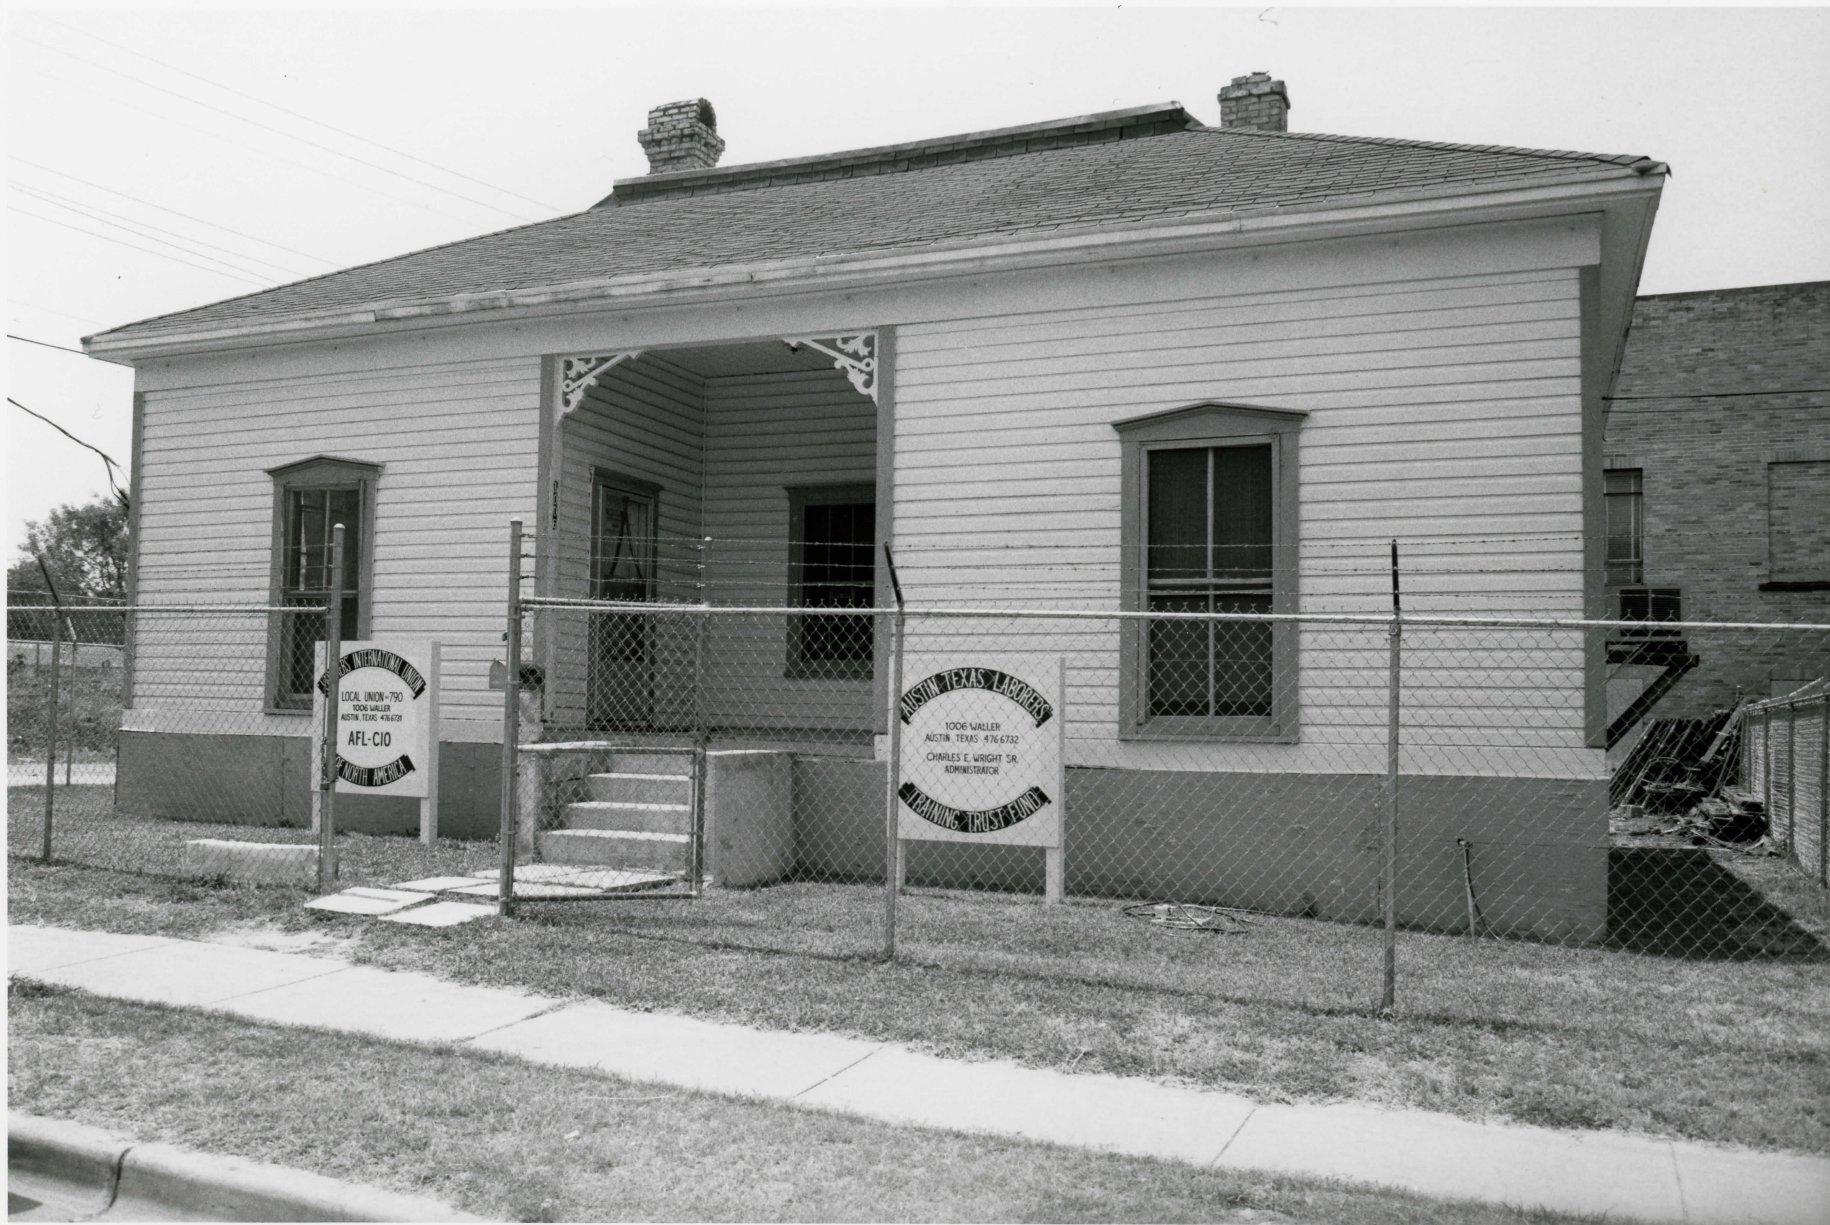
photo 20 of 60

Site No. 17, Bailetti House, 1006 Waller Street
Photo by Joe Freeman, 1984, neg. with Texas
Historical Commission, Austin

East-northeast view
camera facing west-southwest

Physical Condition: Excellent

The Bailetti House is a one-story, raised cottage with two entries opening from either side of a deeply inset porch. It is of simple wood-frame construction covered with clapboard siding, and is characterized by a symmetrical facade and hipped roof with two corbeled-brick chimneys. The two-over-two, double-hung sash windows, which are set to each side of the porch, are surmounted by simple, pointed hood moulds. The porch itself is marked with two delicately carved brackets that form the only significant decorative elements on the house.
