National Register of Historic Places
Inventory—Nomination Form

Site No. 24

Photo No. 28

Name: Shotguns at 1203-1205 Bob Harrison

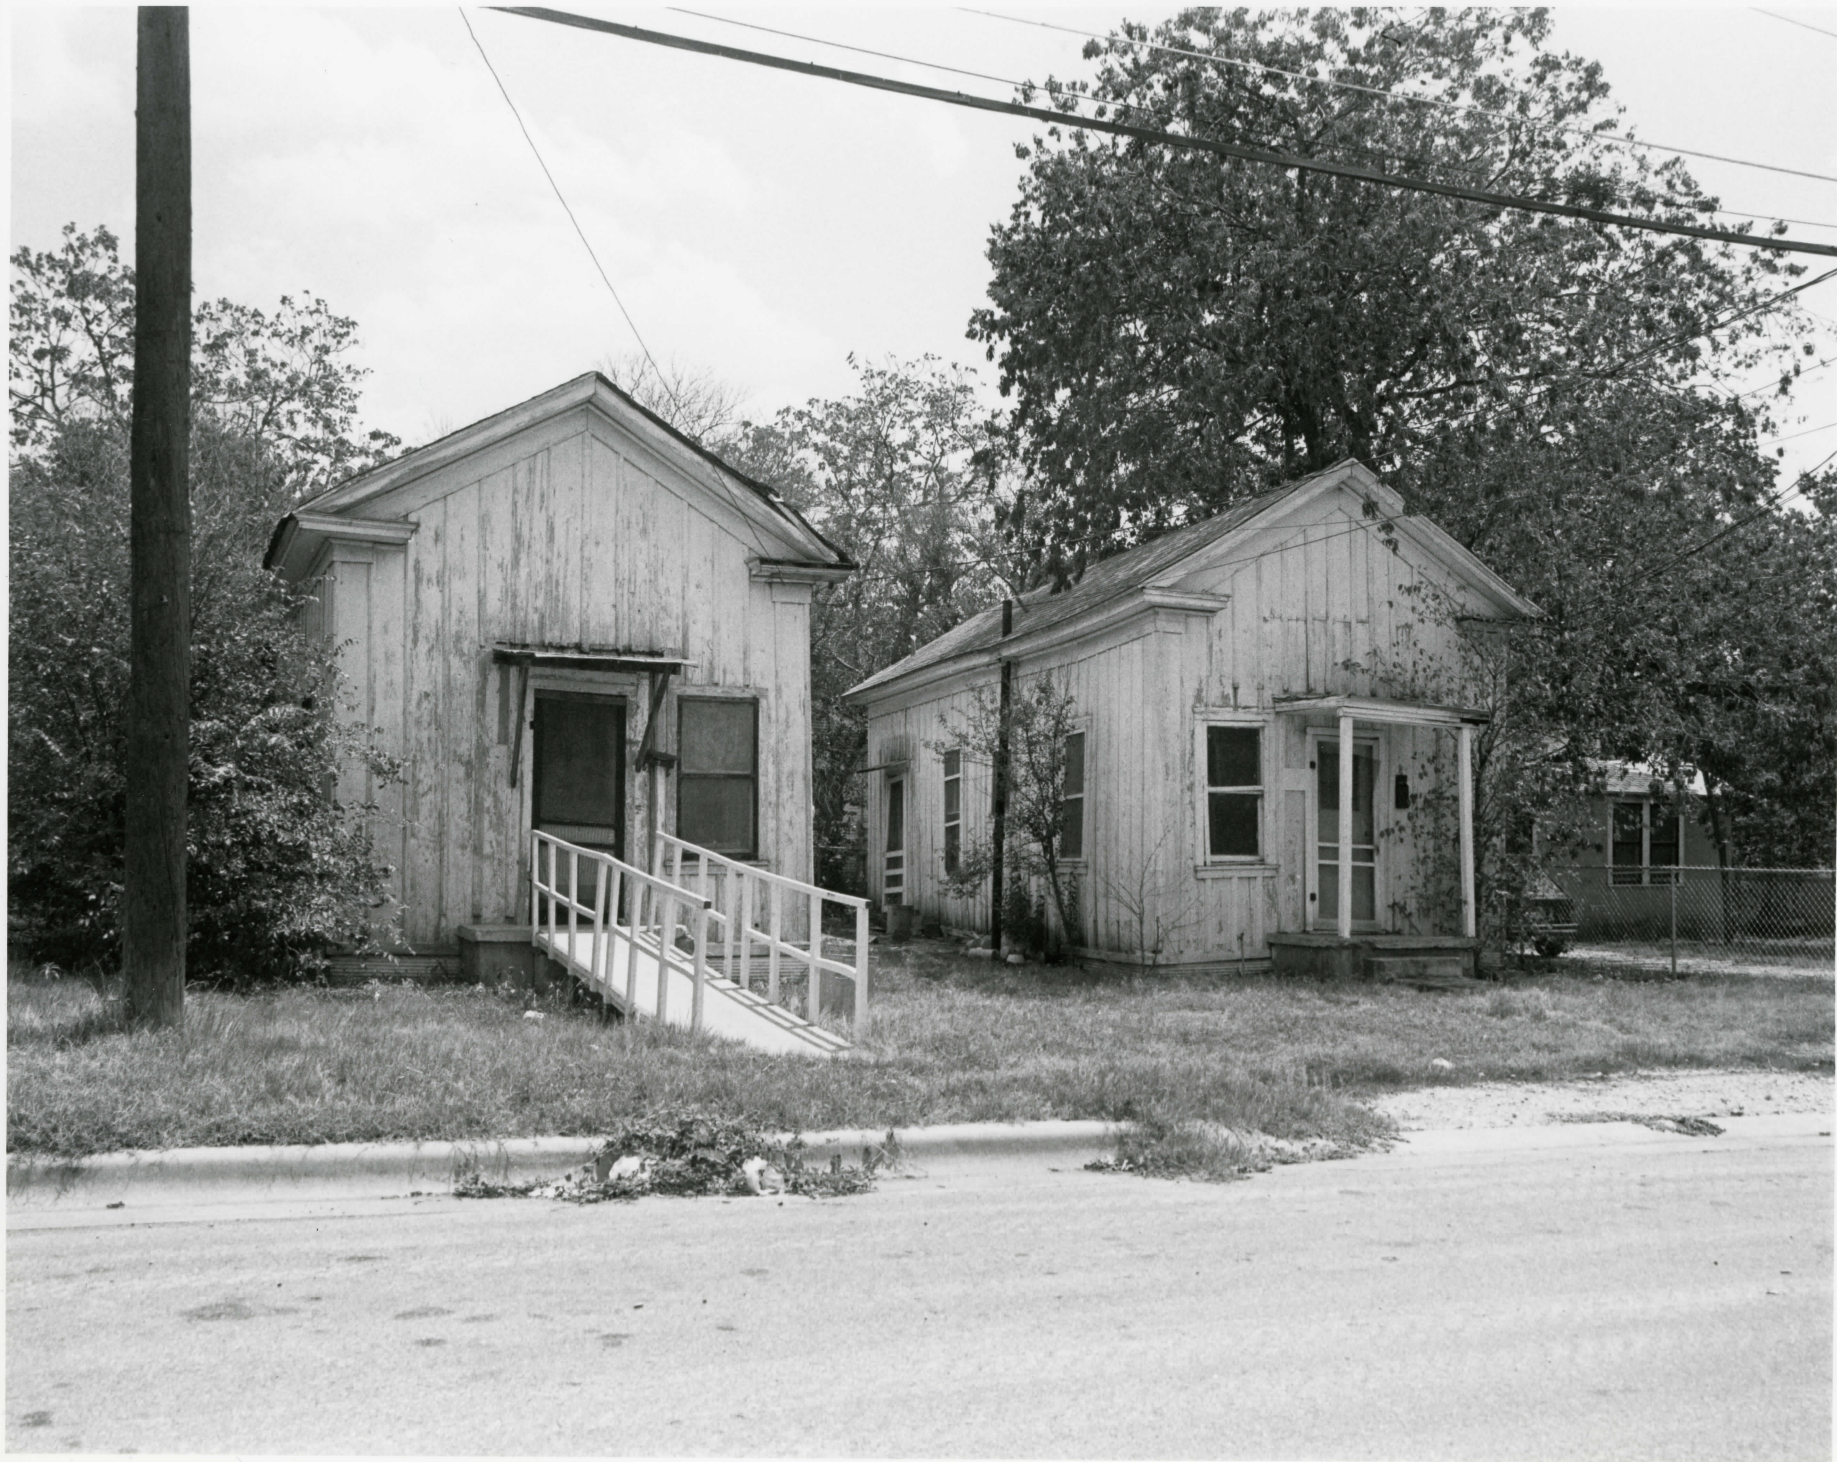
Site 24
Photo 28

Site No. 24, Shotguns at 1203-1205 Bob Harrison
Photo by Joe Freeman, 1984, neg. with Texas
Historical Commission, Austin

Northeast view
camera facing southwest

The structures at 1203-1205 Bob Harrison are a pair of nearly identical, early twentieth-century, shotgun houses. Located side-by-side in close proximity, the two buildings have single-door, central entrances and gabled roofs. A generous gable rake return occurs on the north elevation. Walls are of board-and-batten construction and roofs are covered with corrugated iron.
