# **National Register of Historic Places Inventory—Nomination Form**

Name: Shotgun at 1206 Canterbury Street

Historic Resources of East Austin Austin, Travis County, Texas

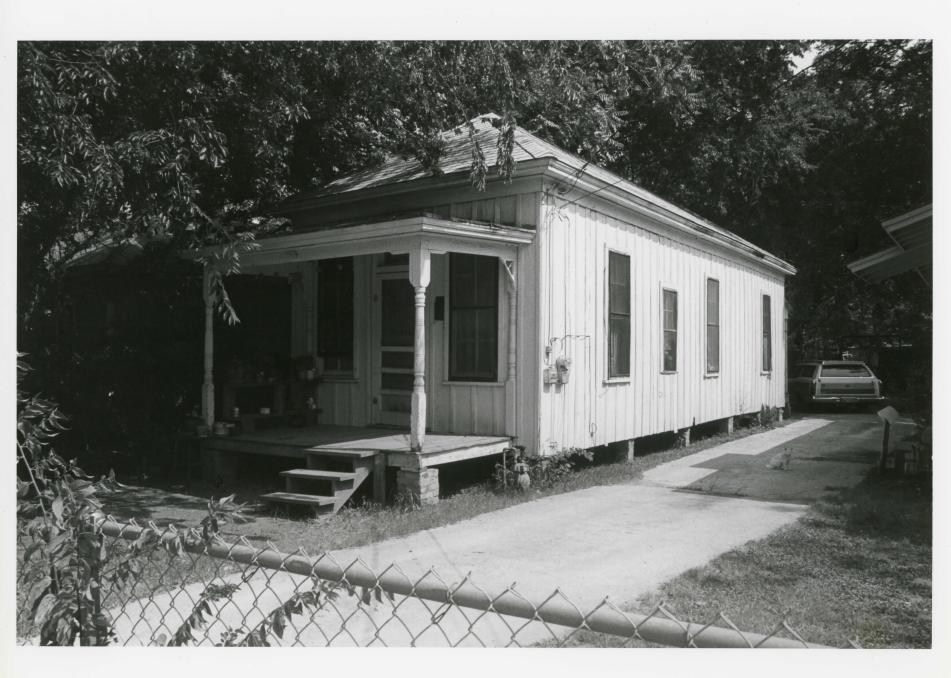
Site 2 Photo 2

Site No. 2, Shotgun at 1206 Canterbury, 1206 Canterbury Street
Photo by Joe Freeman, 1984, neg. with Texas
Historical Commission, Austin

Southeast view camera facing northwest

1206 Canterbury is an early twentieth-century shotgun house which is both typical and classic regarding the tradition of its architectural typology. ported by brick piers, this board-and-batten wood-frame structure has a hipped roof and a simple front porch. The house is oriented with its length at right angles to the street; the porch covers a central front door which is surmounted by a transom. Porch columns are turned and support a bracketed cornice. Boards and battens rise to a continuous frieze board overhung by a projecting eave trimmed with stock moulding typical of the period. The boards are simple "one-by" lumber while the battens are milled pieces with finely detailed edges.
