United States Department of the Interior
National Park ServiceNational Register of Historic Places
Inventory—Nomination Form

1. County DEWITT DEW
City/Rural CUERO CU
2. Name FIRST METHODIST CHURCH
Address 301 E COURTHOUSE
3. Owner First United Methodist Church
Address 301 E. Courthouse Cuero 77954

NR File Name Cuero M-R Nomination

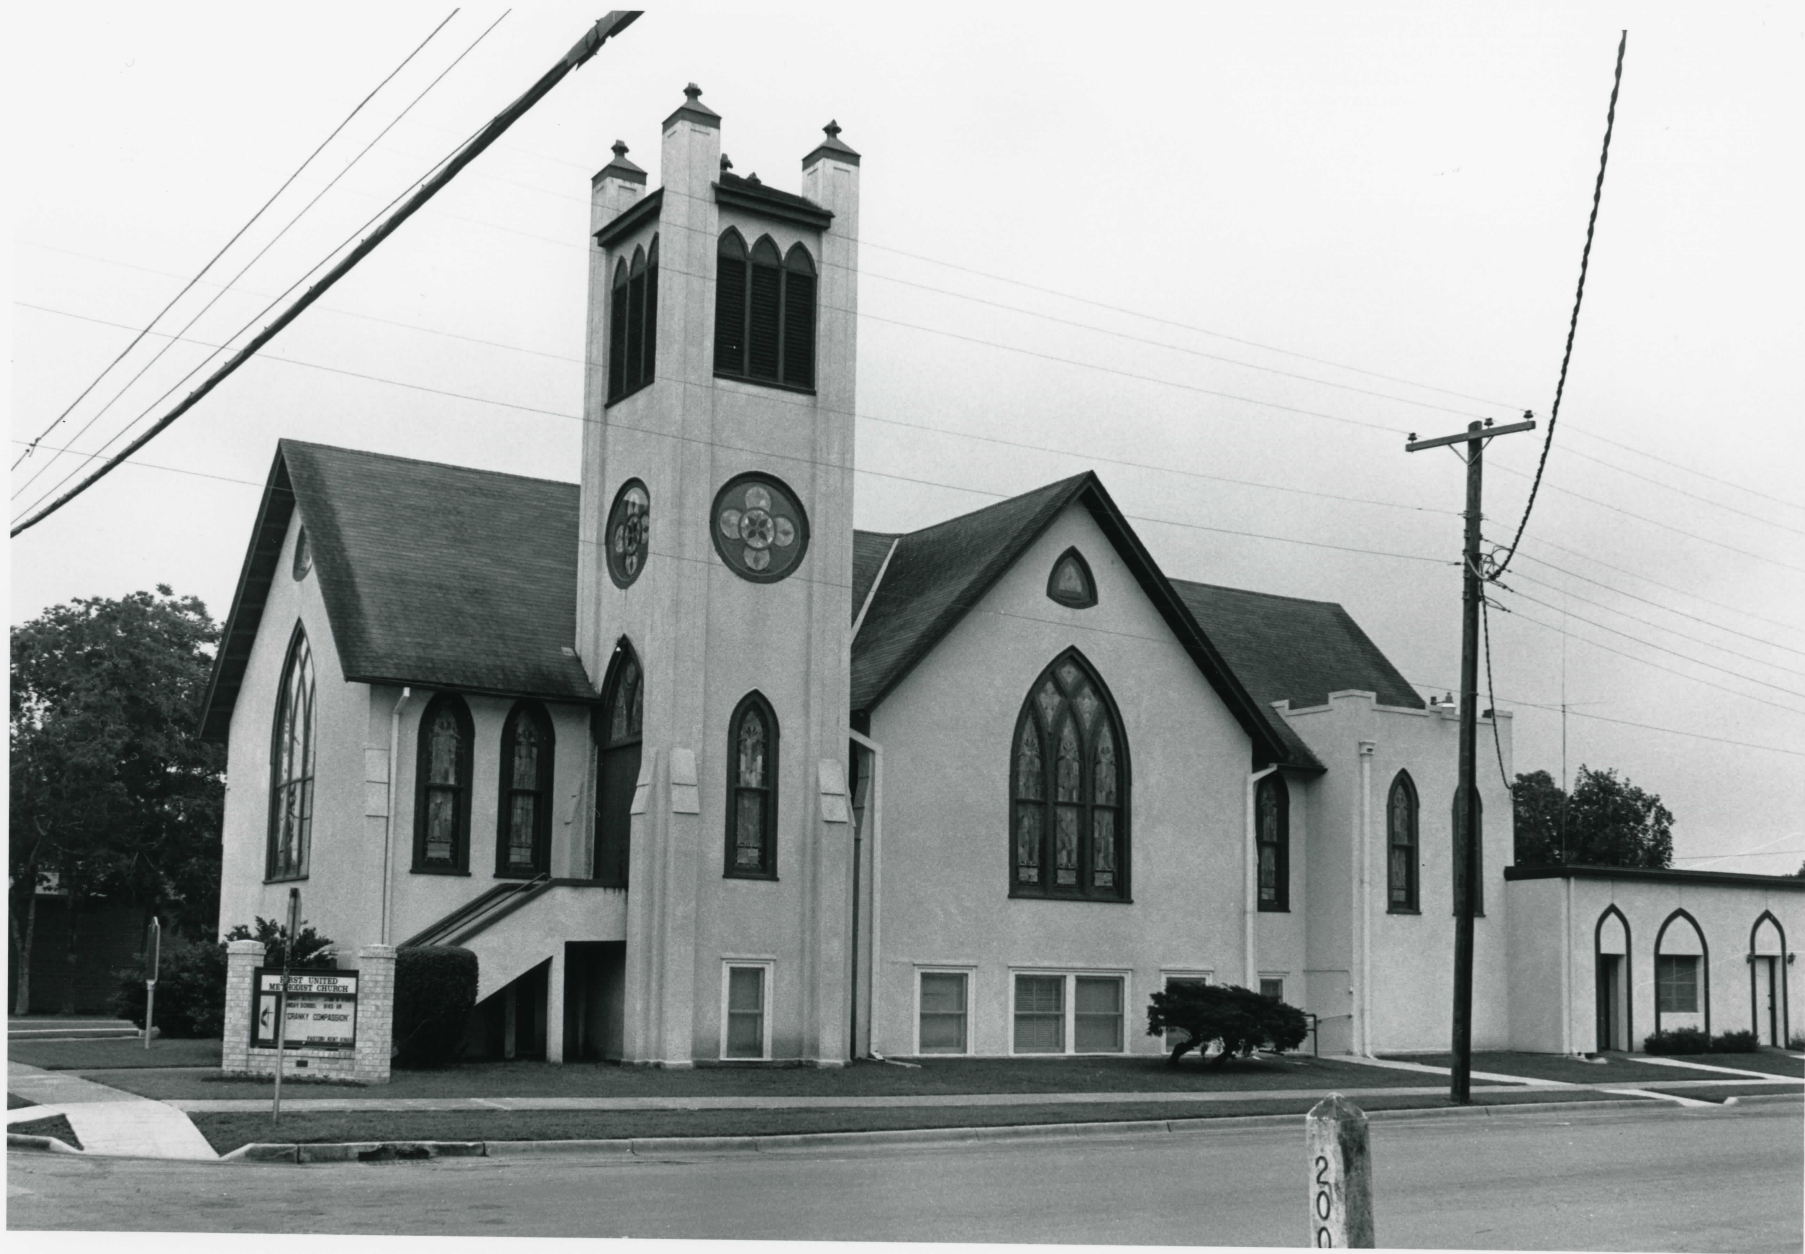
Photo 6 of 77

Subject: First Methodist Church, Site No. 377
301 E. Courthouse

View: Camera looking southeast

8. Style/Type Gothic Revival church
9. Original Use religious
Present Use religious
10. Description Frame church w/ stuccoed exterior; raised foundation w/ partial base-
ment; cross-gable roof w/ composition shingles; squared tower at NW corner of
building; double-door entrance w/ pointed-arch transom at base of tower;
secondary front entry w/ similar detailing at NE corner of building; pointed-

11. Present Condition good; stucco applied in 1929; building raised and reoriented in 1929.
12. Significance ARCHITECTURE: This structure, with Gothic Revival detailing, was built
in 1886 by local contractor Z.A. Finck. Extensive alterations took place in
1929 when a basement was added. The church was organized in February 1876.

Description continued: arch opening w/ stained-glass windows; tower w/ small rose window and triple arches on each elev.; extensions w/ small finials at each corner of tower; pyramidal roof w/ finial caps on tower.
