**NATIONAL REGISTER OF HISTORIC PLACES
REGISTRATION FORM**

historic name Beamer, William, House

street & number 1202 South Beal Street [NA] not for publication

Name of related multiple property listing:
Community Development in Belton, Texas, 1850-1945

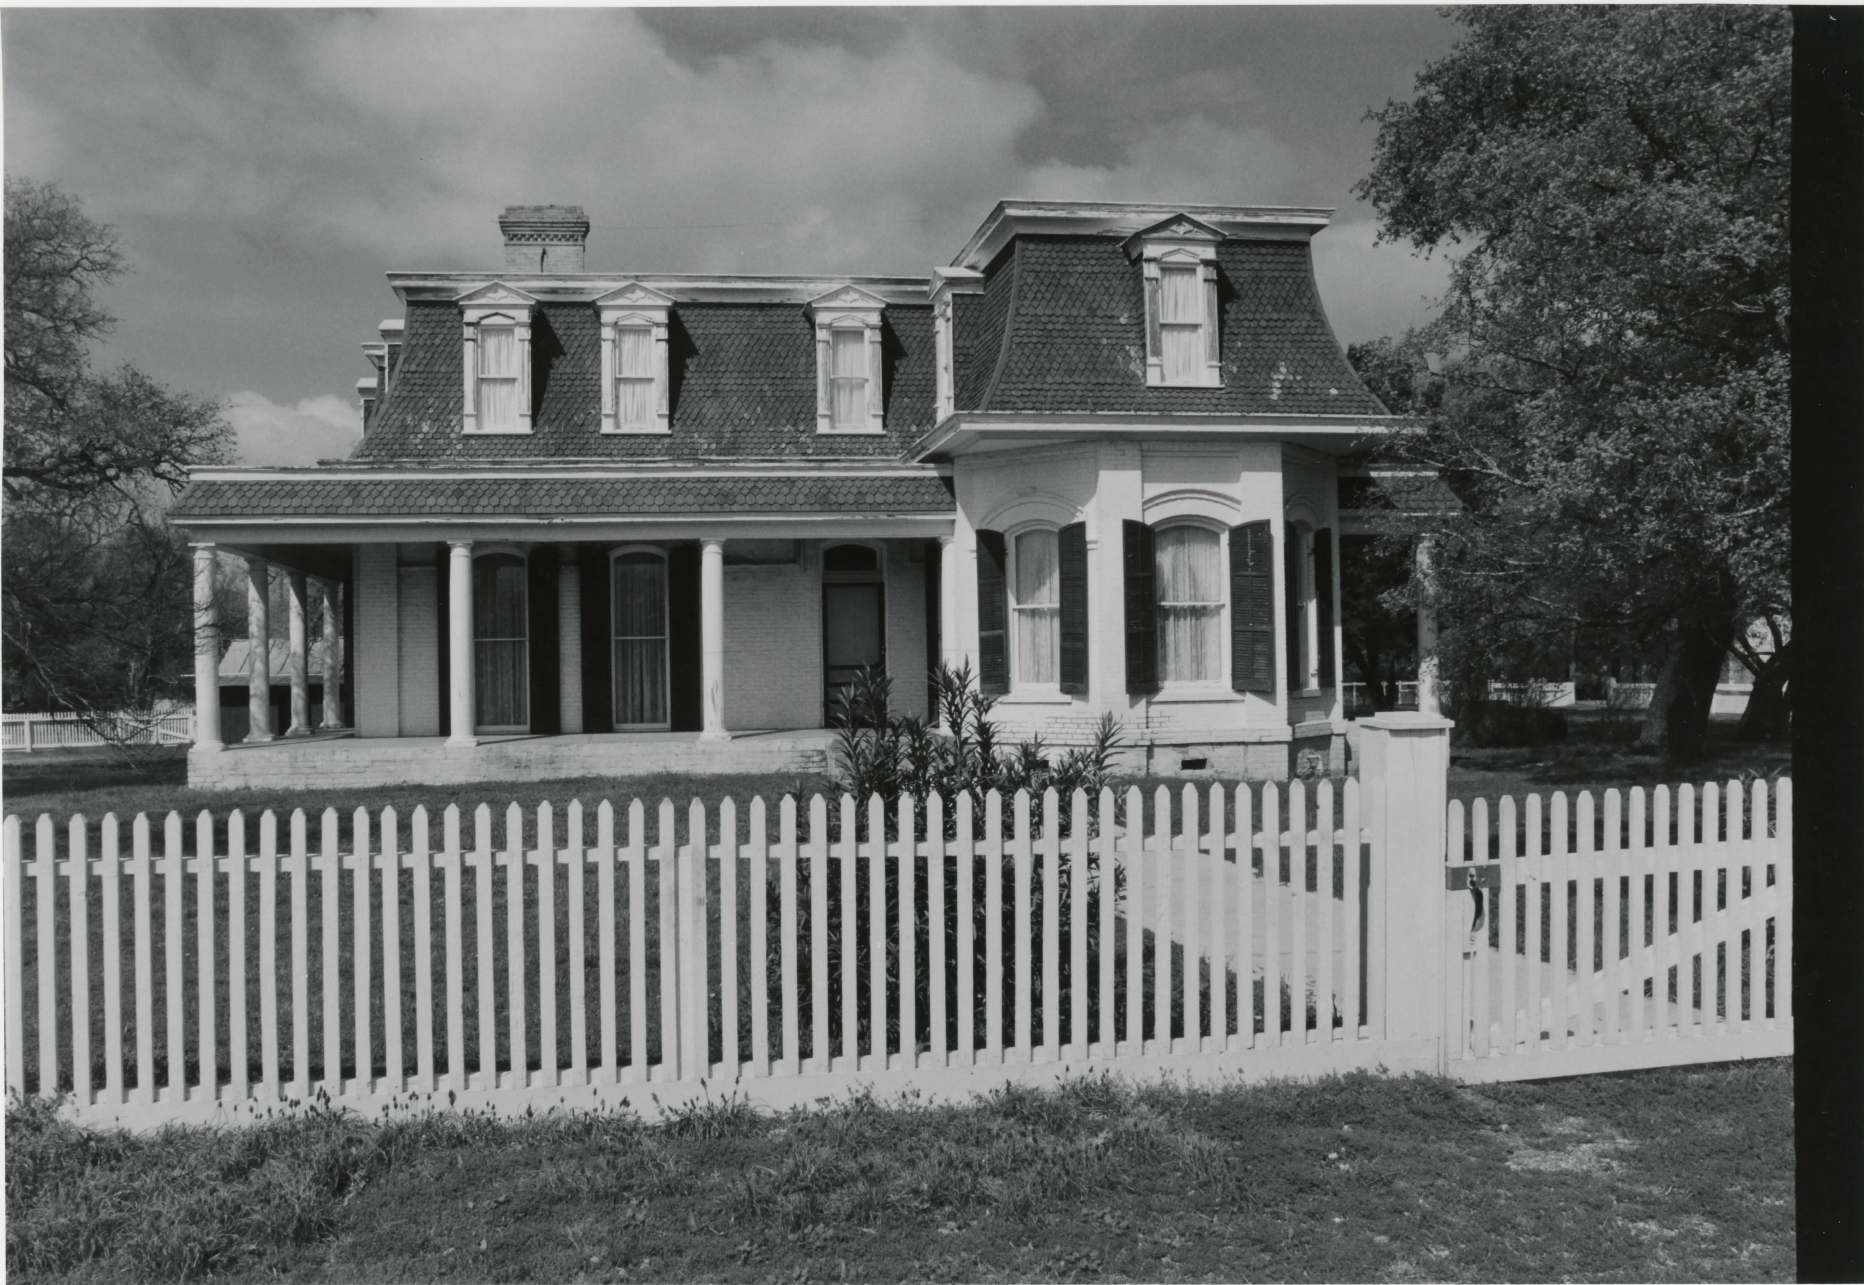
#216
1202 S. BEAL

HISTORIC & ARCHITECTURAL RESOURCES of BELTON, TEXAS
 WILLIAM BEAMER HOUSE
 1202 S. BEAL STREET
 BELTON, BELL CO., TEXAS
 CAMERA FACING NORTHWEST
 NEGATIVE WITH CONSULTANT
 PHOTO 9 OF 38

View N.W. OBLIQUE

The Beamer House is a 2-story brick L-plan residence emulating the Second Empire style with a prominent mansard roof encompassing the second story. A porch wraps around porch on the east and south sides with a flat roof supported on simple columns. The house takes many of the features of an Italianate cottage but with the additional affectation of the Second Empire style. It has been well maintained and retains its original appearance, with the exception of an extension on the rear of the building. The house faces east on a large, wooded lot, occupying an entire city block in a residential neighborhood of South Belton.

The Beamer House takes the L-plan form which was probably the most established vernacular pattern for late-19th century houses in Texas. The walls and foundation are constructed of load-bearing brick. The influence of the Italianate style is evident in the chamfered bay on the main facade and the segmental windows with hood moldings. The wraparound porch with Doric columns is also not typical of the Second Empire style. On the north facade is a smaller porch serving a secondary entrance. The mansard roof is covered with fish scale and diamond wood shingles. In the roof are a series of single dormer windows with a decorative pedimented gable and wooden surrounds. The roof is pierced by two corbeled brick double chimneys. All of the windows are 1/1 double hung with wooden sashes; the larger first floor windows are full length with screens which open out providing access to the porch. The interior walls are of brick and there are arched crawl spaces in each wall of the foundation. A cistern located near the kitchen and fed by copper tubing which collects water from concealed gutters in the roof is still in use. The house is very good condition with only minor alterations, including the extension of the back porch. Surrounding the large yard is a wooden picket fence.
