NATIONAL REGISTER OF HISTORIC PLACES REGISTRATION FORM

1. Name of Property			
	및 규모님이 그리고 하는 사람이 되었다.		
historic name Na	ismith, Robert, House		
other names/site number	#26		
2. Location	the Abrille has been been and		
street & number 44	0 North Penelope		[NA] not for publication
-/+- // P-14			CNR 1!-!-!-
city/town Belton			[NA] vicinity
state Texas cod	e TX County Bell	code 027	zip code 76513
3. Classification			
Ownership of Property Property	Category of Property	Numl	per of Resources within Contributing
Noncontributing [XX] private	[XX] building(s)	1	buildings
[ ] public-local	[ ] district		sites
public-State	[ ] site		structures
[ ] public-Federal	[ ] structure		objects
	[ ] object	1	0 Total
Name of related multiple			contributing resources
Community Development in	Belton, Texas, 1850-1945	previously	listed in NR0

The Naismith House, built in 1876, is an example of the vernacular center-passage house common in Central Texas in the mid- to late-19th century. Contextually, the property relates to Community and Regional Development, specifically to the growth of Belton during the last years of the cattle boom. The house meets National Register Criterion C, significant in the ar

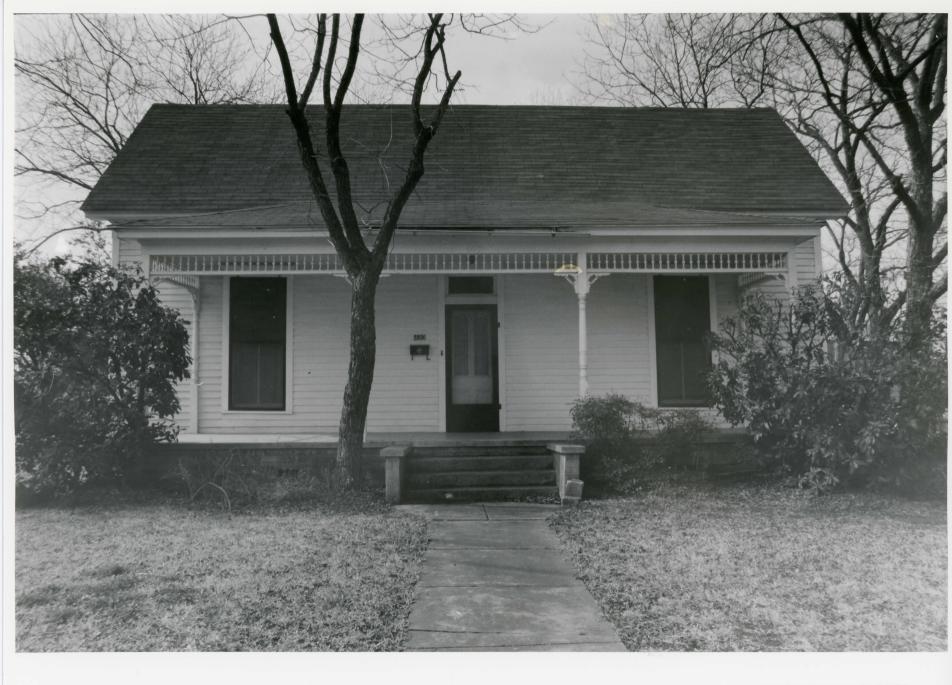
PHOTO 26 OF 38

HISTORIC & ARCHITECTURAL RESOURCES of BELTON, TEXAS
ROBERT NAISMITH HOUSE.
440 N. PENELOPE
BELTON, BELL CO., TEXAS
CAMERA FACING EAST
NEGATIVE WITH CONSULTANT

View W. FACADE

The Naismith House is side gabled with a hipped-roof porch applied to the width of the facade. It is faced with weatherboard siding and covered with a simple side-gabled roof with asphalt shingles. The porch has turned Eastlake-style wooden columns and decorative spindle lattice and brackets. The entry door is centered in the facade with a small transom above it. Windows are 2/2 double hung with simple hood molds. The structure rests on a pier and beam foundation and has a brick foundation skirt. The original porch deck has been replaced by a concrete slab and steps.
