NATIONAL REGISTER OF HISTORIC PLACES
REGISTRATION FORM

historic name Belton Standpipe

Name of related multiple property listing:
Community Development in Belton, Texas, 1850-1945

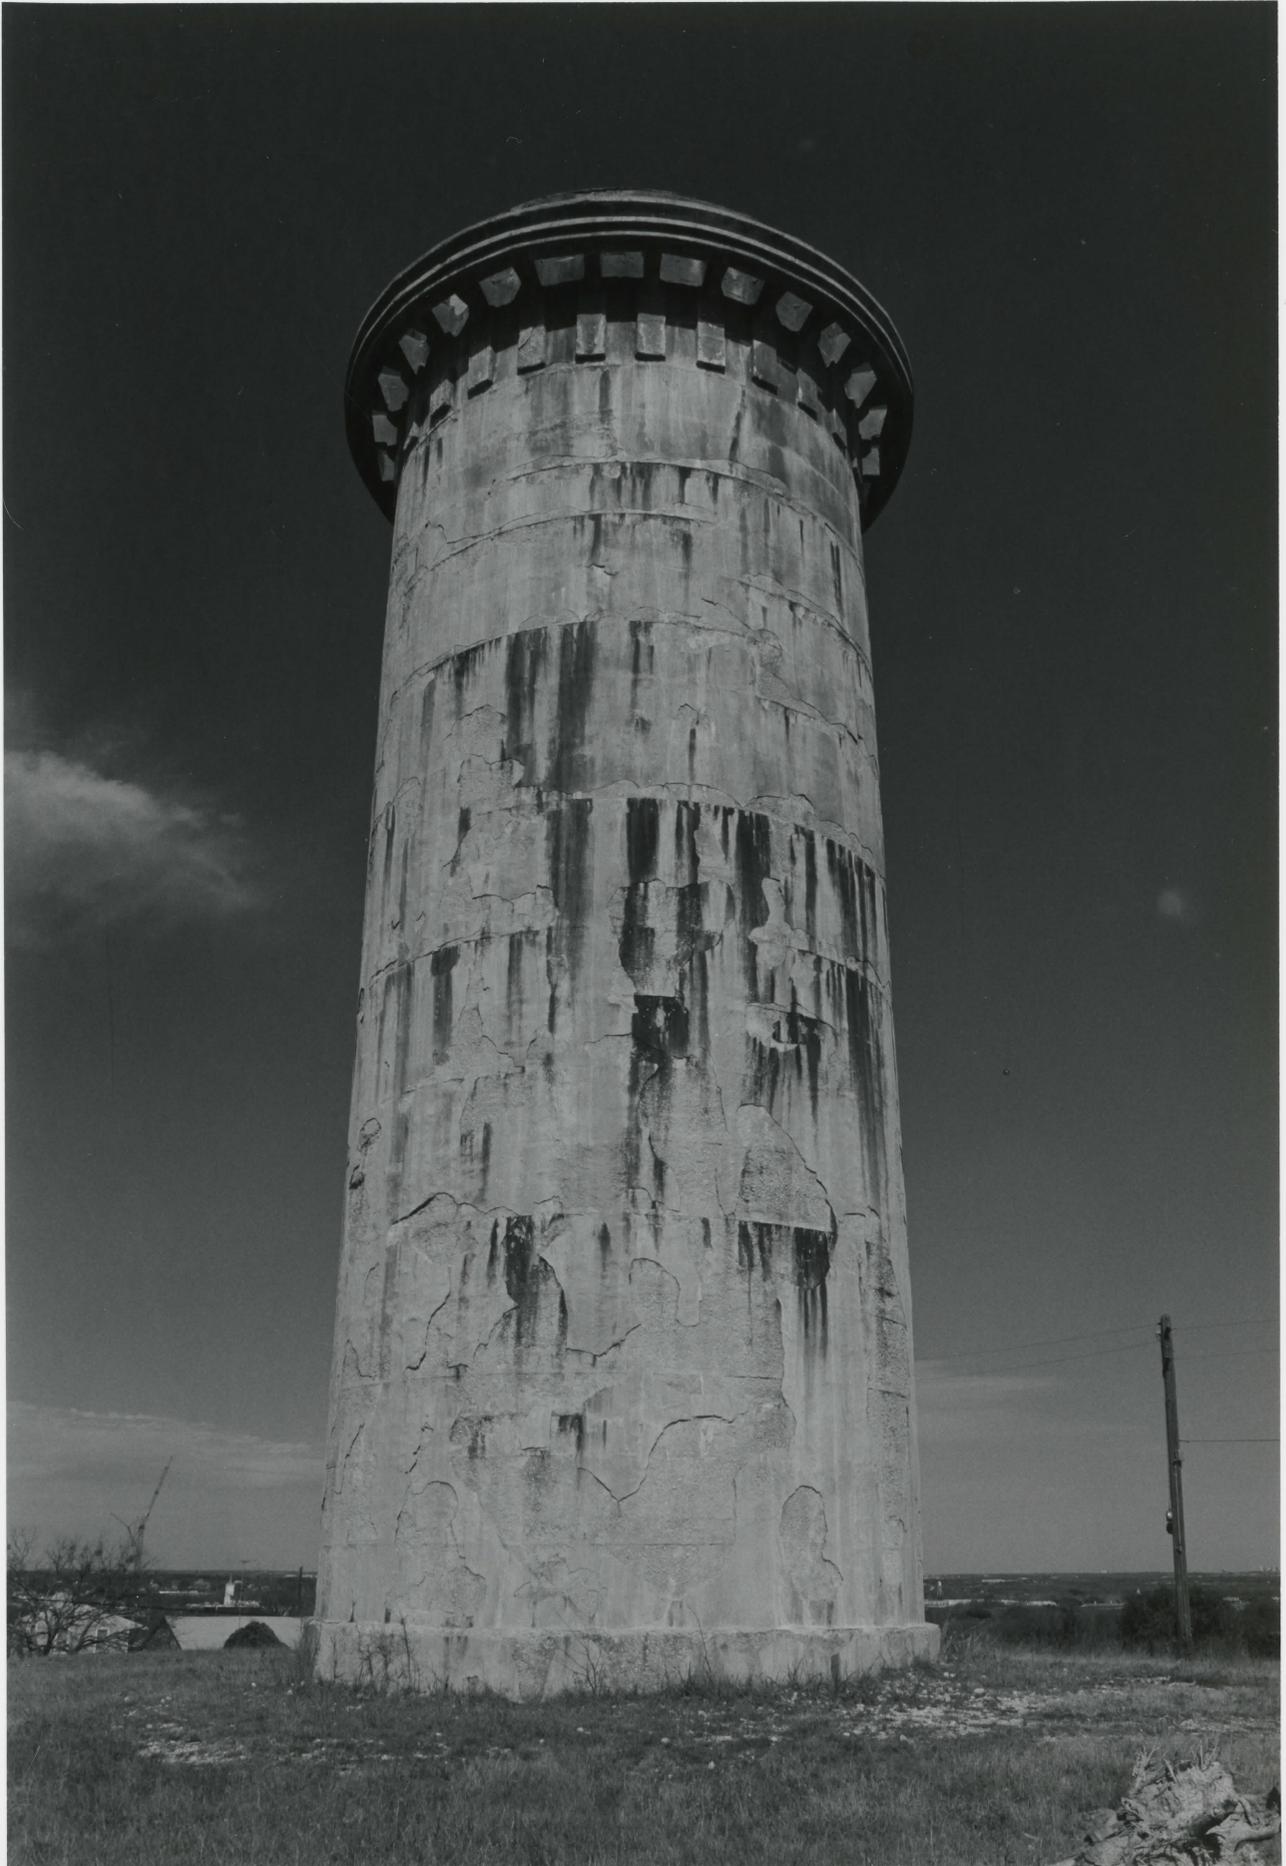
PHOTO 38 OF 38

159
BELTON STAND PIPE

HISTORIC & ARCHITECTURAL RESOURCES of BELTON, TEXAS
BELTON STAND PIPE
300 W. AVENUE J
BELTON, BELL CO., TEXAS
CAMERA FACING NORTHEAST
NEGATIVE WITH CONSULTANT

View N.E. OBLIQUE

The Belton Standpipe is constructed of poured, reinforced concrete. It is cylindrical in shape: approximately 70 feet in height and 30 feet in diameter. At the top is a cantilevered ring extending out several feet that supports a service walkway. The tower is decorated below the service walkway with raised concrete rectangles that suggest crenelation or dentils. The standpipe is in poor condition with cracks and surface spawling of the concrete.
