National Register of Historic Places Registration Form

1. Name of Property			
historic nameNorton-Orgain House			
other names/site number N/A			
2. Location			
street & number <u>Main Street</u>		N/A not fo	or publication
city or townSalado		N/A vio	cinity
state Texas code _TX	county <u>Bell</u>	code <u>027</u> zip co	de <u>76751</u>

7	_ 1	Norton-Orgain House	
Section number	Page	Salado, Bell County, Texas

The Norton-Orgain House is a 2-story frame vernacular center passage I-house. It is in the core of historic Salado, Bell County, Texas, and was constructed in approximately 1872 and has Victorian era and early 20th century alterations. The building faces west and consists of two main elements: a rectangular 2-story central hall volume and a 2-story ell addition on the rear of the house. Prominent architectural features include a 2-story gallery across the front of the house and brick chimneys at the north and south gable ends.

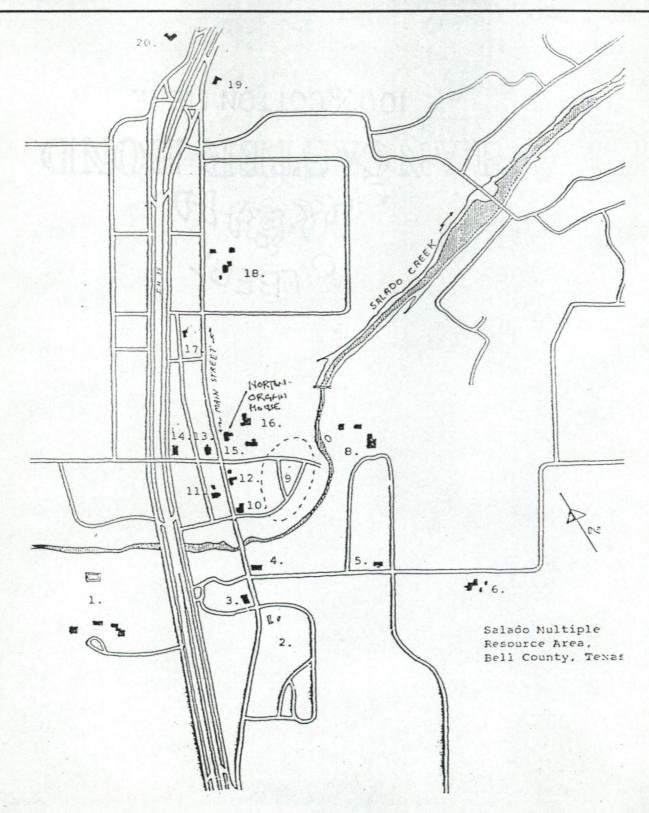
Section number ______ Page ___ Norton-Orgain House Salado, Bell County, Texas S BE STE 103.60 15 LIVE OAK 15 HACKBERRY 12 HACKBERRY GATE CONC. EI7 E18 OARAGE: E14 0. 1959 SEPTIC TANK CREPE MYRTLE HACK BERRY E3 TWALK + PYRACINTHA CHAIN LINK FENCE ES LIVE OAK 20" LIVE ONK 20 HACKBERRY H 84 18'H 44.85"

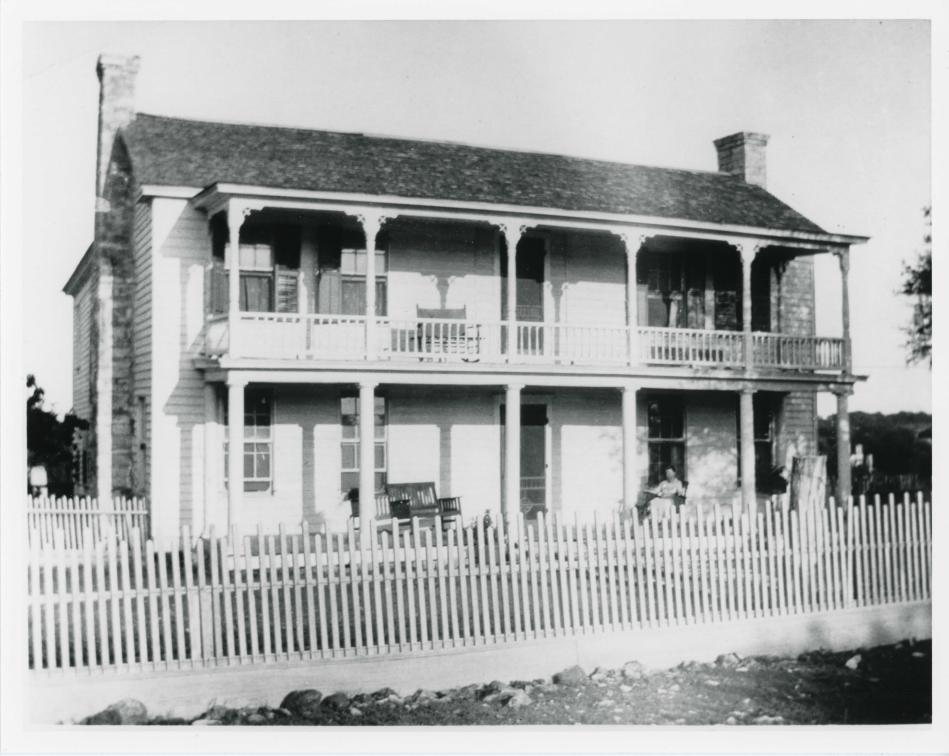
NORTON-ORGAIN HOUSE MAIN STREET SALADO, BELL CO., TEXAS PHOTOGRAPH 1 of 10

PHOTO 1 of 10: Photographer unknown, early 20th century, camera facing southeast.

Little remains of historic improvements although a simple wood picket fence shown in historic photographs (see photo 1) has been reproduced (see photo 2). A cistern for holding rainwater, across from the kitchen, was exposed and repaired during restoration (see photo 4). No other outbuildings or evidence of outbuildings exist. Several trees south and west of the structure are of sufficient size to have been present very early in the life of the house.

The Norton-Orgain House has pleasantly proportioned windows and doors, similar in size, scale, and proportion to openings found on Greek Revival houses. The 2-story full-length gallery was reconstructed in 1990-1991 based on historic photographs (see photo 1). According to local folklore, the porch was removed in the early 20th century after a child fell to his death from the upper level. The elaborate turned columns on the second floor are probably not original, as the details, attached brackets and balustrades suggest the later Victorian/Eastlake period. The scale and proportion of the building, roof, windows and doors are not Victorian. The Doric columns on the first level appear to have been added after the Victorian period. The retention of a full-length gallery and lack of classical detailing around the windows implies an attempt to update the house. This change may well have been in response to the popularity of the Colonial Revival style at the turn of the century in Texas, or to the strong Greek Revival character of many pioneer Salado homes. The house is constructed of materials widely available in Texas -- cypress (foundation posts and joists), oak, pine and limestone.

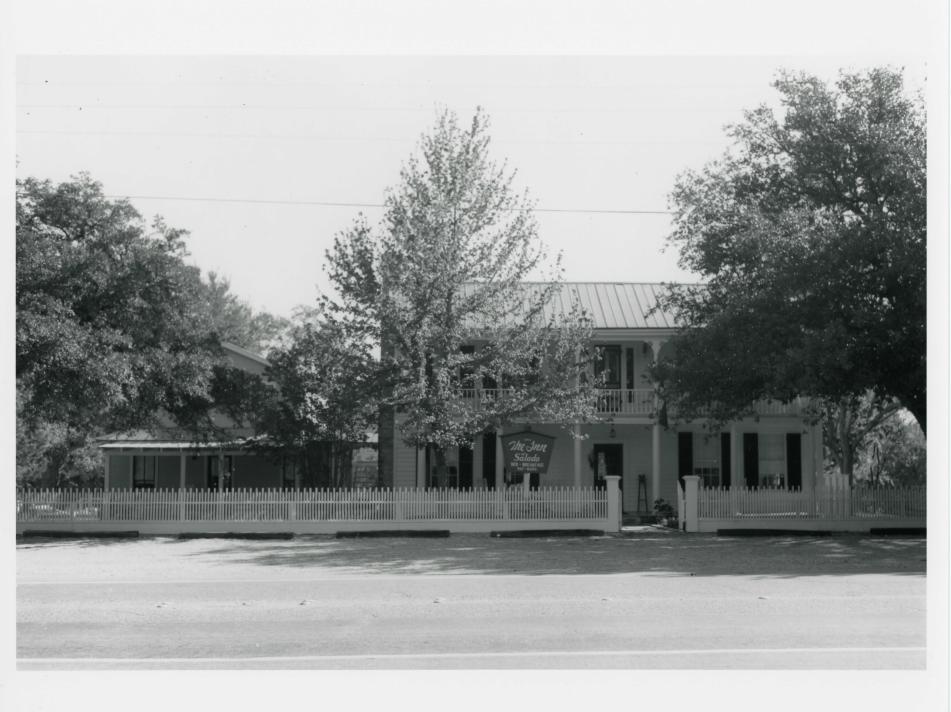
NORTON-ORGAIN HOUSE MAIN STREET SALADO, BELL CO., TEXAS PHOTOGRAPH 2 of 10

PHOTO 2 of 10: camera facing east.

The present owner took advantage of the rehabilitation tax credit program and completed renovation of the Norton-Orgain House in 1991. The Norton-Orgain House is the only building being nominated. The 2-story guest house (see photos 2, 3) was converted, during the 1990-91 renovation, from a garage (built in 1959) and is not being considered in this nomination.

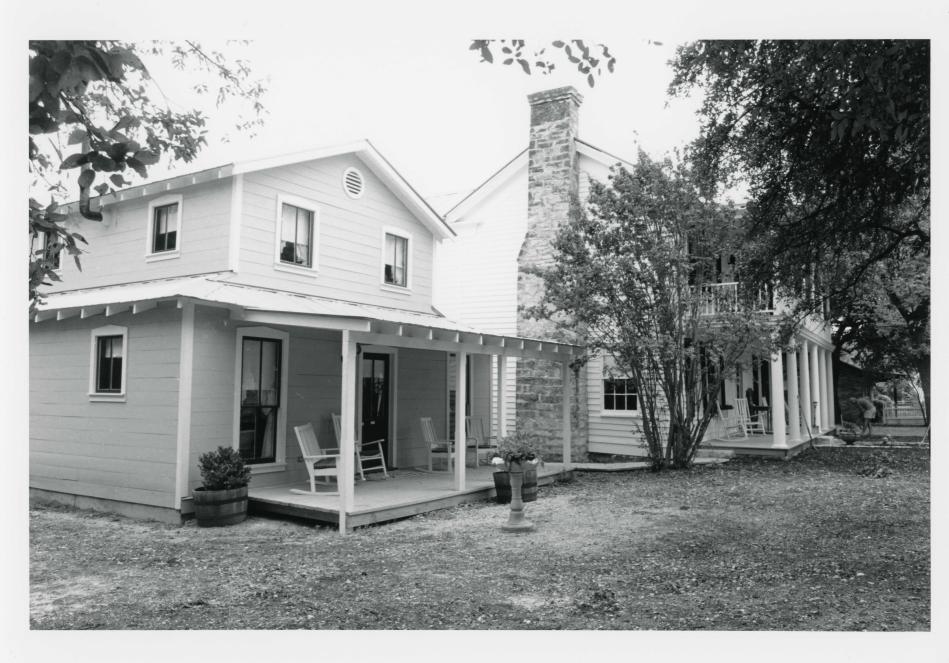
NORTON-ORGAIN HOUSE MAIN STREET SALADO, BELL CO., TEXAS PHOTOGRAPH 3 of 10

PHOTO 3 of 10: camera facing south.

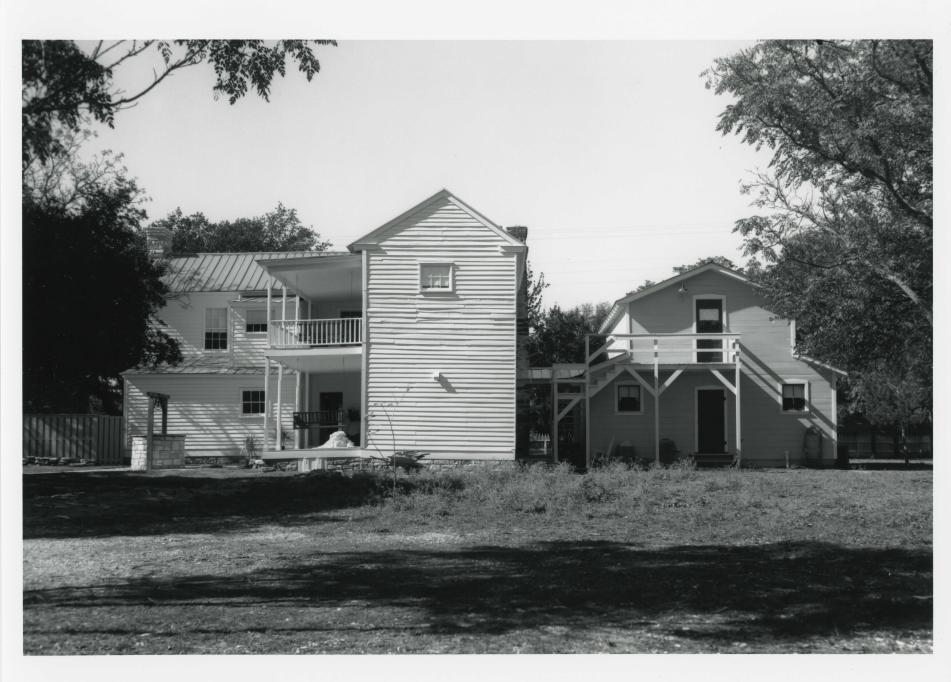
NORTON- ORGAIN HOUSE MAIN STREET SALADO, BELL CO., TEXAS PHOTOGRAPH 4 of 10

PHOTO 4 of 10: camera facing west.

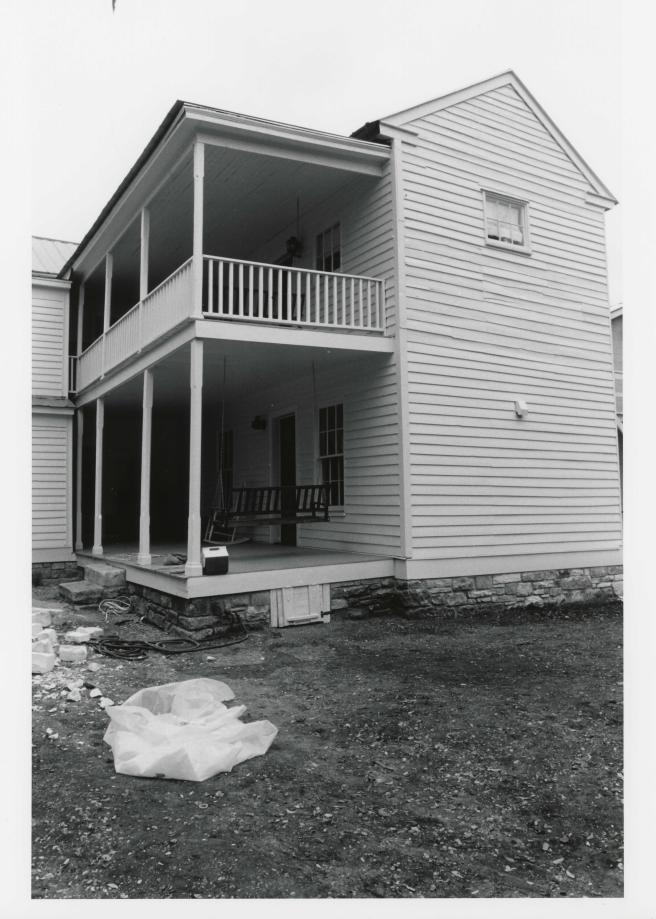
NORTON - ORGAIN HOUSE MAIN STREET SALAPO, BELL CO., TEXAS PHOTOGRAPH 5 of 10

PHOTO 5 of 10: camera facing northwest.

The ell addition consists of a kitchen and dining room downstairs and one bedroom and two baths upstairs. The rooms in the ell are smaller than those of the main structure and have lower ceilings. The 2nd floor level of the ell is slightly higher than the main part of the house. A doorway with two steps connects the stair landing and the ell porch. The porch has narrow chamfered columns and square balusters (see photo 5).

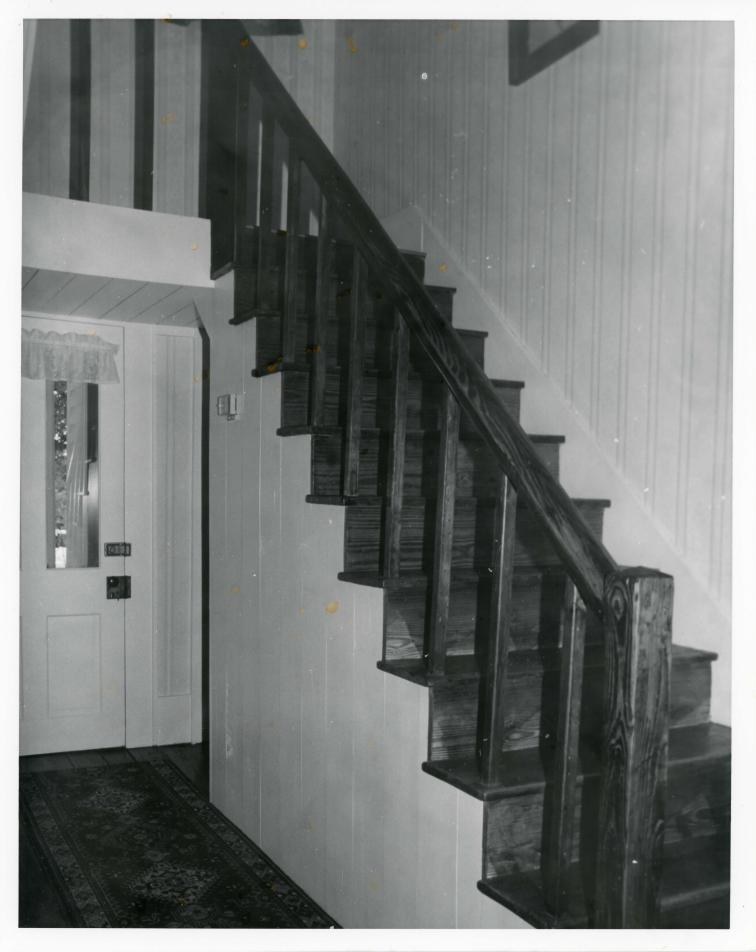
MORTON- ORGAIN HOUSE MAIN STREET SALADO, BELL CO., TEXAS PHOTOGRAPH 7 of 10

PHOTO 7 of 10: interior, stair hall.

The floor plan of the main structure is a center hall plan with entry hall stair and flanking symmetrical rooms upstairs and down. The resulting four rooms are of generous dimensions and each features a fireplace and mantle with simple classical inspired detailing. Enclosed porches on the east facade of the main structure contain bathrooms (see photo 4). The dog-leg entry hall stair climbs up three sides of the well. Newel post, balustrade and riser and tread details are simple (see photo 7).
